**Subject: Recall Campaigns M7 and JL (07V-375) and
Recall Campaign JV (07V-334)**

Subject: Revision to Safety Recall M7 (Fuel Pump)

2003 MY Passat with 1.8L Turbo or 2.8L V6 Engine

**2003 Model Year Audi A4 quattro with 1.8L Turbo or 3.0L Engine and
2003 Model Year Audi A6 with 3.0L Engine
Replace Fuel Pump**

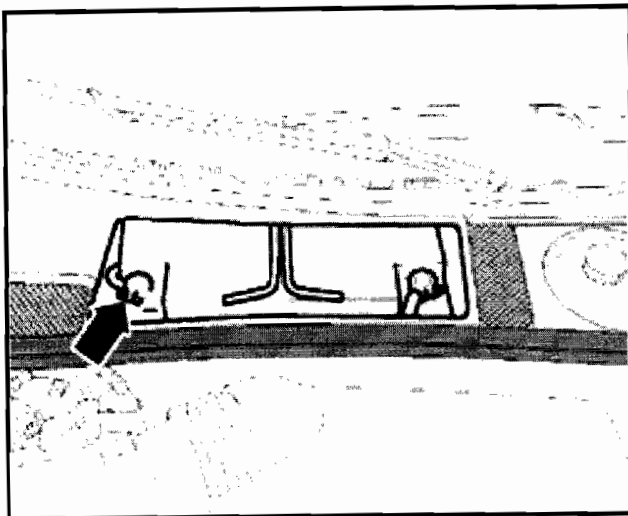
- Obtain radio anti theft coding
- Make note of quantity of fuel in fuel tank
- Switch off all electrical consumers
- Turn ignition switch to off position and remove key
- Open fuel filler door
- ⇐ Open hood and disconnect negative battery cable (GND) from battery
- Loosen gas cap to release any pressure from fuel tank
- If vehicle is front wheel drive, **go to Section B**
- If vehicle is 4Motion, **go to Section C**

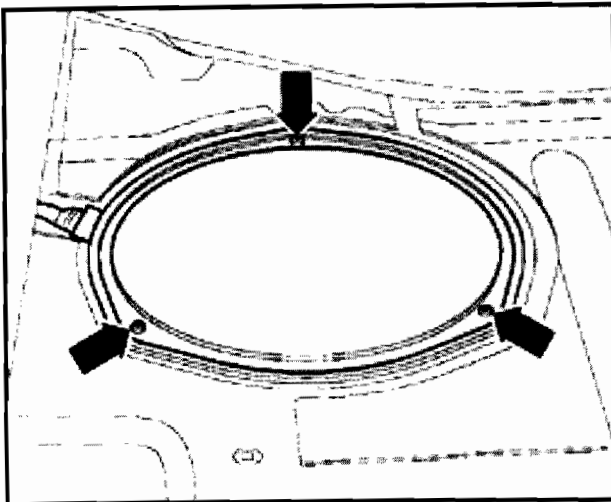
- If fuel tank is more than $\frac{1}{4}$ full, use FM 3000 GH fuel cart or equivalent and remove fuel to a level below $\frac{1}{4}$ full
- Fold right side rear seat back forward
- Remove luggage compartment floor covering
- ⇐ Remove Phillips screws -arrows- and cover for closing flange

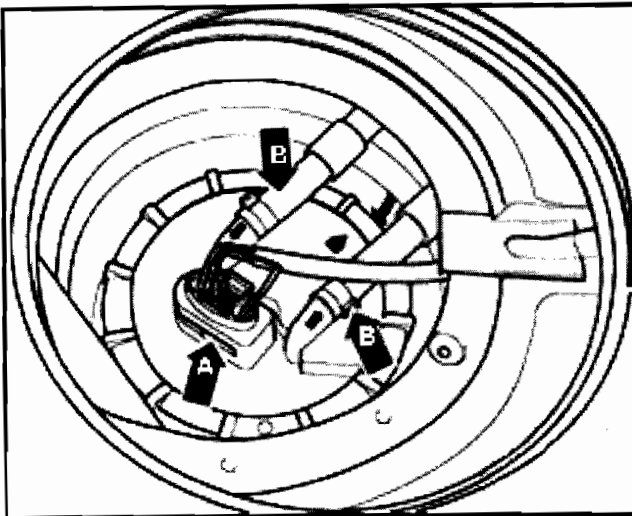
- ⇐ Disconnect 4-pin connector -arrow A- and fuel supply and return lines -arrow B- from closing flange
- Cover fuel lines to prevent dirt or debris from contaminating fuel

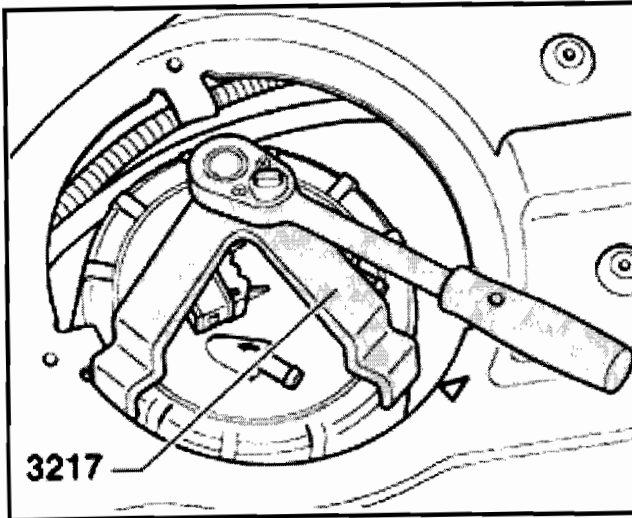
- ⇐ Use ring nut spanner tool 3217 and remove union nut
- Lift closing flange and remove sealing washer from fuel tank opening

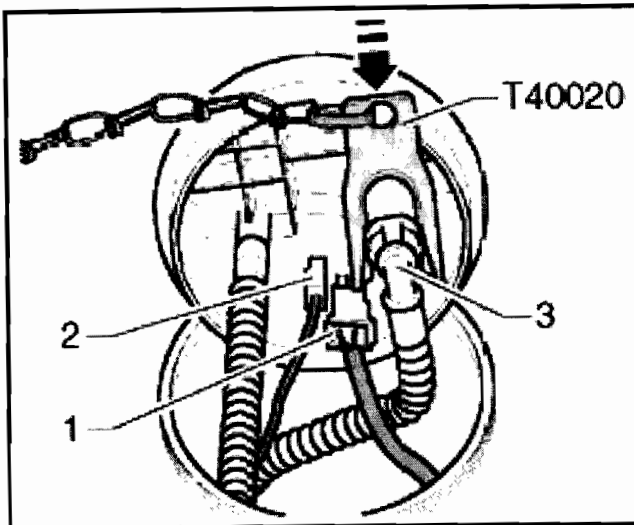
- ⇐ Disconnect connector -1- for fuel gauge from underside of flange
- ⇐ Disconnect fuel return line -3- from underside of flange using release tool T40020

Note: Connector -2- to fuel pump can remain connected

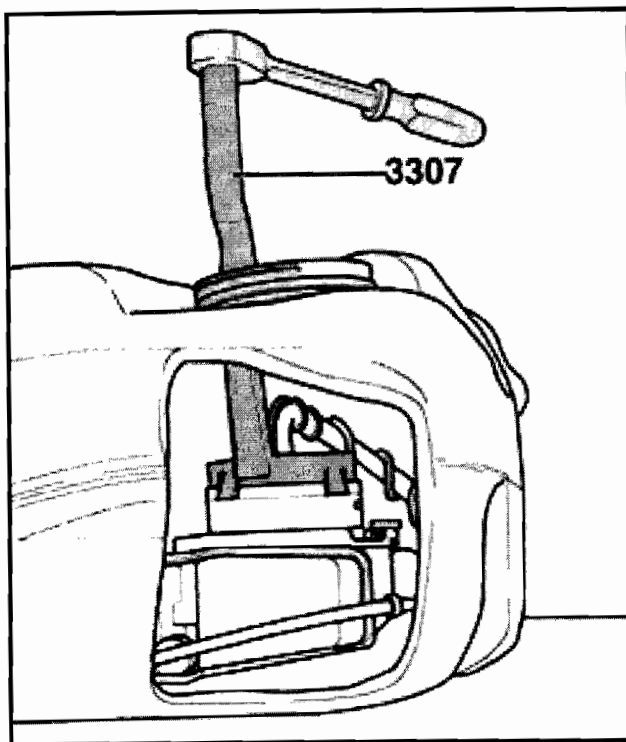
- ⇐ Insert 3307 fuel pump wrench into fuel tank opening and position on fuel delivery unit
- ⇐ Release fuel delivery unit by turning approximately 15° counterclockwise until it stops (bayonet connection)

ⓘ Note: For illustrative purposes, a cross-sectional view of fuel tank is shown

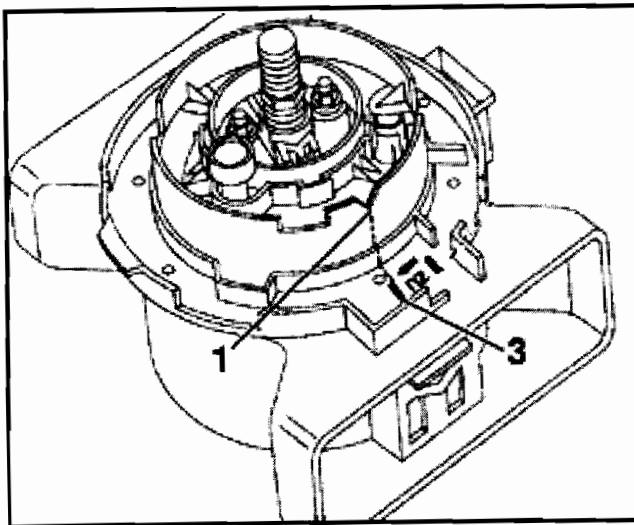
- Insert 3307 fuel pump wrench into fuel tank opening and position on fuel delivery unit
- ⇐ Secure fuel delivery unit in position by turning approximately 15° clockwise until notch -1- aligns with marking -3- (bayonet connection) and remove fuel pump wrench 3307

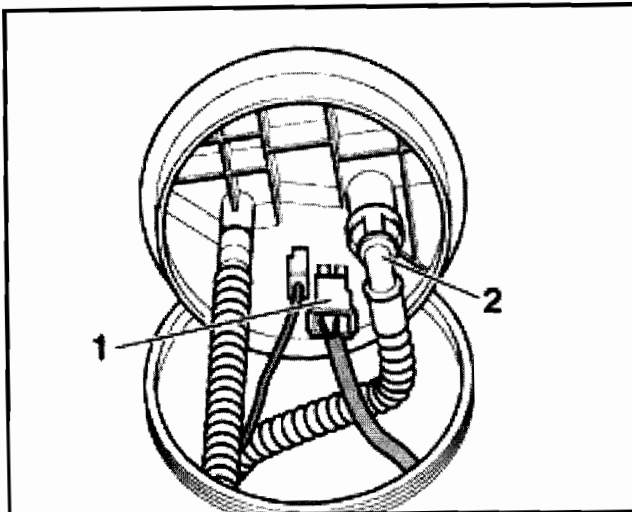
- ⇐ Reconnect fuel return line -2- to closing flange
- ⇐ Reconnect connector -1- for fuel gauge sender to closing flange
- Reinstall dry sealing washer into fuel tank opening

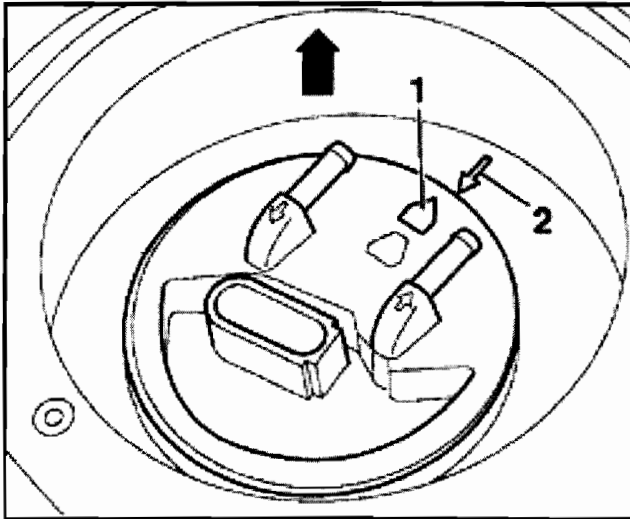
- Lubricate sealing washer with fuel, turn closing flange counter-clockwise and insert into fuel tank opening

⇐ Marking -1- on closing flange must align with arrow -2- on fuel tank

**Note:** Black arrow in illustration is pointing toward front of vehicle

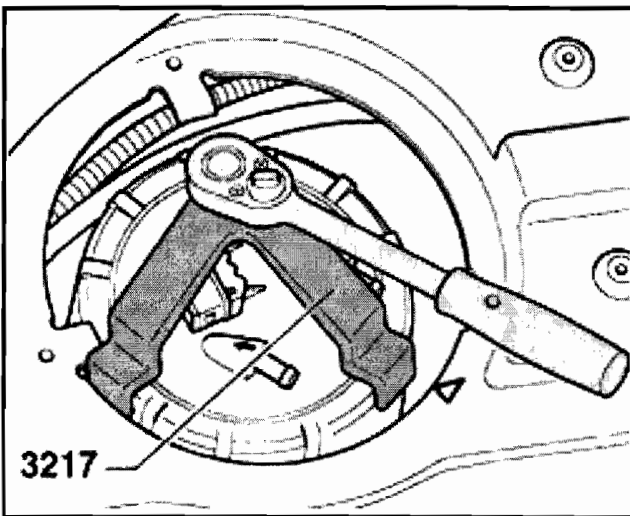
⇐ Secure closing flange to fuel tank with union nut and using ring nut spanner tool 3217, tighten to 60 Nm (44 ft. lbs.)

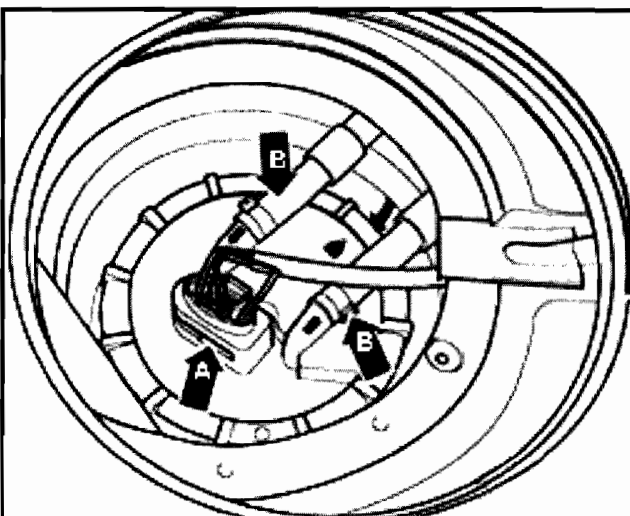
⇐ Reconnect fuel return and supply lines -arrow B- to closing flange and secure with new clamps (N 101 969 01)

- Reconnect harness connector -arrow A- to closing flange
- Reinstall closing flange cover and secure with Phillips screws
- Reposition luggage compartment floor covering and rear seat back
- **Proceed to Section D**

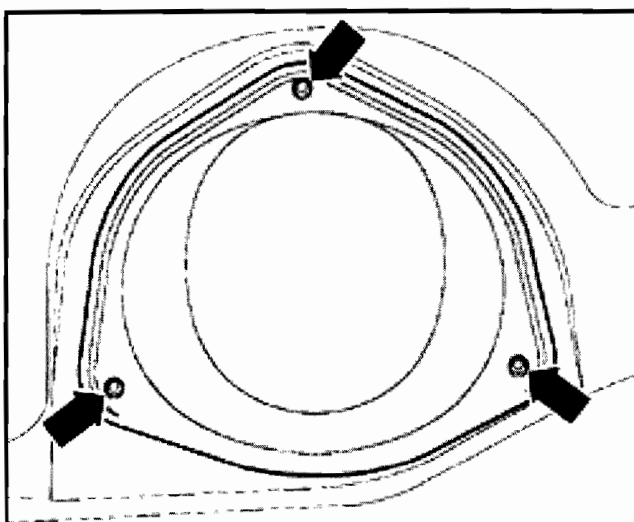
- If fuel tank is more than $\frac{1}{4}$ full, use FM 3000 GH fuel cart or equivalent and remove fuel to a level below $\frac{1}{4}$ full
- Lift up right side rear seat bottom and fold forward
- Move cover material aside to access cover for locking flange
- ⇐ Remove Phillips screws -arrows- and cover for locking flange on right side of vehicle

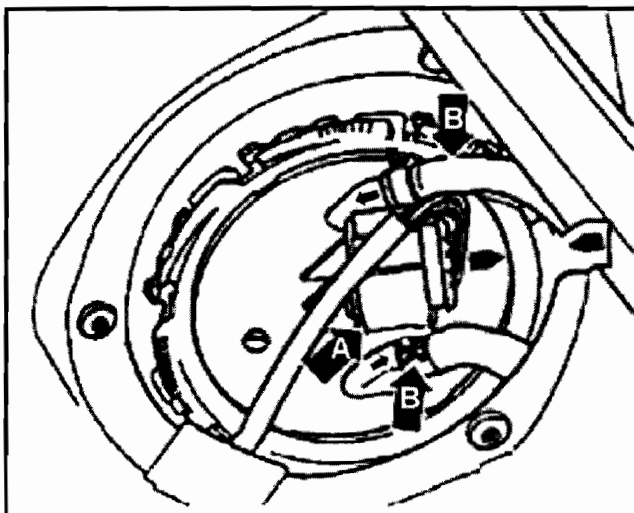
- ⇐ Disconnect 4-pin connector -arrow A- and fuel supply and return lines -arrow B- from flange
- Cover fuel lines to prevent dirt or debris from contaminating fuel

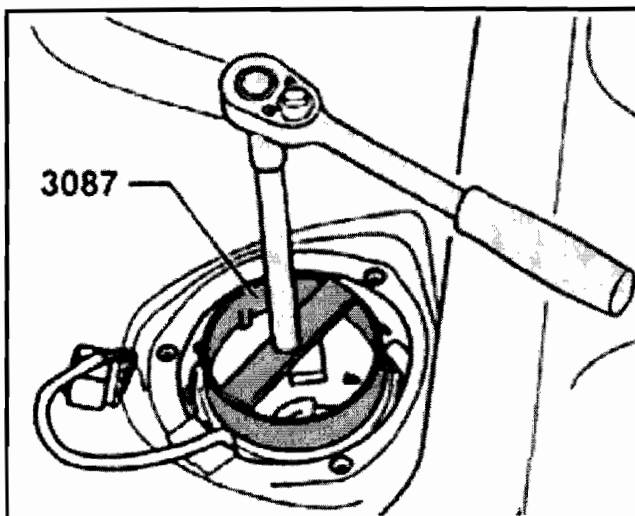
⇐ Remove locking ring using 3087 wrench

- Lift closing flange and remove sealing washer from fuel tank opening

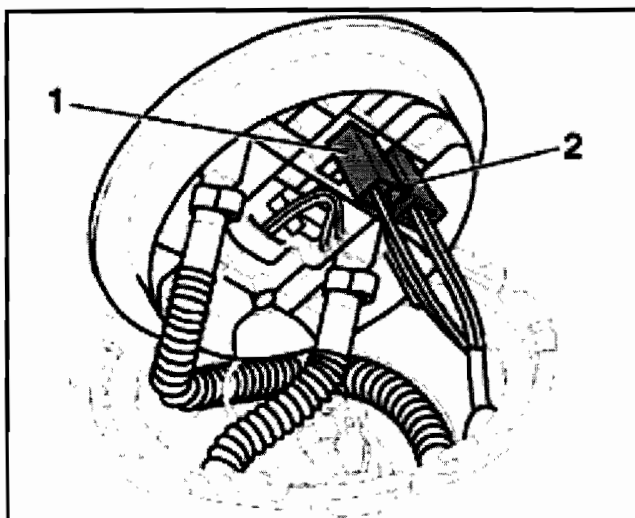
⇐ Disconnect both harness connectors -1- and -2- for fuel gauge from underside of closing flange

- Make note of connector location for reassembly

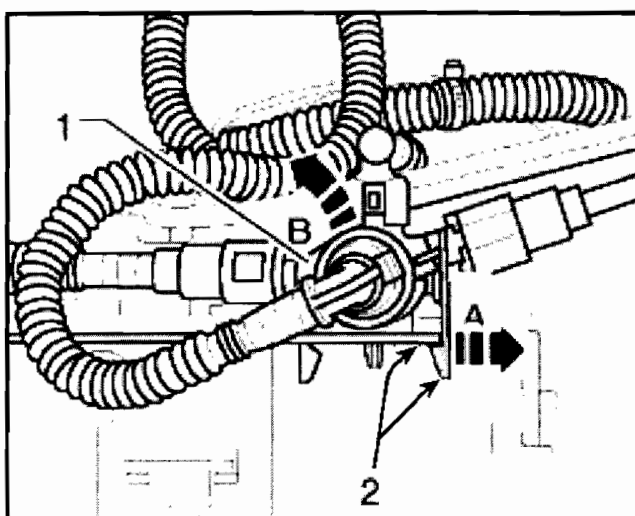
⇐ Unclip fuel distributor piece -1- from baffle housing by pressing two catches -2- toward outside -arrow A- to release and lift in direction of -arrow B-

Note: For illustrative purposes, baffle housing is shown without fuel tank

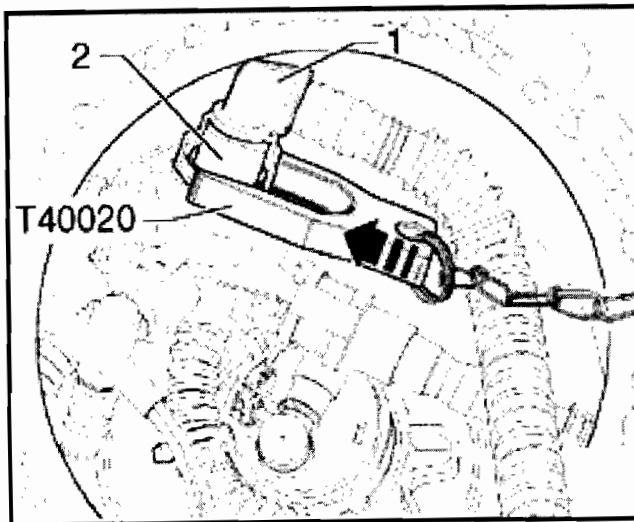
- ⇐ Disconnect fuel return line -1- from fuel distributor connector -2- using unlocking tool T40020

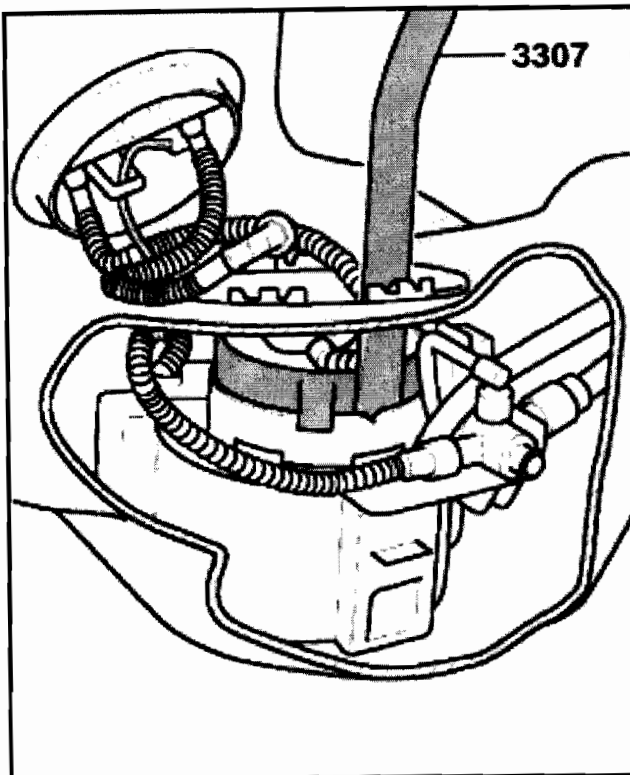
- ⇐ Insert 3307 fuel pump wrench into fuel tank opening and position on fuel delivery unit
- ⇐ Release fuel delivery unit by turning approximately 15° counterclockwise until it stops (bayonet connection)

Note: For illustrative purposes, a cross-sectional view of fuel tank is shown

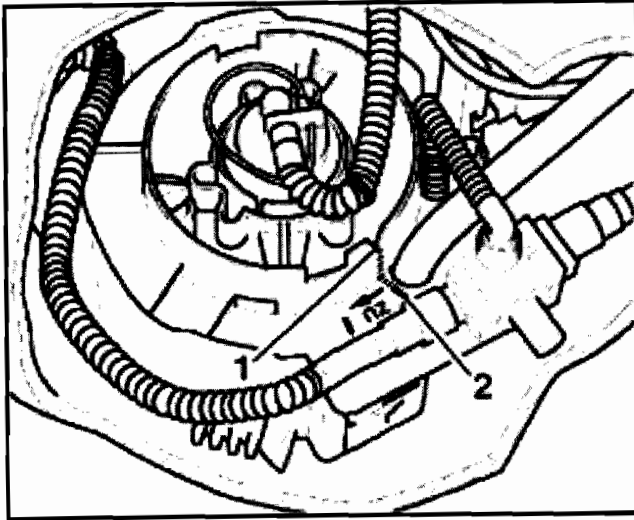
- ⇐ Remove fuel delivery unit from baffle housing when notch -1- is aligned with mark -2-

- Insert new fuel delivery unit (8E0 906 087 E) into baffle housing
- ⇐ Align notch -1- on fuel delivery unit with marking -2- on baffle housing and press fuel delivery unit downward

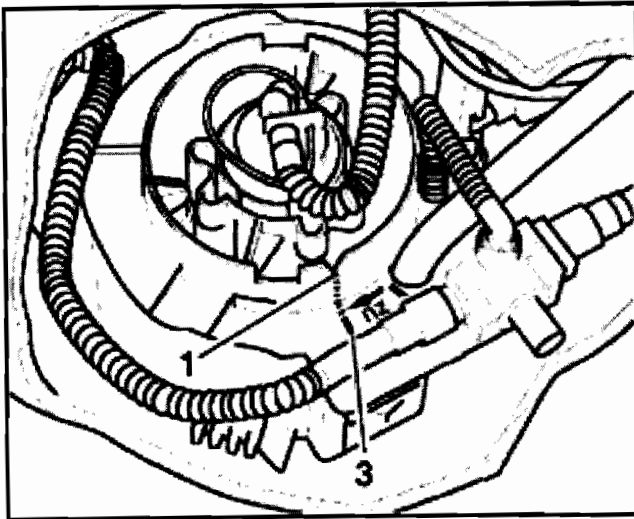
- Insert 3307 fuel pump wrench into fuel tank opening and position on fuel delivery unit
- ⇐ Secure fuel delivery unit in correct position by turning approximately 15° clockwise until notch -1- aligns with marking -3- (bayonet connection) and remove fuel pump wrench 3307

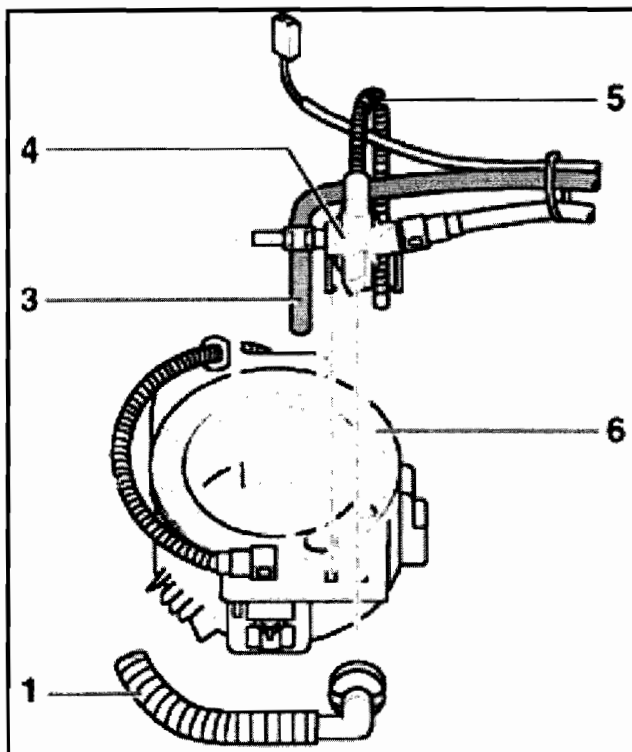
- Lubricate O-ring seals in fuel return line connector -1- with fuel prior to connecting to distributor

⇐ Push fuel return line -1- onto distributor connector -4- until coupling engages

⇐ Re-clip distributor connector -4- onto accumulator -6-

Note: Make certain solid line -3- and hose -5- are still in relevant openings of accumulator -6-

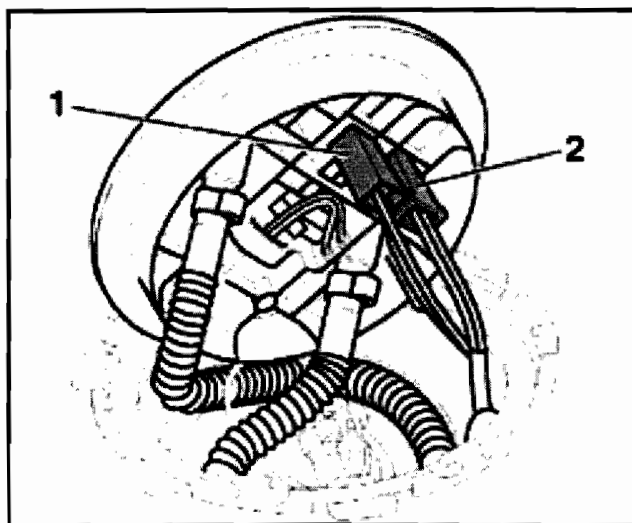
⇐ Reconnect white harness connector -1- for fuel level sensor to fuel supply side and black harness connector -2- for fuel level sensor 2 to fuel return side on underside of closing flange

- Reinstall dry sealing washer into fuel tank opening

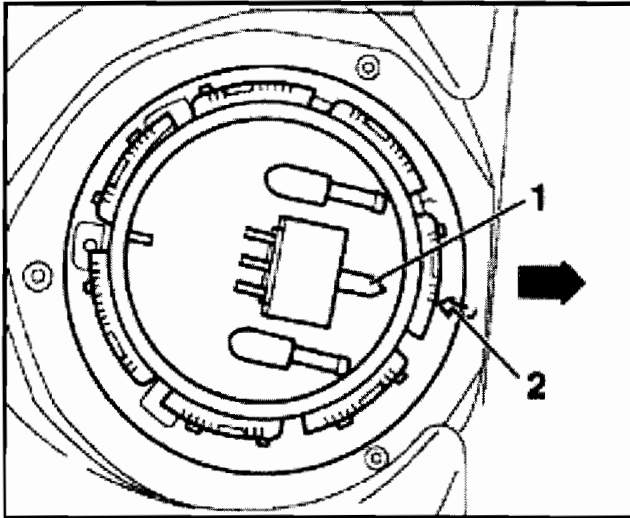
- Lubricate inside surface of sealing washer with fuel
- ⇐ Install closing flange into tank opening making certain marking -1- is aligned with arrow -2- on fuel tank
- Check that sealing washer is correctly seated

Note: Black arrow in illustration is pointing toward front of vehicle

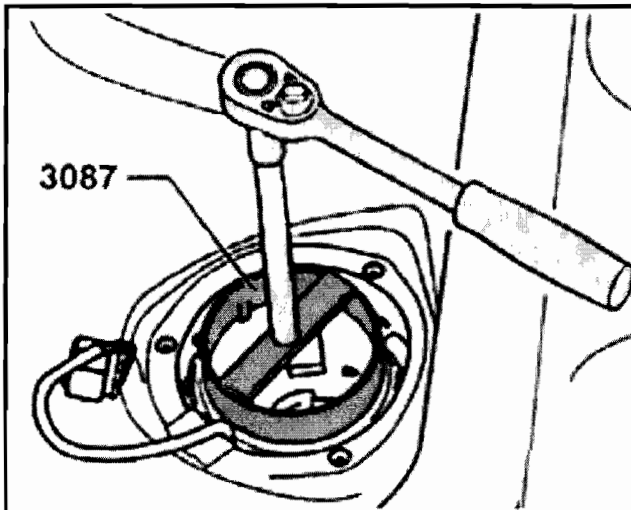
- ⇐ Secure closing flange with locking ring using 3087 wrench and tighten to 145 Nm (106 ft. lbs.)

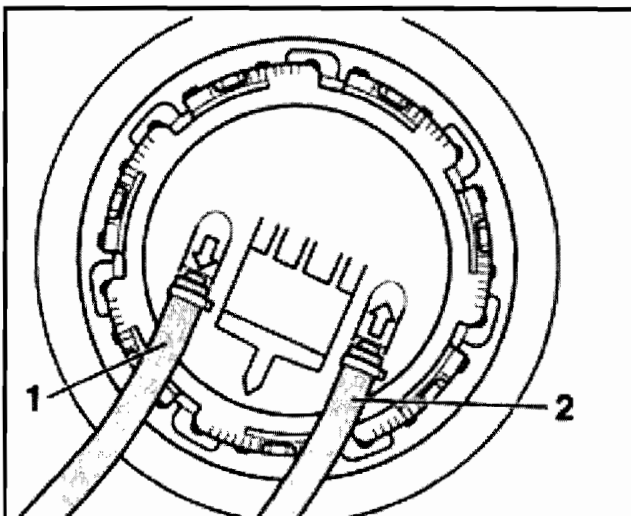
- ⇐ Connect fuel supply line -1- and fuel return line -2- to closing flange and secure with new clamps (N 101 969 01)
- Reconnect 4-pin electrical connector
- Reinstall cover for closing flange with indentation over electrical connector and secure with Phillips screws
- Reposition rear seat bottom
- **Proceed to Section D**

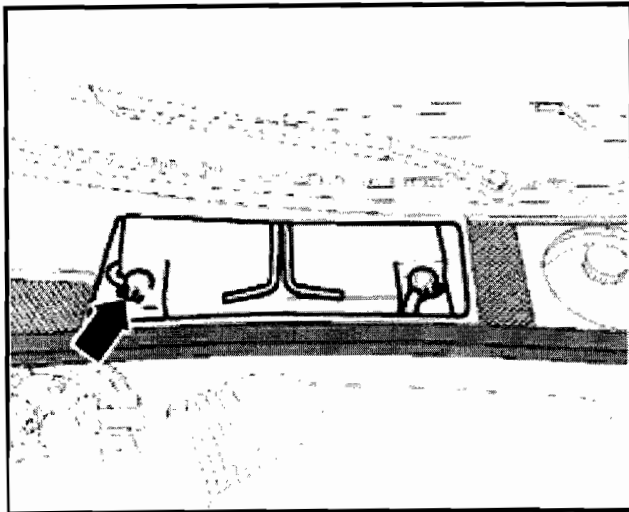
- If fuel was removed from vehicle, return fuel to vehicle
- ⇐ Reconnect the negative battery cable (GND) to the battery and tighten bolt to 5 Nm (44 in. lbs.)
- If required, reactivate radio with radio code
- Reset window pinch protection
- Reset time on clock
- Clear diagnostic trouble codes (DTCs) and reset readiness code
- Destroy and properly dispose of removed parts in accordance with local, state and federal/provincial environmental regulations

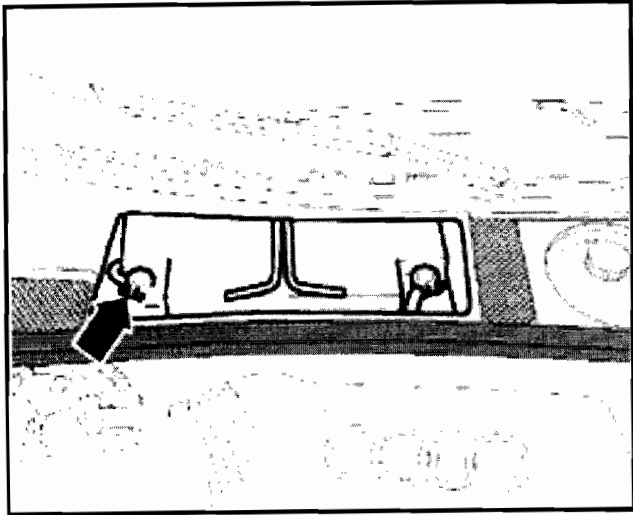
- Obtain radio anti theft coding
- Make note of quantity of fuel in fuel tank
- Switch off all electrical consumers
- Turn ignition switch to the off position and remove key
- If vehicle is equipped with Audi Telematics, by OnStar®, switch-off emergency (back up) battery for Telematic/Telephone control module prior to disconnecting vehicle battery
- ⇐ Open hood, remove battery cover and disconnect the negative battery cable (GND) from the battery
- Loosen gas cap to release any pressure in fuel tank and retighten
- If vehicle is A6 front wheel drive **go to Section B**
- If vehicle is A4 quattro **go to Section C**
- If vehicle is A6 quattro **go to Section D**

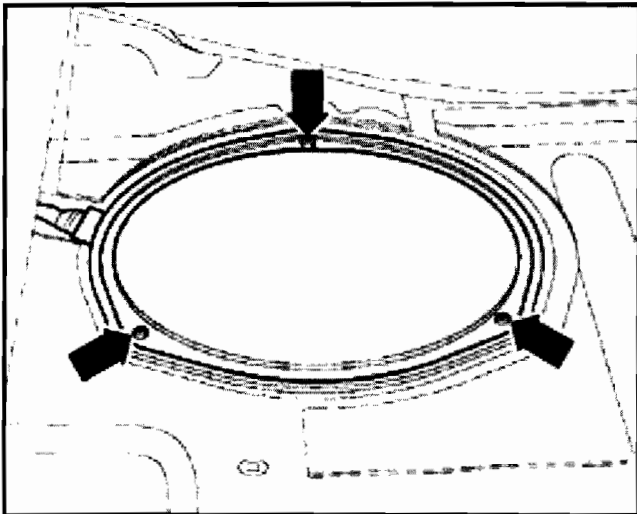
- If fuel tank is more than $\frac{1}{4}$ full, use FM 3000GH fuel cart and remove fuel to a level of $\frac{1}{4}$ full
 - Remove luggage compartment floor covering and fold right rear seatback forward
- ⇐ Remove Phillips screws and cover on floor to access the fuel delivery unit -arrows-

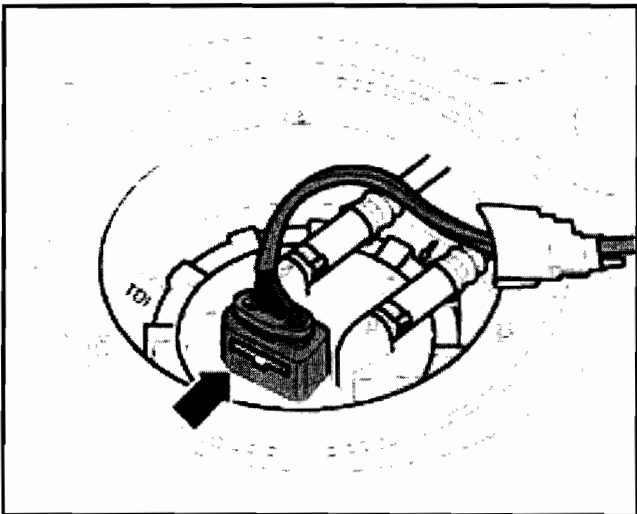
- ⇐ Carefully release 4-pin harness connector -arrow- and disconnect

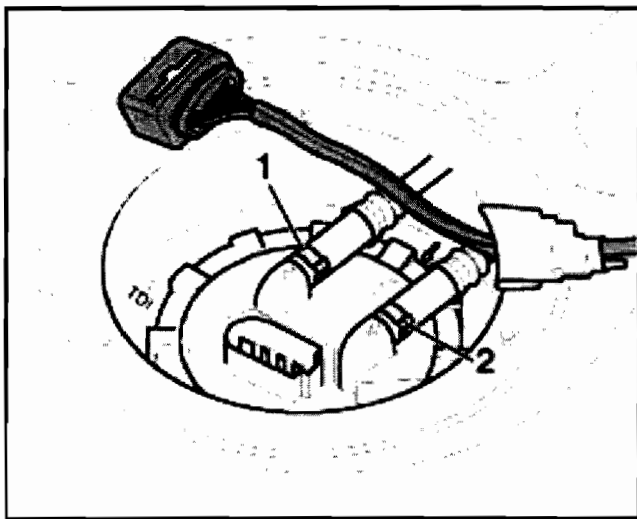
⇐ Mark fuel supply line -2- and fuel return line -1- for reconnection

- Remove clamps and disconnect both fuel lines
- Cover fuel lines to prevent dirt or debris from contaminating fuel

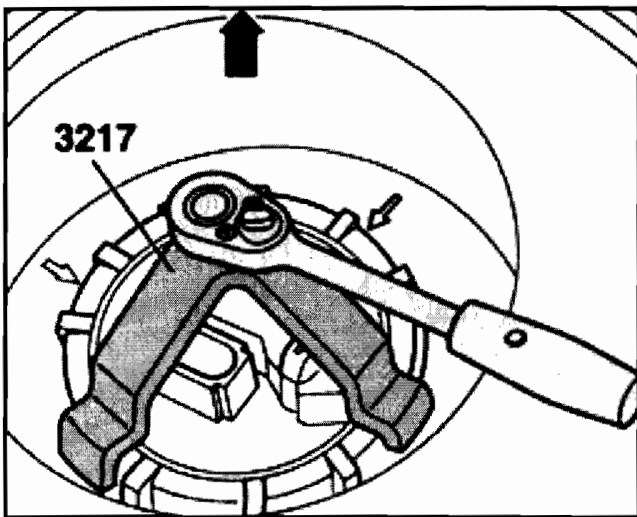
Fuel delivery unit may only be removed when fuel tank is a maximum $\frac{1}{4}$ full. A fuel tank more than $\frac{1}{4}$ full may spill out a large amount of fuel.

Note: Black arrow in illustration is pointing toward front of vehicle

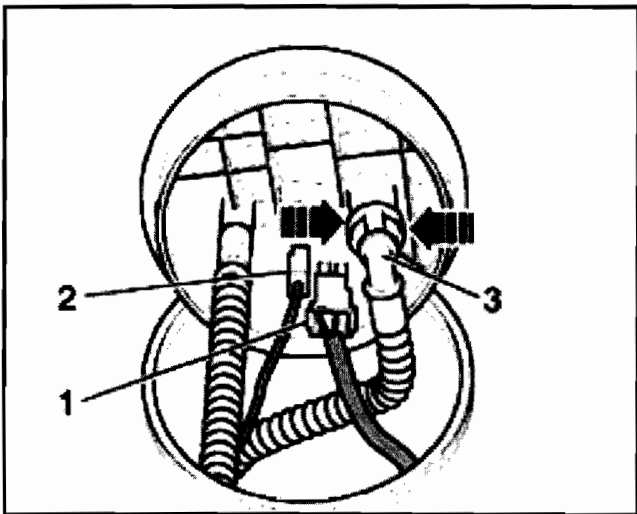
⇐ Disconnect harness connector -1- for sender for fuel gauge from underside of closing flange

⇐ Disconnect fuel return line -3- from underside of flange by pressing release tabs -arrows- on connector

Note: Harness connector -2- remains connected to closing flange

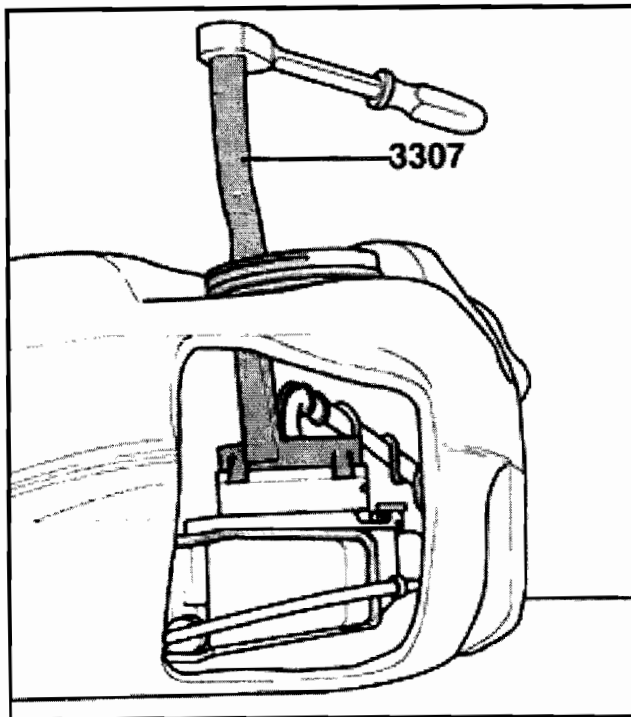
- ⇐ Insert 3307 fuel pump wrench into fuel tank opening and position on fuel delivery unit
- ⇐ Release fuel delivery unit by turning approximately 15° counterclockwise until it stops (bayonet connection)

Note: For illustrative purposes, a cross-sectional view of fuel tank is shown

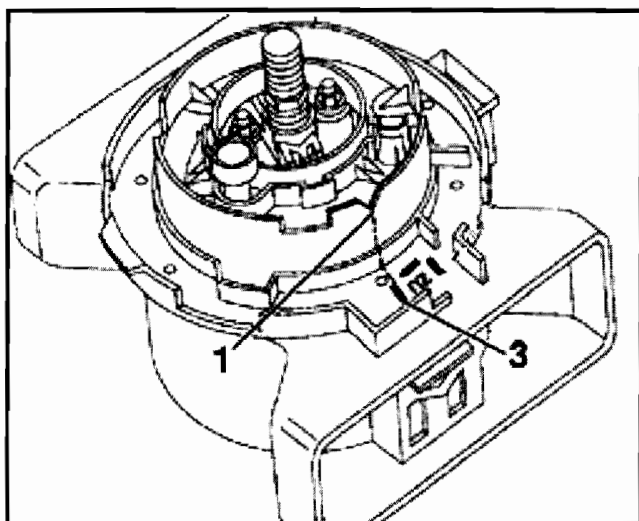
- Insert 3307 fuel pump wrench into fuel tank opening and position on fuel delivery unit
- ⇐ Secure fuel delivery unit in position by turning approximately 15° clockwise until notch -1- aligns with marking -3- (bayonet connection) and remove fuel pump wrench 3307

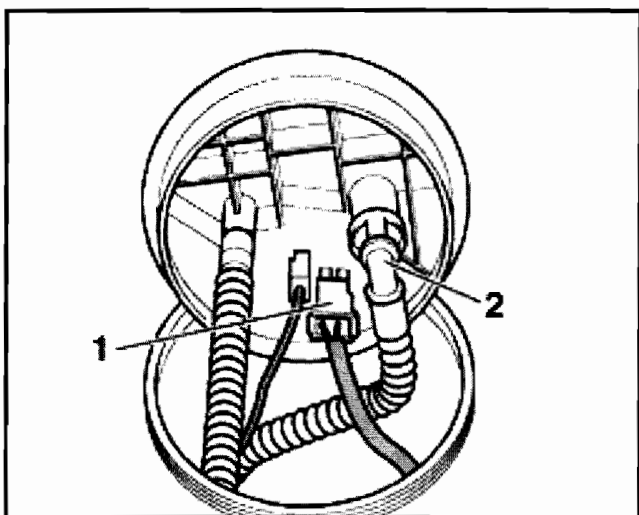
- ⇐ Reconnect fuel return line -2- to closing flange
- ⇐ Reconnect connector -1- for fuel gauge sender to closing flange
- Insert new dry sealing washer (1J0 919 133 A) into fuel tank opening

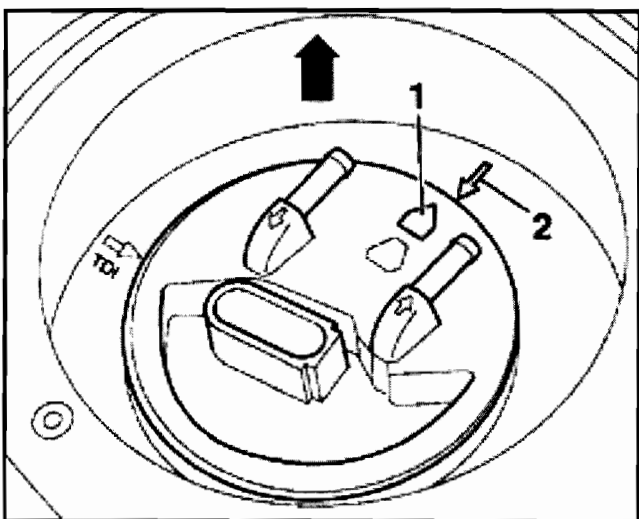
- Lubricate sealing washer with fuel, turn closing flange counter-clockwise and insert into sealing washer
- ⇐ Marking -1- on closing flange must align with arrow -2- on fuel tank

Note: Black arrow in illustration is pointing toward front of vehicle
DO NOT use "TDI" marking on fuel tank

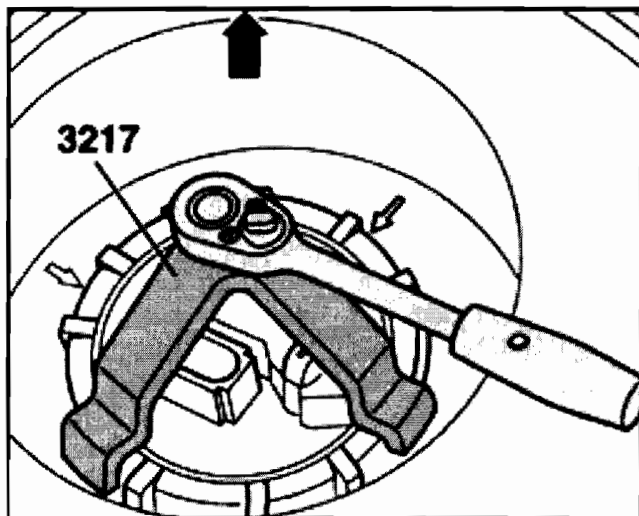
- ⇐ Secure closing flange to fuel tank with union nut and using ring nut spanner tool 3217, tighten to 80 Nm (59 ft. lbs.)

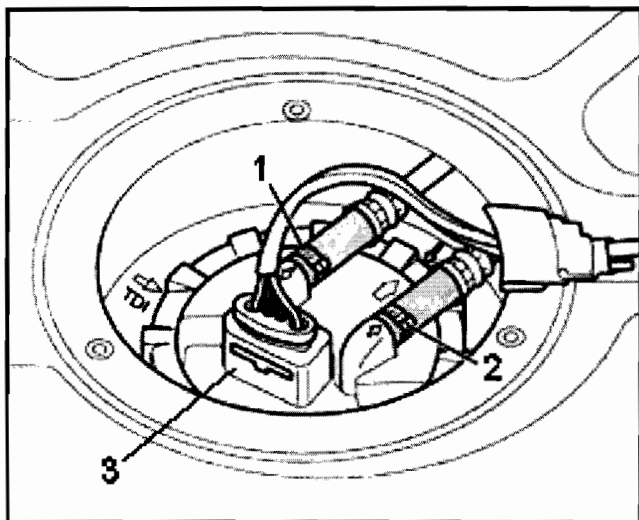
- ⇐ Reconnect fuel return line -1- and fuel supply line -2- to closing flange and secure with new clamps (N 101 969 01)
- ⇐ Reconnect harness connector -3- to closing flange
- Reinstall closing flange cover and secure with Phillips screws
- Reposition luggage compartment floor covering and rear seat back
- If fuel was removed from vehicle, return fuel to the vehicle
- **Proceed to Section E**

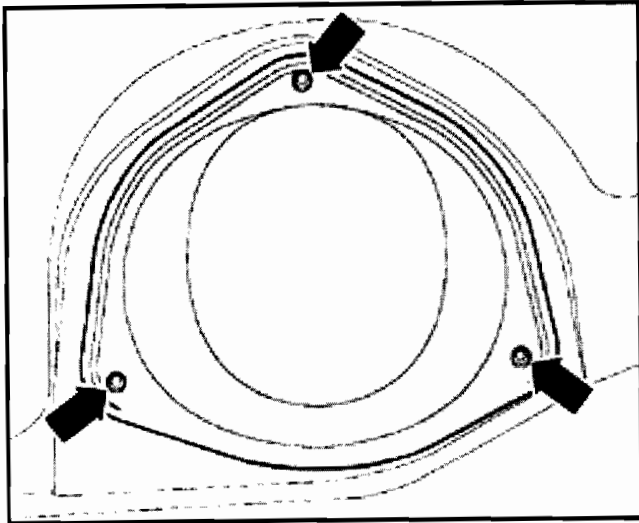
⇐ Remove Phillips screws -arrows- and cover for closing flange on right side of vehicle

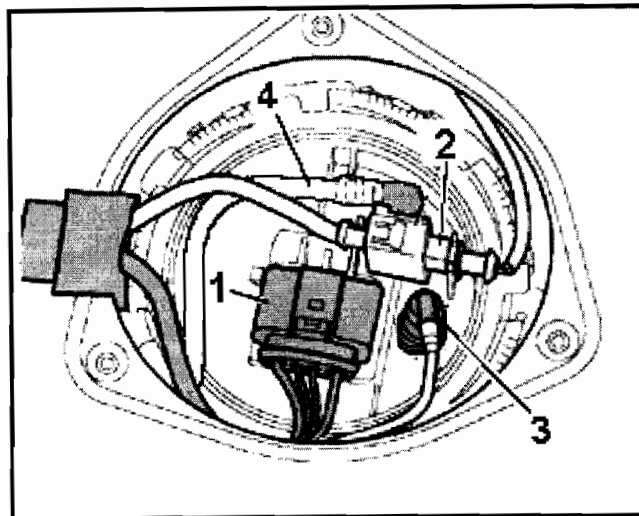
Vehicles with 1.8L Turbo Engine

⇐ Disconnect ventilation line -3- by pressing the release buttons

⇐ Disconnect fuel line -4- from closing flange by pressing release buttons

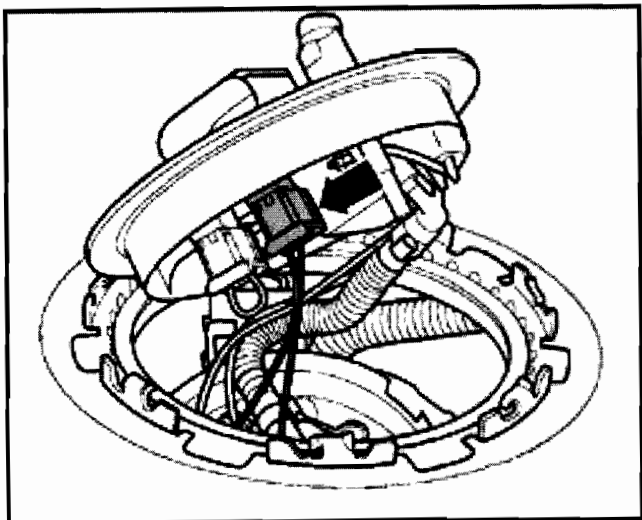
- Remove locking ring using T10202 wrench
 - Lift closing flange and remove sealing washer from fuel tank opening
- ⇐ Disconnect electrical connector -arrow- from underside of closing flange

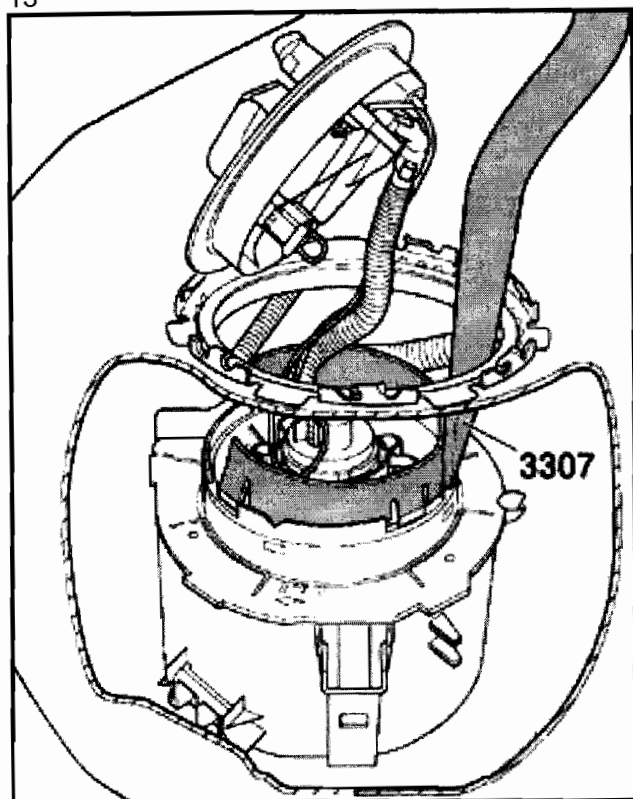
- ⇐ Insert 3307 fuel pump wrench into fuel tank opening and position on fuel delivery unit
- ⇐ Release fuel delivery unit by turning approximately 15° counterclockwise until it stops (bayonet connection)

Note: For illustrative purposes, a cross-sectional view of fuel tank is shown

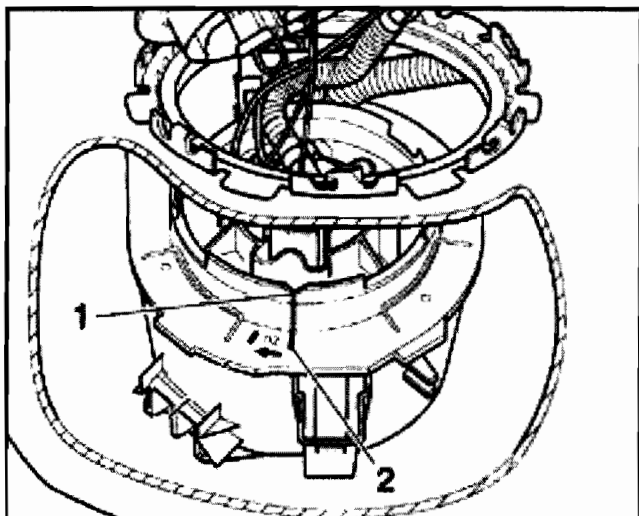
- ⇐ Remove fuel delivery unit from baffle housing when notch -1- is aligned with mark -2-

- ⇐ Insert new fuel delivery unit (for 1.8L Turbo engine use part number 8E0 906 087 P and for 3.0L engine use part number 8E0 906 087 N) into baffle housing
- ⇐ Align notch -1- on fuel delivery unit with marking -2- on baffle housing and press fuel delivery unit downward

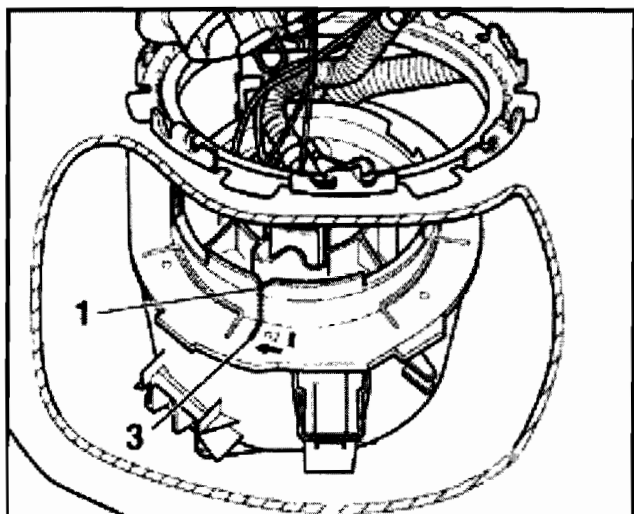
- Insert 3307 fuel pump wrench into fuel tank opening and position on fuel delivery unit
- ⇐ Secure fuel delivery unit in position by turning approximately 15° clockwise until notch -1- aligns with marking -3- (bayonet connection) and remove fuel pump wrench 3307

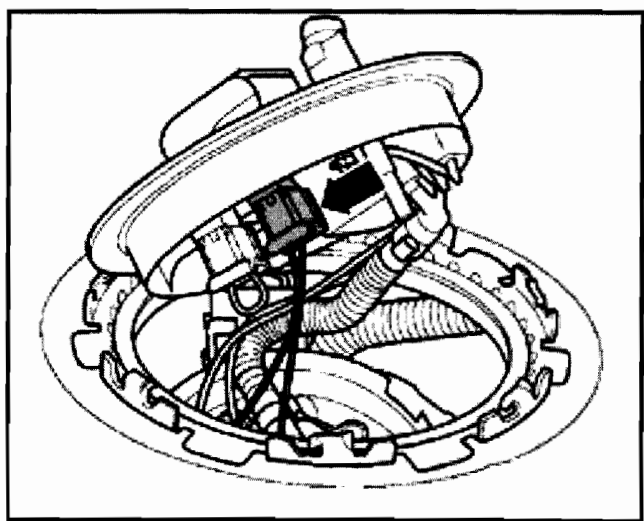
- ⇐ Reconnect electrical connector -arrow- onto underside of closing flange
- Install new closing flange seal dry (8E0 919 133 G) into fuel tank opening
- Lubricate sealing washer with fuel

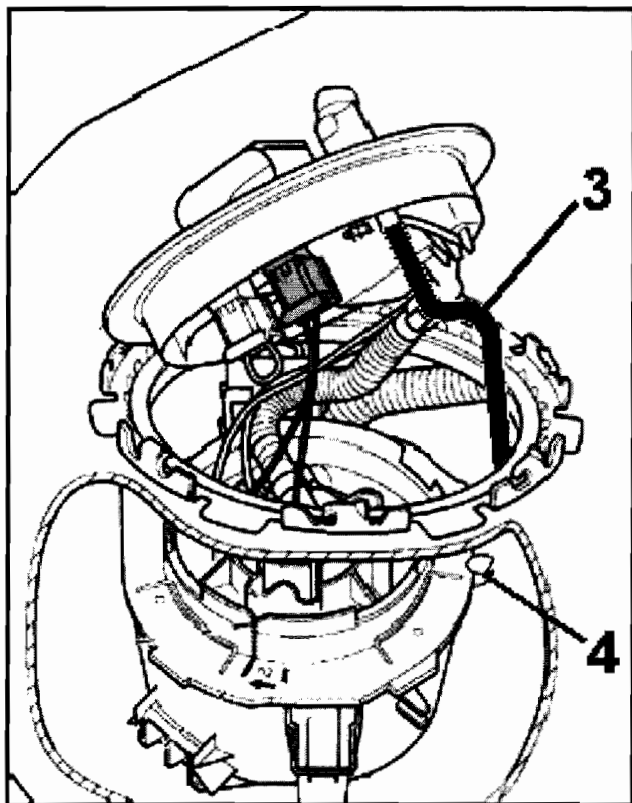
Vehicles with 1.8L Turbo Engine

- ⇐ While pushing closing flange into fuel tank opening, guide vent line -3- into holder -4- on side of baffle

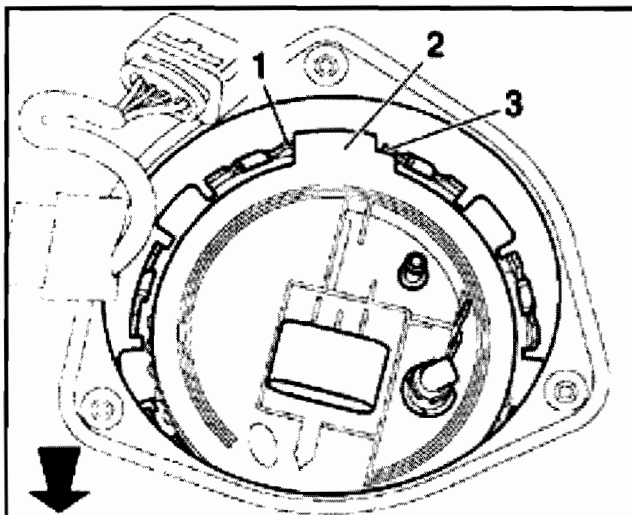
Vehicles with 1.8L Turbo and 3.0L Engine

- ⇐ Position tab -2- on locking flange between tabs -1- and -3- on fuel tank and push closing flange into sealing washer
- Secure closing flange with locking ring and tighten to 145 Nm (106 ft. lbs.) using T10202 wrench

Note: Arrow in illustration is pointing toward front of vehicle

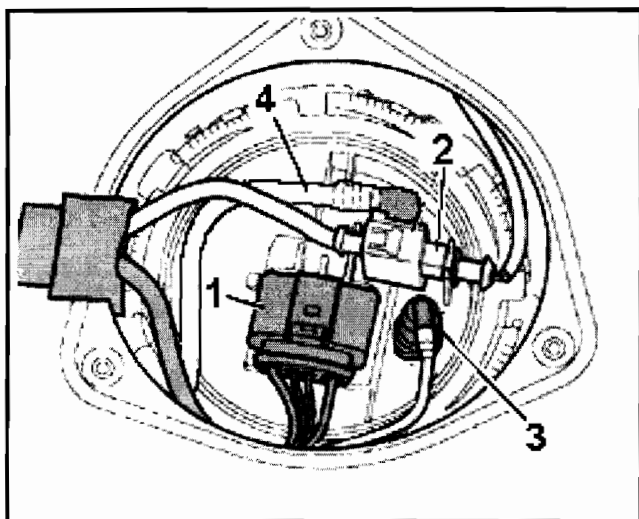
- ⇐ Reconnect fuel line -4- to closing flange
- ⇐ Clip electrical harness connector -2- onto closing flange
- ⇐ Reconnect electrical harness connector -1-

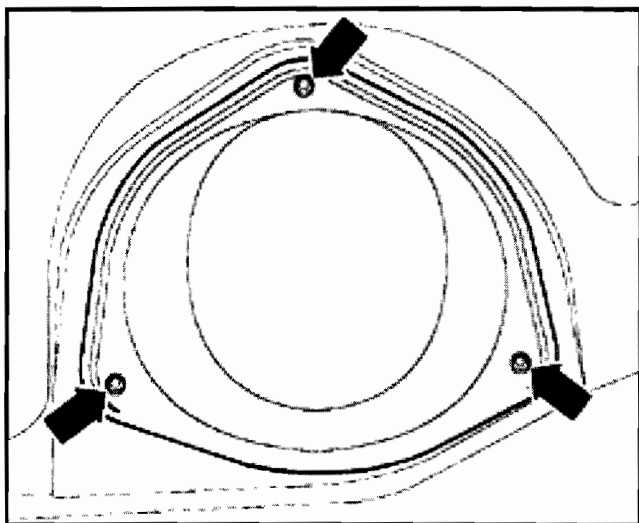
- If fuel tank is more than $\frac{1}{4}$ full, use FM 3000GH fuel removal cart or equivalent and remove fuel to a level below $\frac{1}{4}$ full
- Remove rear seat bottom
- ⇐ Remove Phillips screws -arrows- and cover for locking flange on right side of vehicle

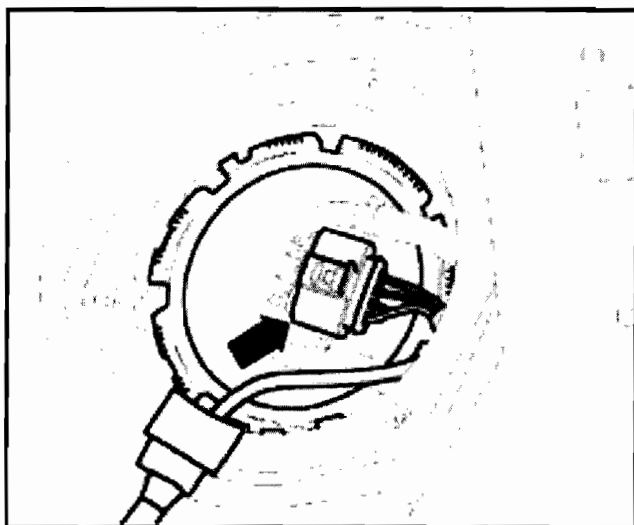
- ⇐ Carefully release 4-pin harness connector -arrow- and disconnect

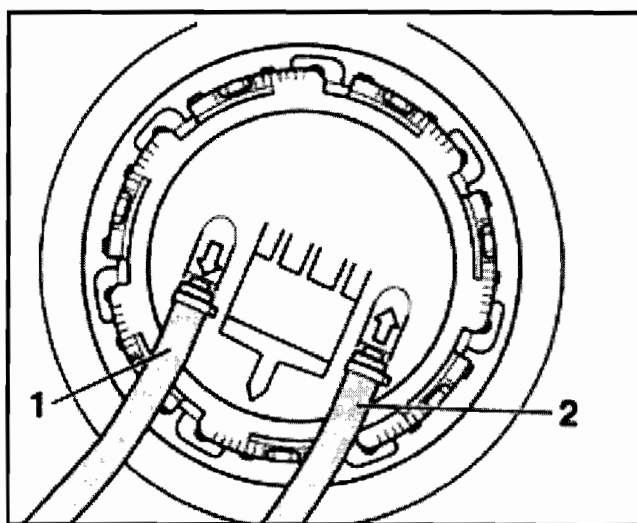
- ⇐ Mark fuel supply line -1- and return line -2- for reconnection and disconnect from closing flange
- Cover fuel lines to prevent dirt or debris from contaminating fuel

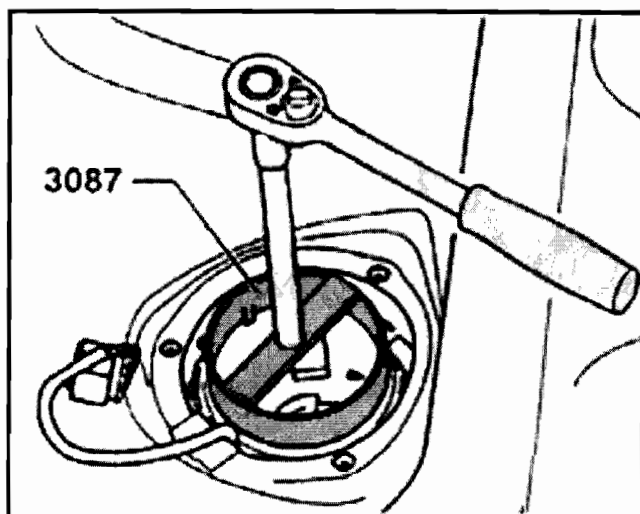
- ⇐ Remove locking ring using 3087 wrench or T10202 wrench
- Lift closing flange and remove sealing washer from fuel tank opening

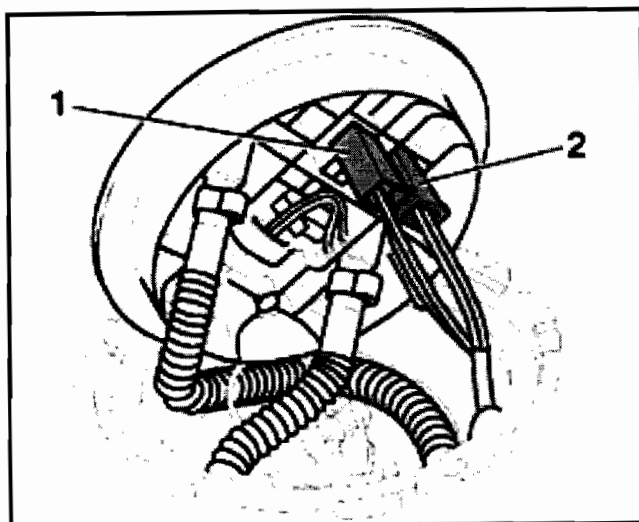
⇐ Disconnect both harness connectors -1- and -2- for fuel gauge from underside of closing flange

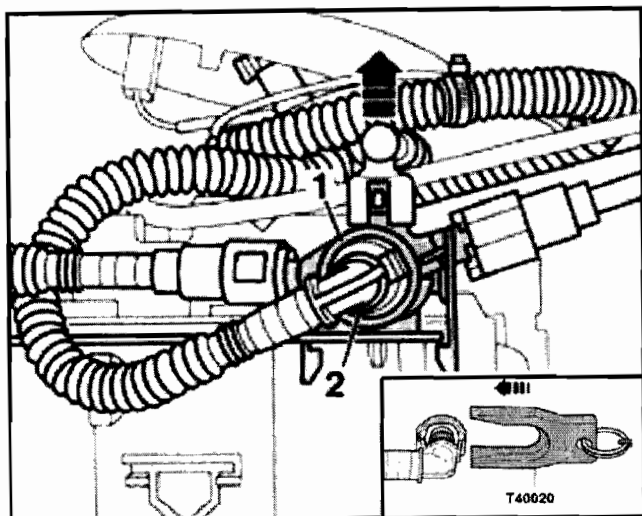
⇐ Disengage fuel distributor connector -1- from accumulator by pressing fuel distributor connector slightly to left side of vehicle and lift upward -arrow-

⇐ Disconnect fuel return line -2- from fuel distributor connector using unlocking tool T40020

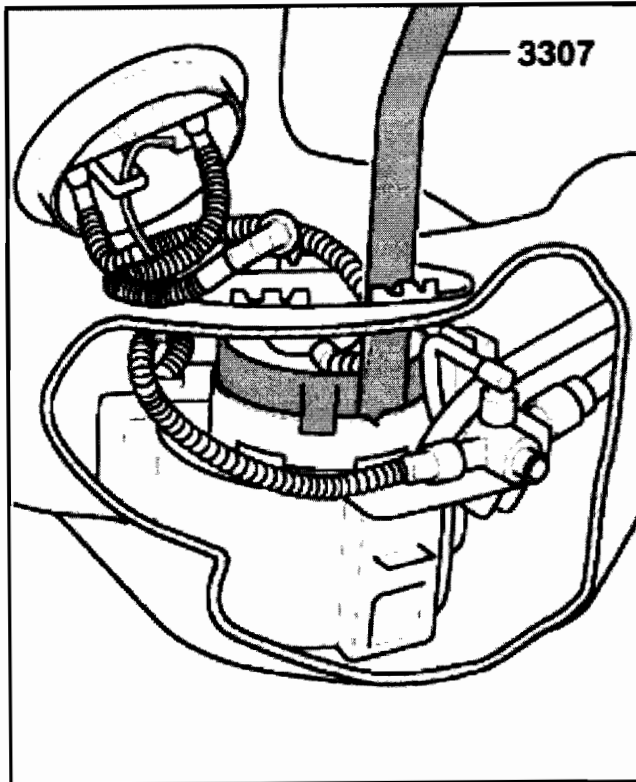
- ⇐ Insert 3307 fuel pump wrench into fuel tank opening and position on fuel delivery unit
- ⇐ Release fuel delivery unit by turning approximately 15° counterclockwise until it stops (bayonet connection)

Note: For illustrative purposes, a cross-sectional view of the fuel tank is shown
