**Subject: Recall Campaigns M7 and JL (07V-375) and
Recall Campaign JV (07V-334)**

Subject: Revision to Safety Recall M7 (Fuel Pump)

2003 MY Passat with 1.8L Turbo or 2.8L V6 Engine

**2003 Model Year Audi A4 quattro with 1.8L Turbo or 3.0L Engine and
2003 Model Year Audi A6 with 3.0L Engine
Replace Fuel Pump**

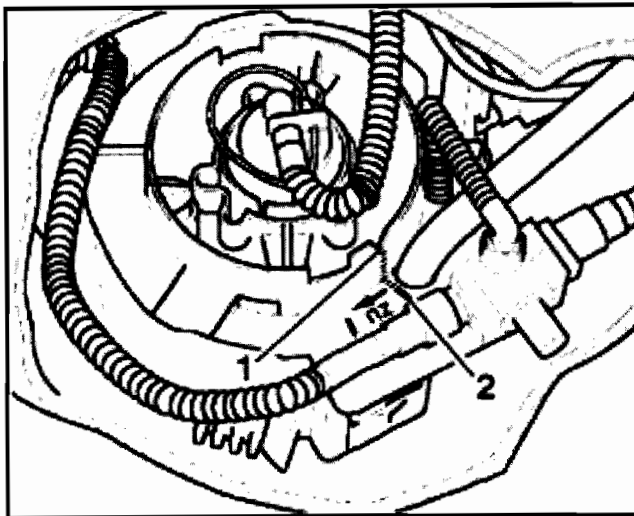
- ⇐ Remove fuel delivery unit from baffle housing when notch -1- is aligned with mark -2-

- ⇐ Insert new fuel delivery unit (8E0 906 087 E) into baffle housing
- ⇐ Align notch -1- on fuel delivery unit with marking -2- on baffle housing and press fuel delivery unit downward

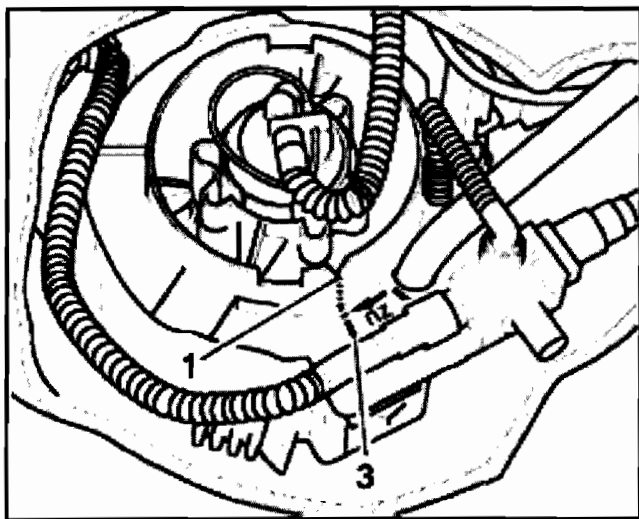
- Insert 3307 fuel pump wrench into fuel tank opening and position on fuel delivery unit
- ⇐ Secure fuel delivery unit in position by turning approximately 15° clockwise until notch -1- aligns with marking -3- (bayonet connection) and remove fuel pump wrench 3307

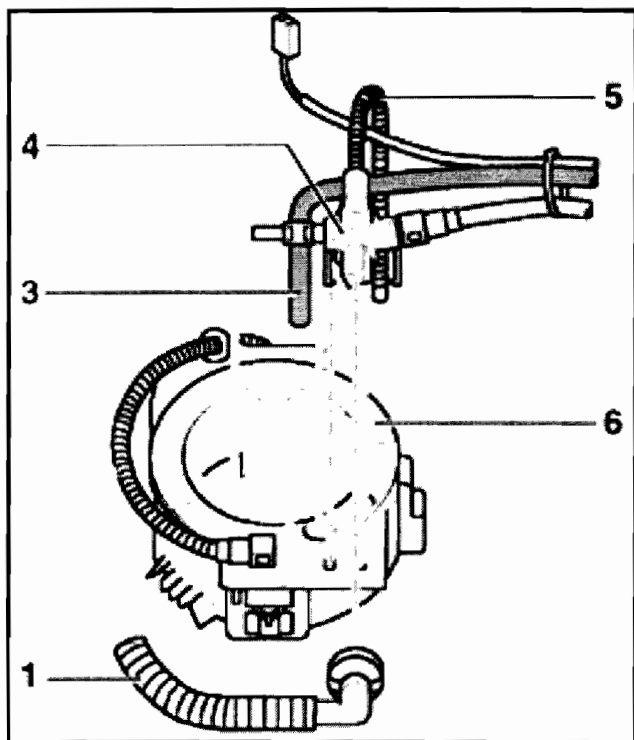
- ⇐ Insert solid line -3- and hose -5- into relevant openings of accumulator -6-
- ⇐ Lubricate O-rings inside fuel return line -1- connector with fuel and push connector onto distributor connector -4- until coupling engages
- ⇐ Re-clip distributor connector -4- onto accumulator -6- and check that the clips are holding

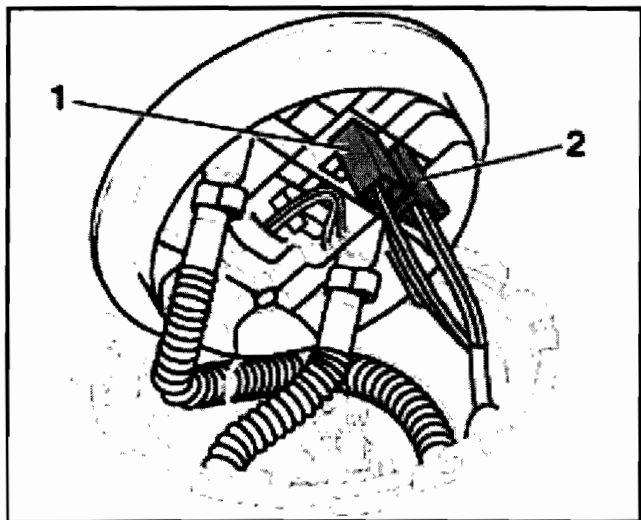
⇐ Reconnect both harness connectors -1- and -2- for fuel gauge to underside of closing flange

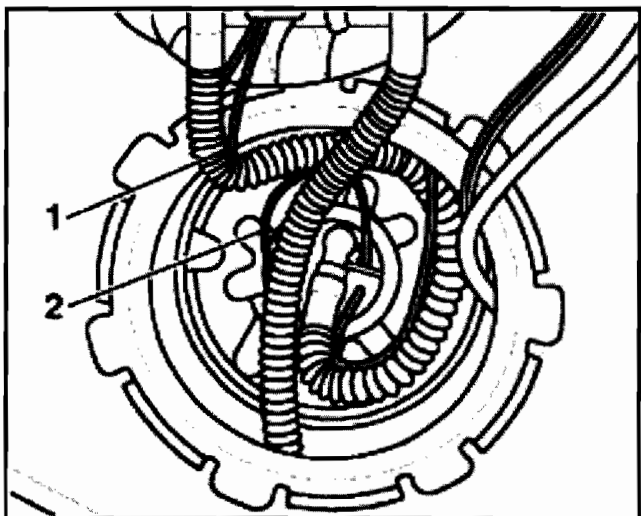
⇐ Ensure that wiring for fuel pump -2- and fuel return line -1- is correctly routed when installing closing flange

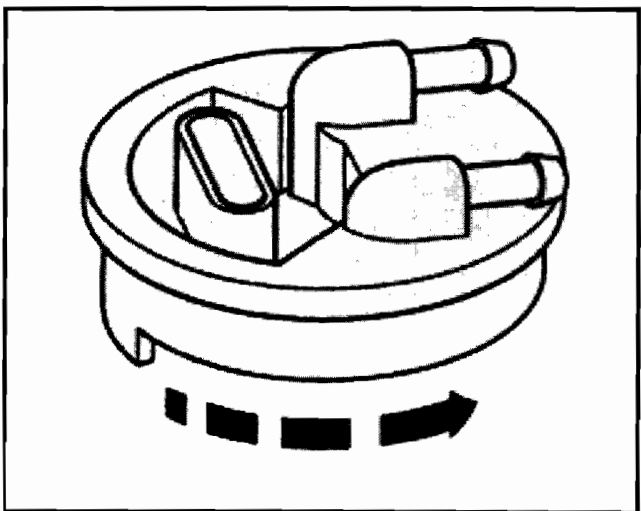
⇐ When installing closing flange, turn in direction of arrow, as shown in illustration

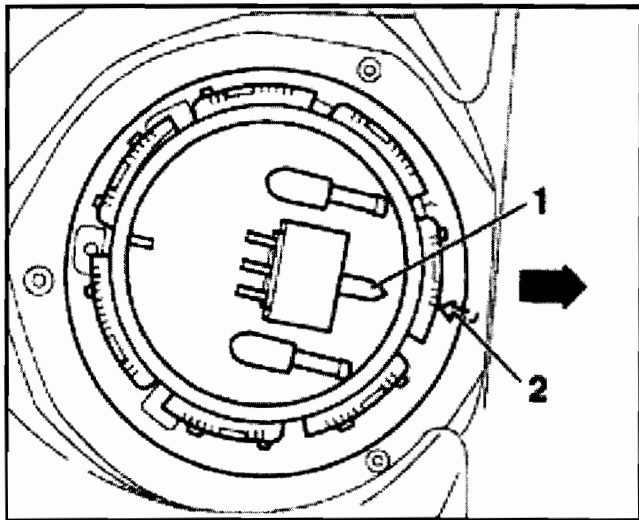
⇐ Insert closing flange into sealing washer making certain marking -1- is aligned with arrow -2- on fuel tank

Note: Black arrow in illustration is pointing toward front of vehicle

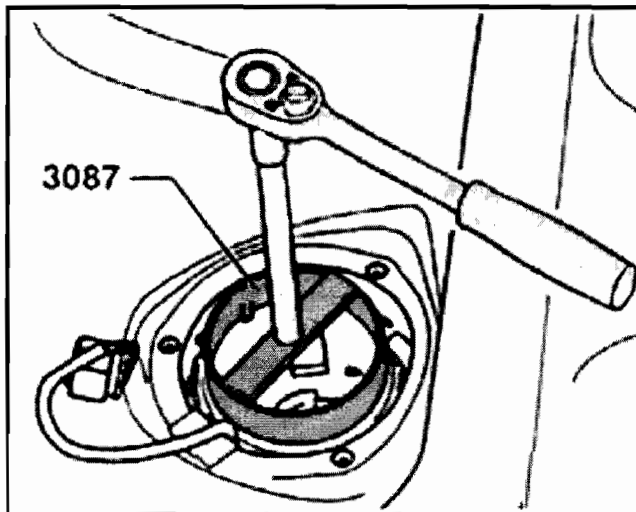
⇐ Secure closing flange with locking ring using 3087 wrench or T10202 and tighten to 145 Nm (106 ft. lbs.)

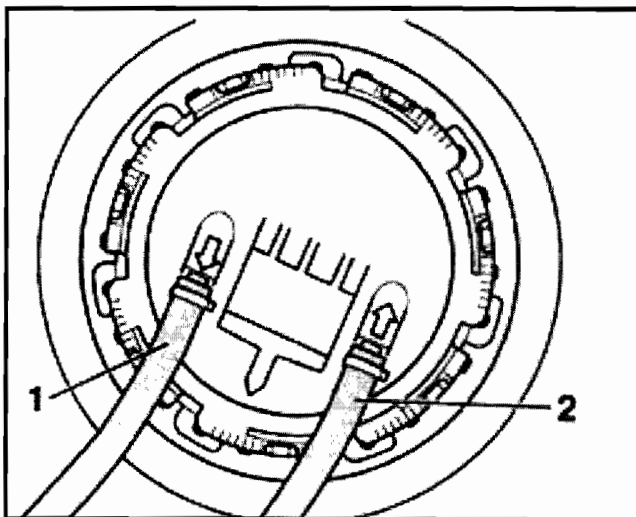
⇐ Connect fuel supply line -1- and return line -2- to closing flange and secure with new clamps (N 101 969 01)

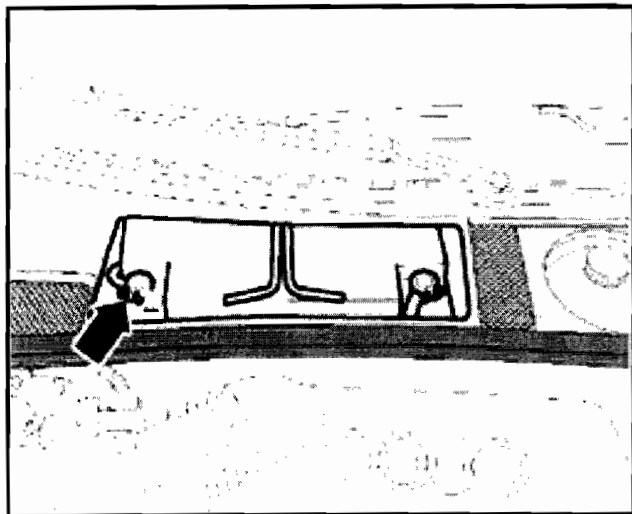
- ◀ Reconnect the negative battery cable (GND) to the battery and tighten bolt to 5 Nm (44 in. lbs.)
- Start engine to check fuel delivery unit function. **If vehicle is A4 1.8L Turbo quattro** and fuel filter is making a rattling sound, **go to Section F**, otherwise continue
- If vehicle is equipped with Audi Telematics, by OnStar®, switch-on emergency (back up) battery for Telematic/Telephone control module after vehicle battery is reconnected
- If required, reactivate radio with radio code
- Reset window pinch protection
- Reset power door lock transmitter
- Reset time and date on clock
- Clear diagnostic trouble codes (DTCs) and reset readiness code
- If ESP fault light is illuminated in instrument panel, drive vehicle a few meters until light turns off
- Destroy and properly dispose of removed parts in accordance with local, state and federal/provincial environmental regulations

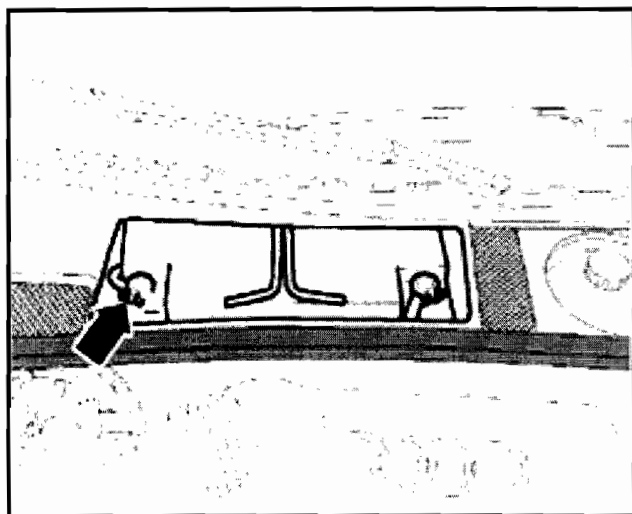
- Turn ignition switch to the off position and remove key
- ◀ Open hood, remove battery cover and disconnect the negative battery cable (GND) from the battery
- Raise vehicle on hoist

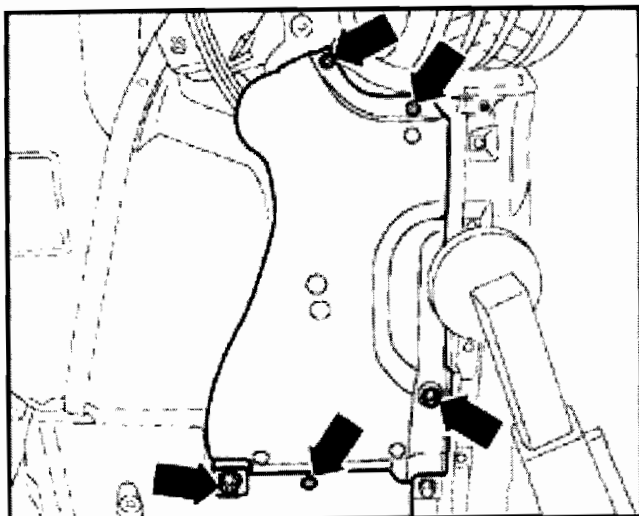
- ⇐ Remove screws -arrows- and right cover next to fuel tank
- Place drip tray under fuel filter to catch fuel

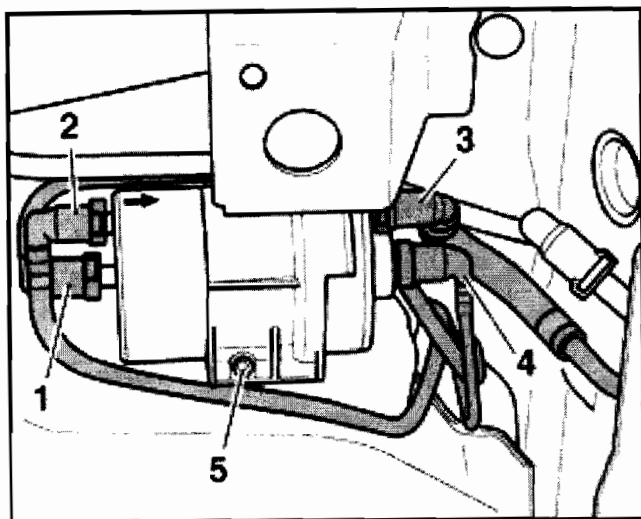
- ⇐ Disconnect fuel return line -1-, fuel supply from fuel tank -2-, fuel supply line to engine -3- and ventilation line -4-
- ⇐ Remove bolt -5- and fuel filter

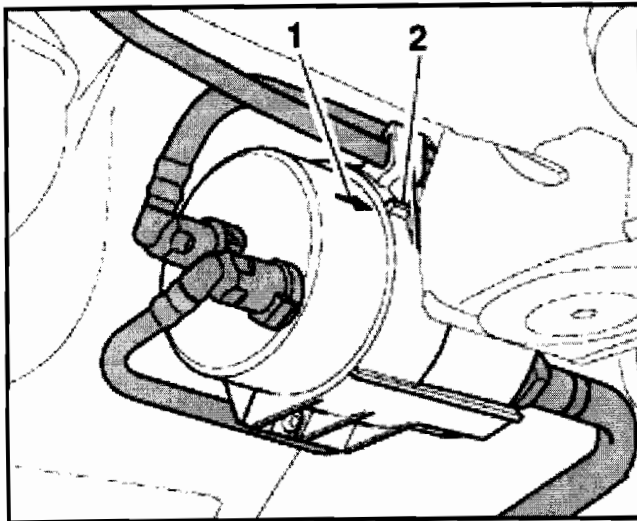
- ⇐ Install new fuel filter (8E0 201 511 J) into bracket

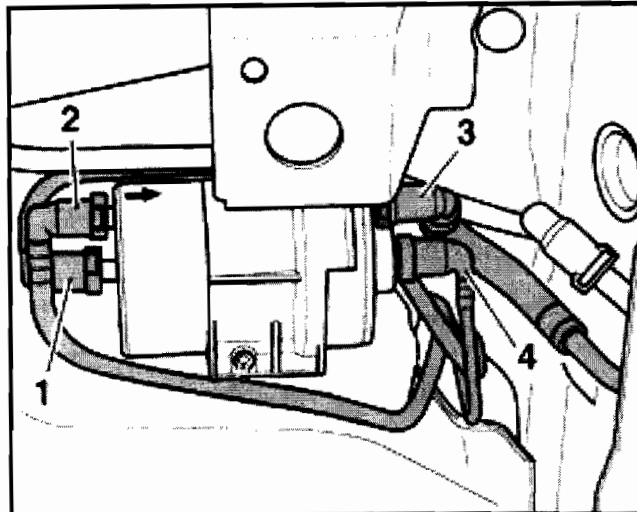
- ⇐ Connect fuel return line -1- to connector marked "RL" on fuel filter

- ⇐ Connect fuel supply line from fuel tank -2- to connector marked "VL" on fuel filter
