**PART 573 NOTICE RE: TRW TAS85 STEERING GEAR**

**Safety Defect and Noncompliance Report Guide for Vehicles**  
**PART 573 Defect and Noncompliance Report**

MODEL <b>D Series Coaches</b>	TYPE <b>Field Change Program</b>	SECTION/GROUP <b>11 – Steering</b>	DATE
SUBJECT <b>TRW AUTOMOTIVE TAS85 STEERING GEAR</b>			
CONDITIONS

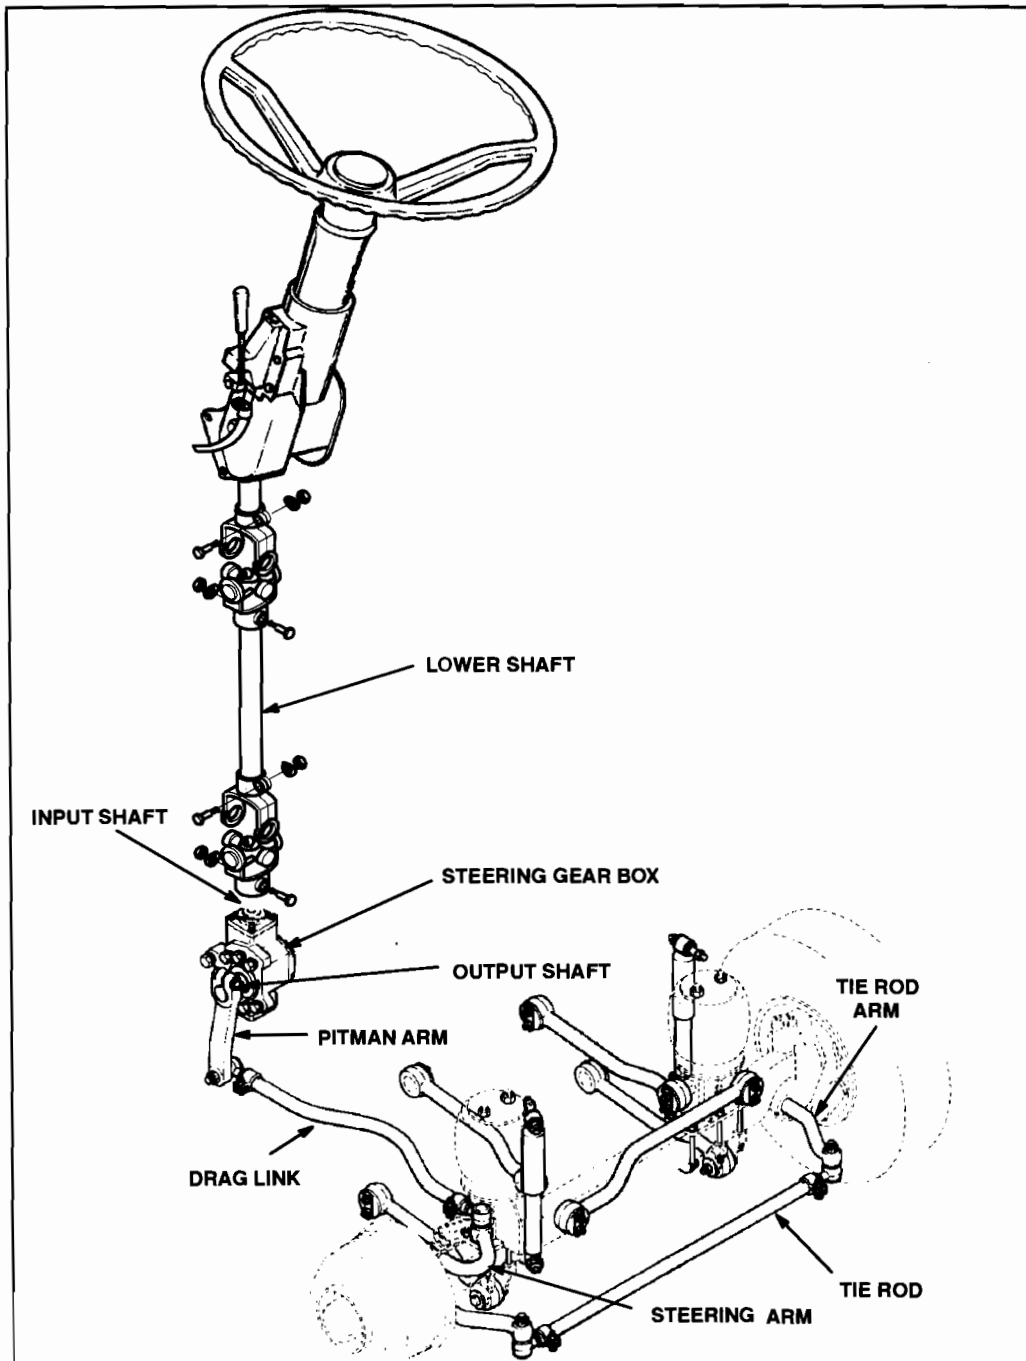
**Figure 2.**

5. Unfasten and loosen the lower shaft clamp yoke that connects the lower column section to the steering gear's input shaft. Retain any parts removed to be re-installed at a later step in this procedure.

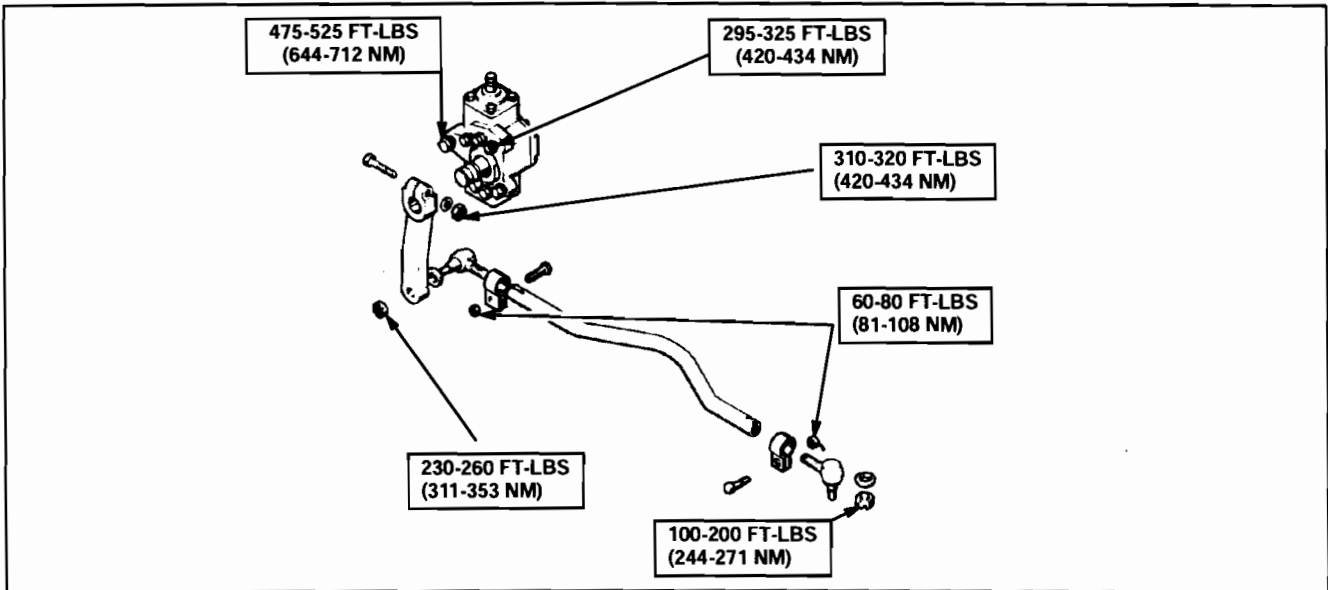
Figure 3. Torque Chart

11. Using two people, remove the seven bolts that hold the gear to the mounting plate and carefully remove the gear.
12. Position the new steering gear ( p/n 11L-1-4 ) on the mounting plate at the same orientation as the old gear.
13. Align steering gear housing with mounting holes in frame.
14. Install gear bolts with hard steel washers. Torque the 7/8 inch bolt to 475-525 ft-lbs ( 644-712 Nm ). Torque the 3/4inch bolts to 295-325 ft.-lbs ( 400-441 Nm ) ( see Figure 3 / Torque Chart ).

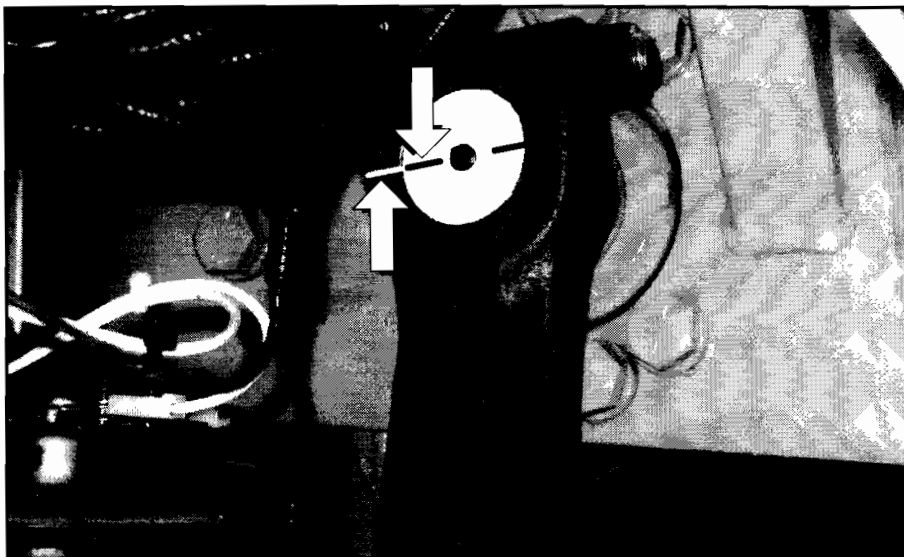
Figure 4.

15. Apply Never-Seize to the output shaft splines prior to installing the pitman arm (lubricant p/n 21-7512-7), to ensure against seizure of the pitman arm to the output shaft splines of the steering gear.
16. Rotate the steering gear input shaft as required to orient the timing marks scribed on the end of the sector shaft in a horizontal position ( Figure 4 ).

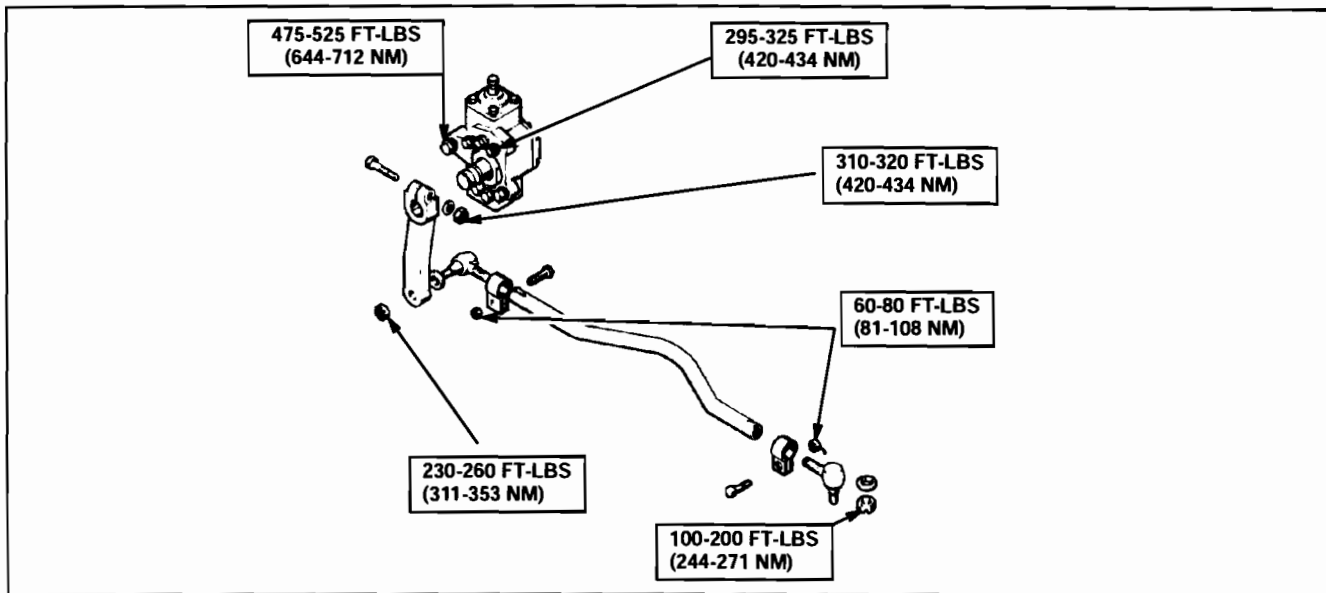
Figure 5. Torque Chart

17. Install Pitman arm on steering gear output shaft with alignment marks aligned. Tighten pitman arm hex nut to 310-320 ft-lbs ( 420-434 Nm ) torque.

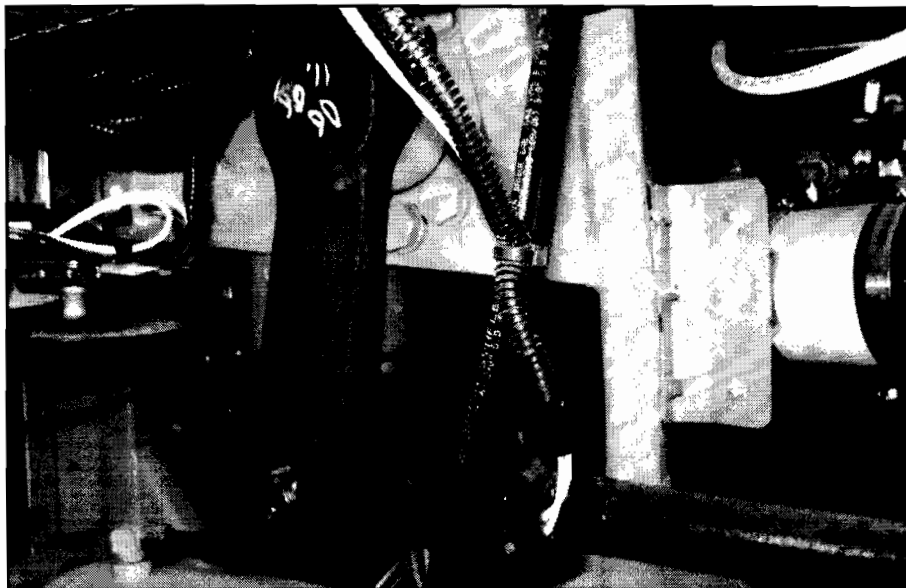
Figure 6.

18. Rotate the steering gear input shaft as required to align pitman arm with drag link. Attach drag link to pitman arm. Torque nut to 230–260 ft-lbs. Install a new cotter pin. DO NOT adjust draglink and ball joint.

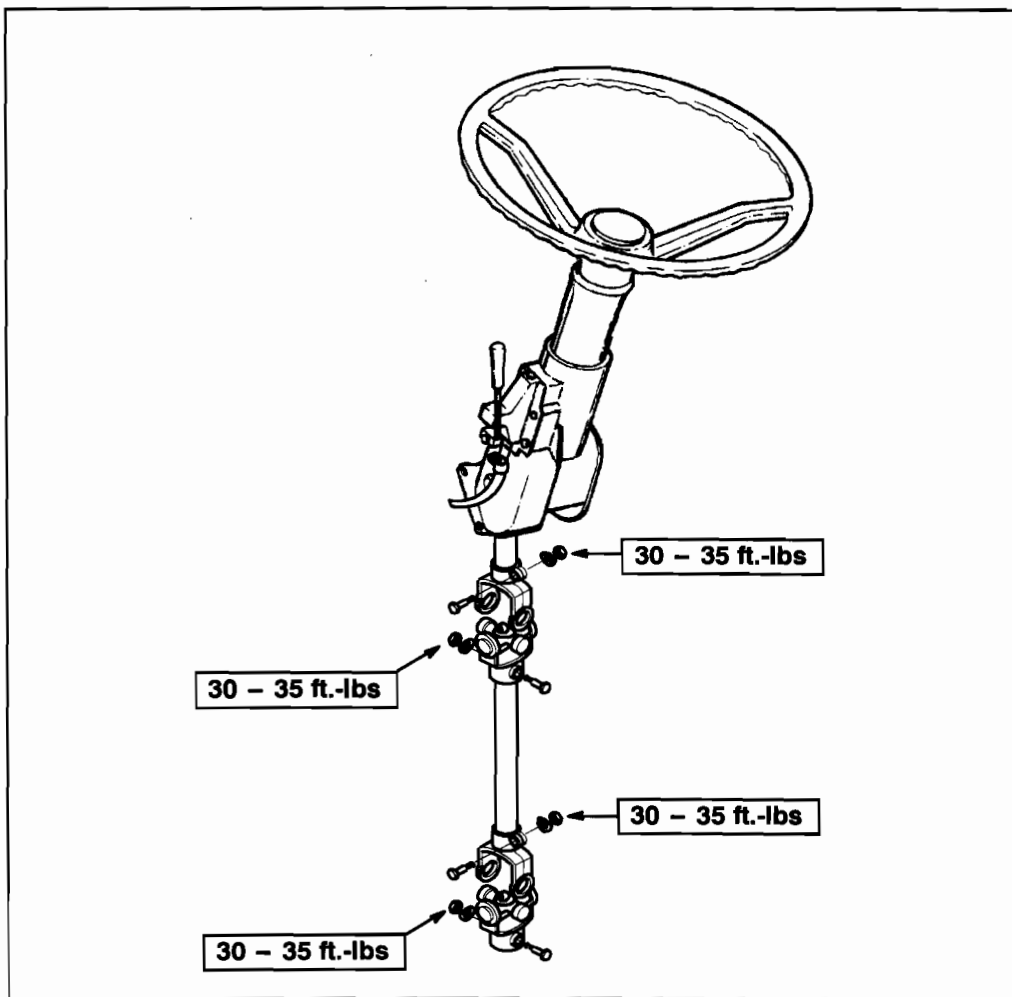
**Figure 7.**

**NOTE:** Torques should be re-checked to the values shown in Figure 7.
