HYUNDAI DE PUERTO RICO
C/O MMSC
Road 2 Km. 20.1 Candelaria Ward, Toa Baja, PR 00949
P.O. Box 192216, San Juan, PR 00919-2216
Tel. (787) 999-4310 Fax (787) 251-3024 / 8700
www.hyundaipr.com

RE: Defect Information Report

Certain model year 2008 Hyundai Elantra vehicles with 2.0 liter Beta engines produced beginning November 5, 2007 through June 28, 2008 and equipped with fuel pumps manufactured with upper body components from a different supplier than those manufactured prior to November 5, 2007.

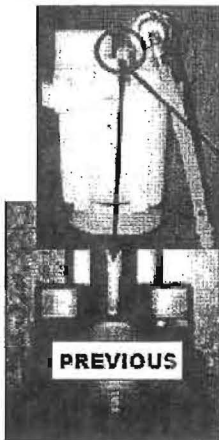
PART NAME	PART NUMBER		REMARK
	PREVIOUS	NEW	
Fuel Pump Sub Assembly (Including O-ring and E-ring)	-	31110-2H005QQH	Color of wiring connector: Black→Brown

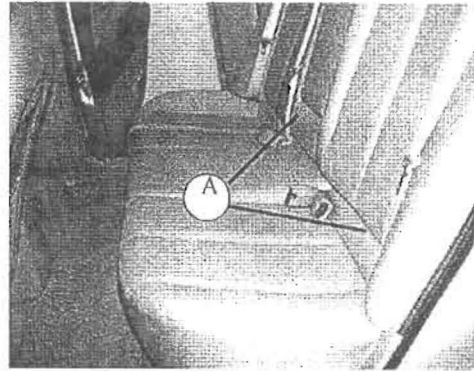
1. Remove the 2 rear seat cushion mounting bolts (A).

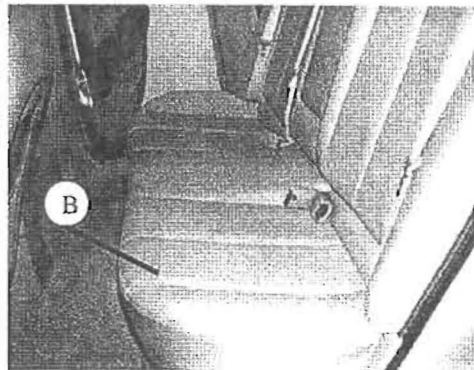
2. Remove the rear seat cushion assembly (B).

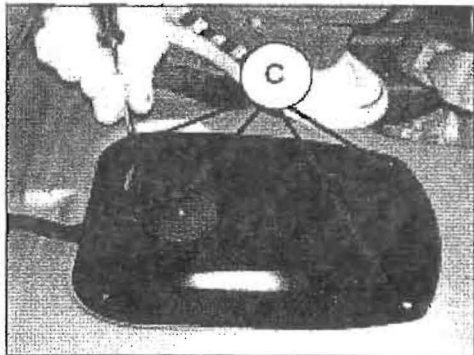
3. Unfasten the 4 fuel pump service cover mounting screws (C).

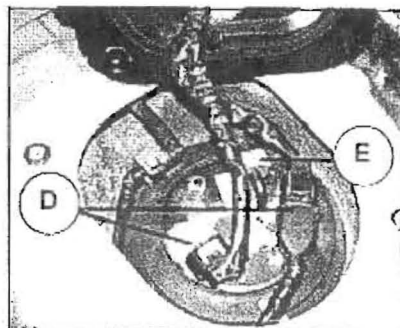
4. Disconnect the fuel pump wiring connector and the fuel hose quick connector (E).

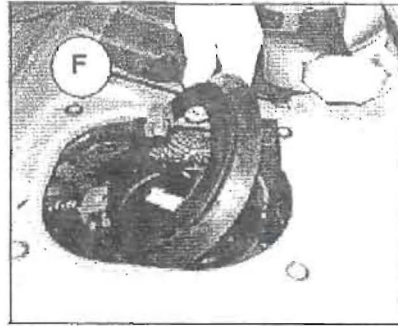
5. Remove the rubber cover (F).

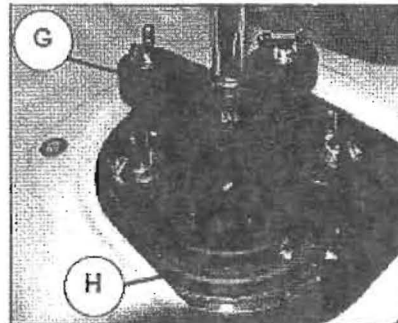
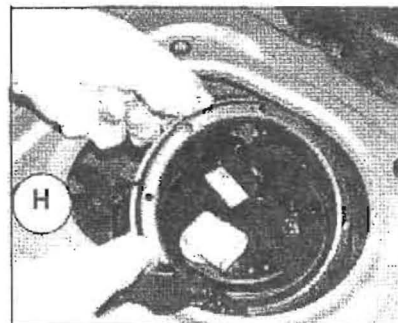
6. Using SST (G), unscrew the fuel pump plate cover (H) and remove the fuel pump plate cover.

SST no.: 09310-2B200

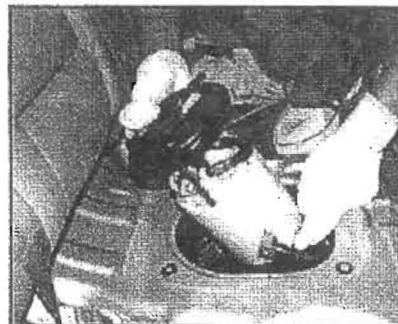
7. Remove the fuel pump complete assembly from the fuel tank.

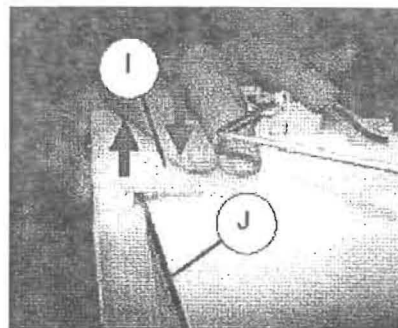
8. Undo the hook by pressing the return hose (I) and remove the return hose by prying up with a flat head screwdriver (J).

Care not to damage the fuel sender.

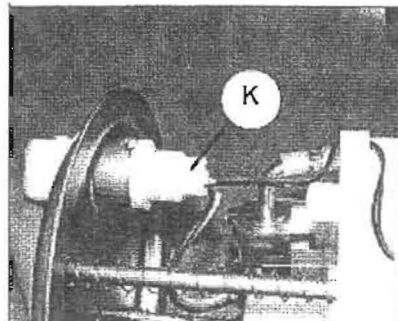
9. Disconnect the fuel sender wiring connector (K).

Make sure to pull the connector, not the wire when disconnecting.

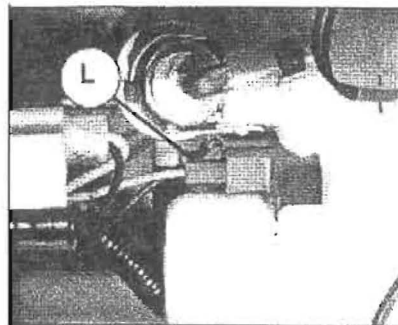
10. Disconnect the fuel pump wiring connector (L).

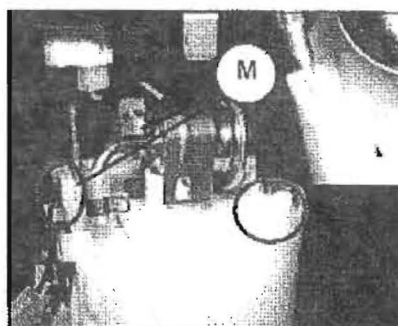
11. Release the 3 lock keys (M) of fuel pump reservoir by using a flat head screwdriver.

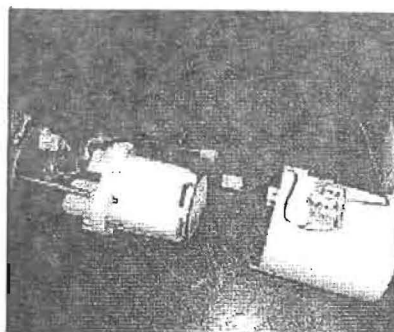
12. Take out the fuel pump from the reservoir.

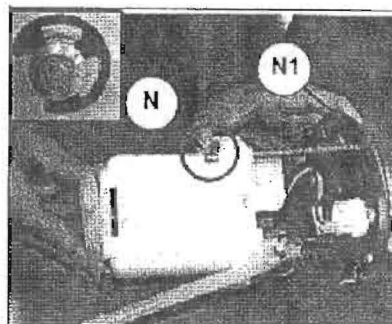
13. Remove the E-ring (N), and then remove the fuel pump plate (N1) from the fuel pump.

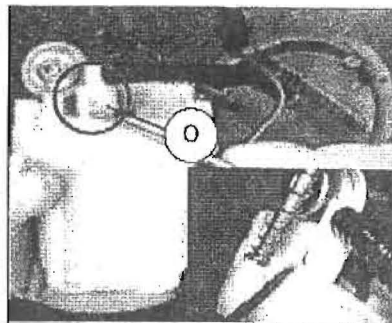
14. Release the 3 lock keys of the upper cap (O) by using a flat head screwdriver and remove the upper cap from the fuel pump. Discard the fuel pump sub assembly.

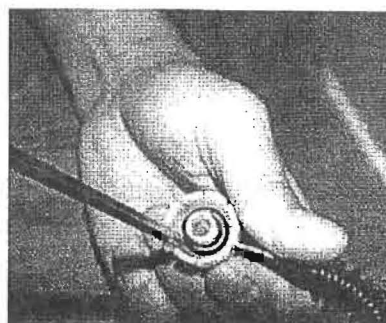
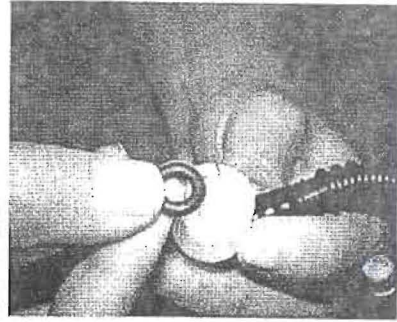
15. Remove the O-ring from the upper cap and install the new O-ring into the upper cap.

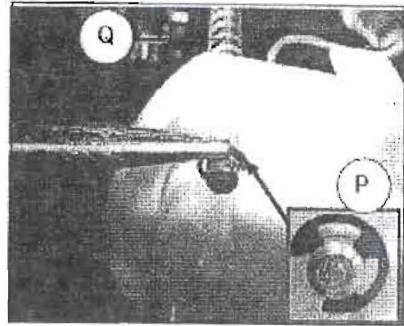
16. Install the upper cap and the fuel pump plate to the new fuel pump sub assembly in reverse order of removal.

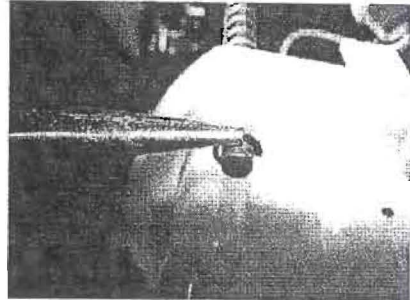
17. Install the new E-ring (P) to the fuel pump plate stay (Q) as shown on the photo.

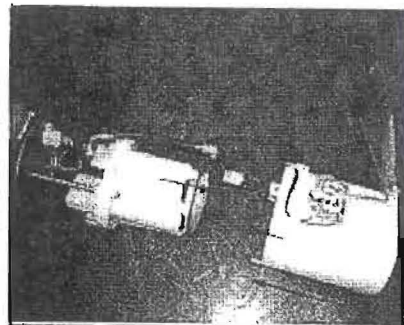
18. Install the fuel pump assembly in reverse order of removal.
