RE: NHTSA Recall 08V-161, Hyundai Recall 083

MOTOR VEHICLE RECALL

Revised Recall Procedure – Confirmation Requirement Eliminated

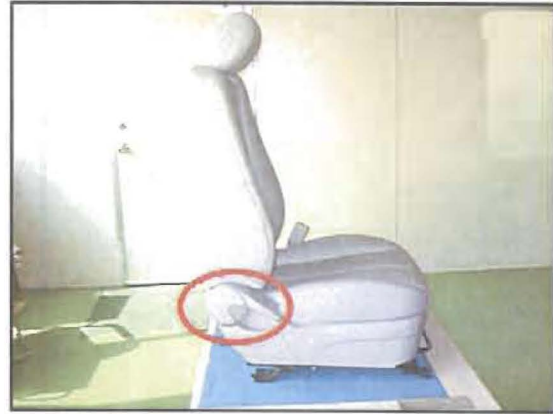
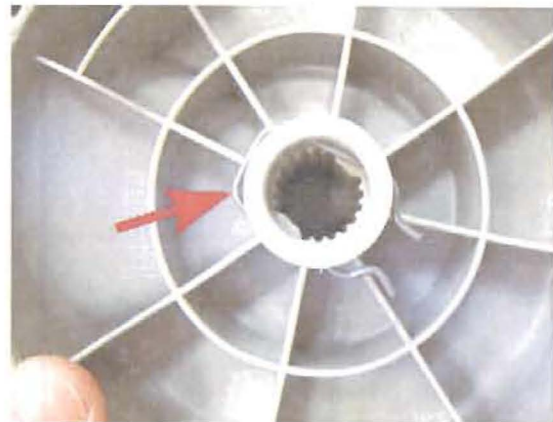
2. Disconnect all connectors from under the seat and remove the front passenger seat assembly.
3. Remove the recliner lever by removing the metal clip.

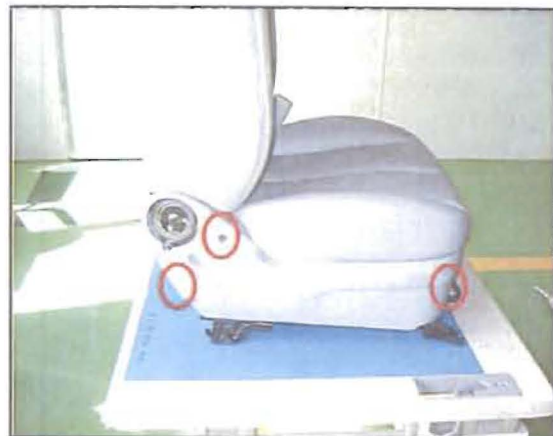
4. Remove the plastic side outer cover by unfastening 3 mounting screws.

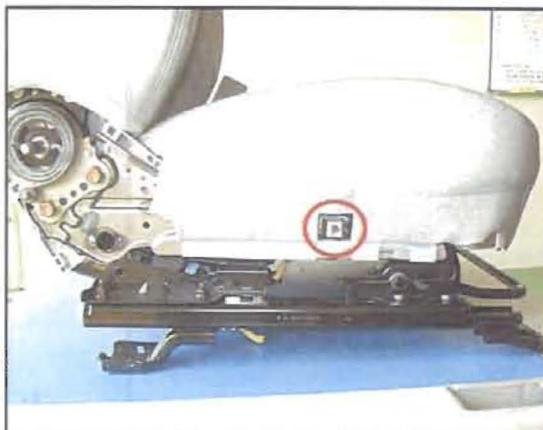
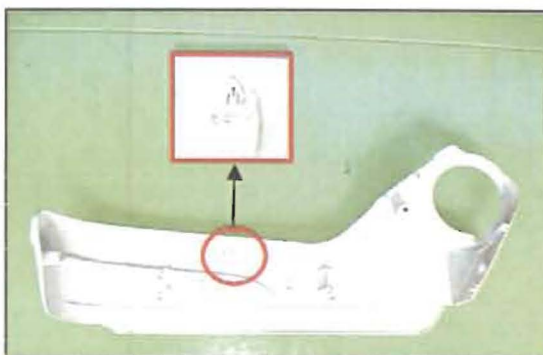
NOTE: When removing the side outer cover, verify the clip (p/n 88173-3K000) is installed on the outer cover. If the clip remains lodged on the seat bracket, remove it and install it onto the side outer cover.

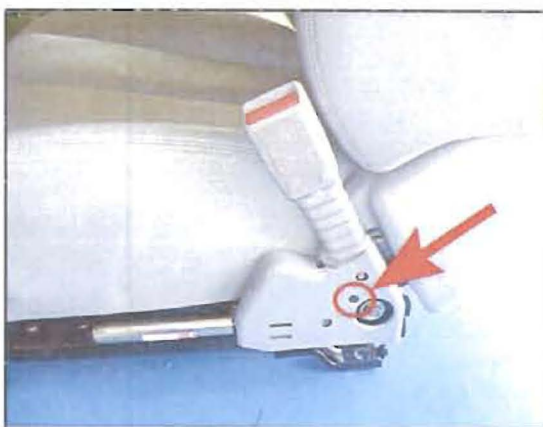
5. Remove the seat buckle cover by unfastening the screw.

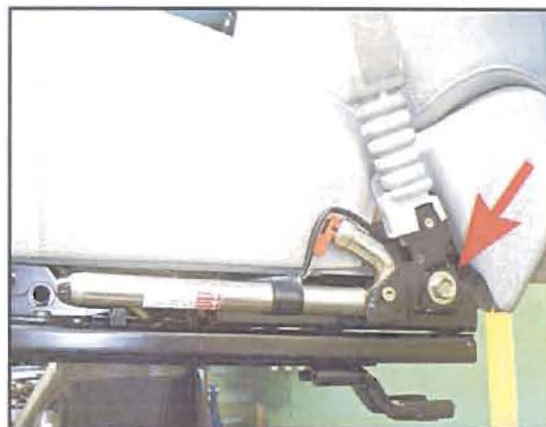
6. Unfasten the seat buckle mounting bolt to get access to the seat cushion covering fixing hook. Tightening torque: 39.2~53.9 N.m (4.0~5.5 kgf.m, 28.9~39.8 lb.ft).

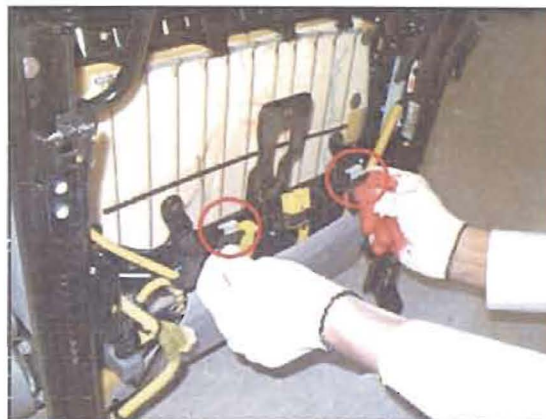
7. Raise the front seat and disengage the 2 seat covering fixing hooks on the bottom side of the seat.

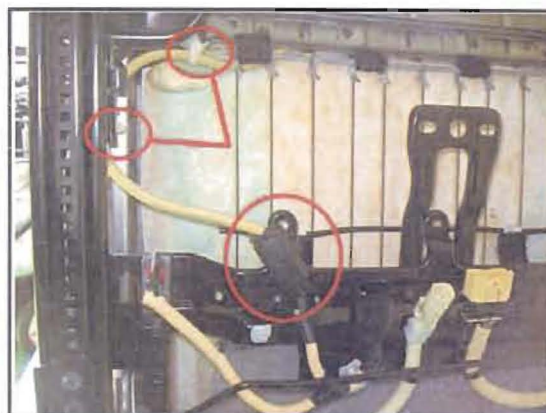
8. Disconnect the OCS wiring connector and disengage the 2 wiring clips.

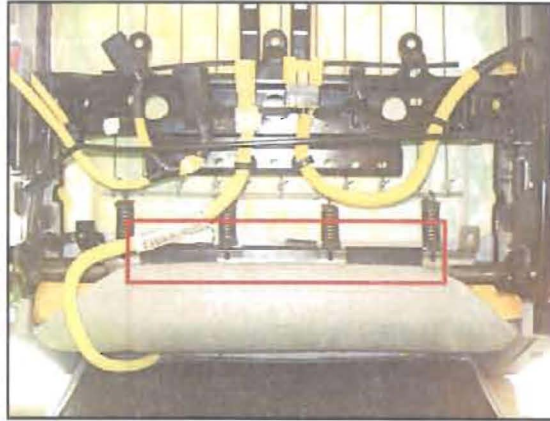
9. Disengage the front seat covering fixing clips.

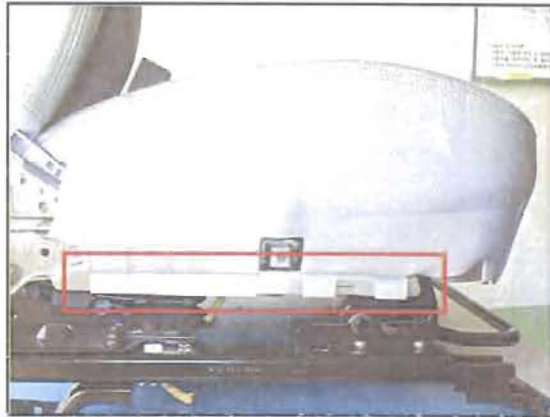
10. Disengage the right and left seat covering fixing clips.

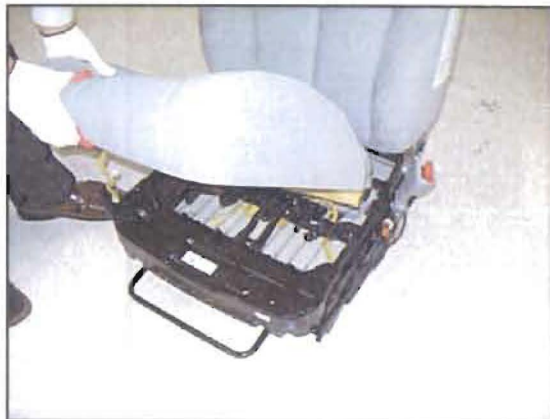
11. Remove the seat cushion assembly from the seat assembly.
