Recall Campaign 08V-170: Replace Rear Stabilizer Bar

X5 (E70)

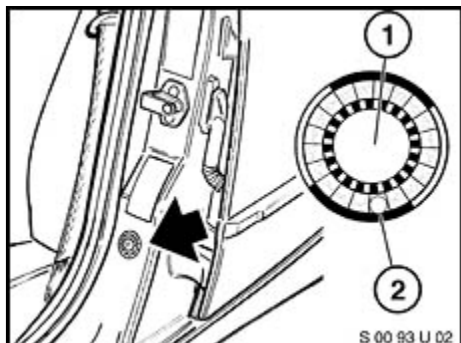
LABEL INSTRUCTIONS

This Recall Campaign has been assigned code number **520**. After the vehicle has been checked and/or corrected, obtain a label (SD 92-335) and:

- A. Emboss your BMW center warranty number in the middle of the label (1);
- B. Punch out code number **520** (2), printed on the label; and
- C. Affix the label to the **B**-pillar as shown.
