Safety Recall - 90L

Certain 2007 – 2010 Model Year Camry Vehicles

Potential Floor Mat Interference with Accelerator Pedal (January, 2010)

Phase 2 - Vehicles Equipped with Accelerator Pedals manufactured by CTS Corporation

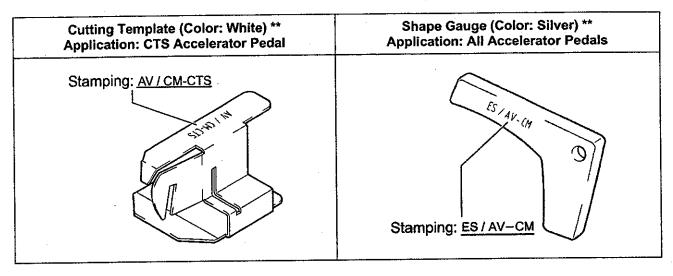
C. ACCELERATOR PEDAL TEMPLATE & GAUGE

** One CTS cutting template and one shape gauge will be provided to each dealership.

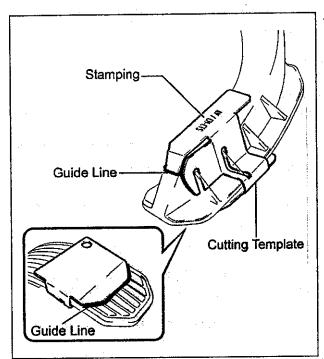
1. MARK THE AREA TO BE CUT

- DO NOT mark the area beyond the template.
- Use a flat tip screwdriver if a scribe is not available.
- Make sure to use the correct cutting template by verifying the color and stamping.
- Never cut or sand the pedal while the template is on the pedal.

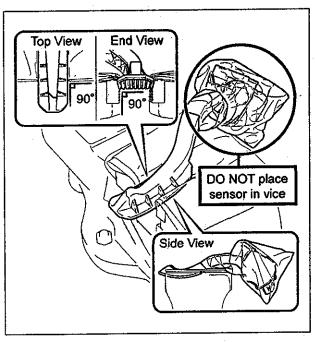
2. SECURE THE ACCELERATOR PEDAL ASSEMBLY

a) Set the pedal in the vise at a right angle using a shop cloth while avoiding the sensor.

- DO NOT place the sensor in the vise to avoid damage.
- Firmly secure the pedal to prevent it from moving.
- DO NOT over tighten the vise.

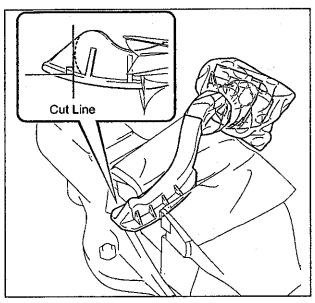
3. CUT THE LOWER SECTION OF THE ACCELERATOR PEDAL ASSEMBLY

a) The cut line is slightly outside from the scribed line and its positioned 90 degrees from the pedal foot pad as illustrated.

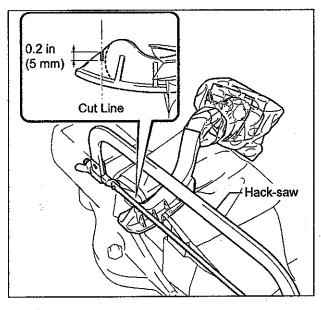
b) Using a hack-saw and cut the pedal 0.2 in (5 mm) to create a guide cut for the reciprocating-saw.

- Always wear protective eyewear, gloves, and dusk mask when cutting.
- Guide cut must be straight and clean.

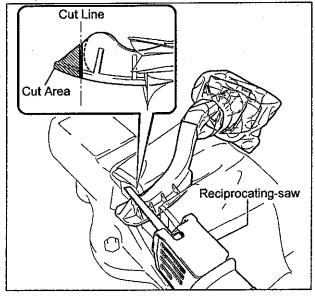
c) Using a reciprocating-saw and cut off the lower section of the pedal as illustrated.

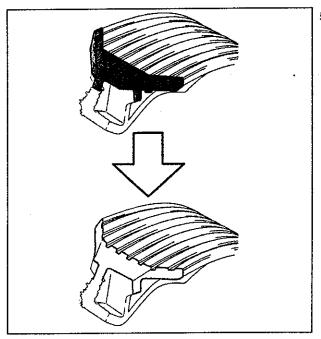
4. CUT THE CORNERS OF THE ACCELERATOR PEDAL ASSEMBLY

- a) Turn the pedal over in the vise so the top of the pedal is facing up; do not clamp the sensor portion of the pedal.
- b) The cut line is 0.12 in (3 mm) outside from the scribed line as illustrated.

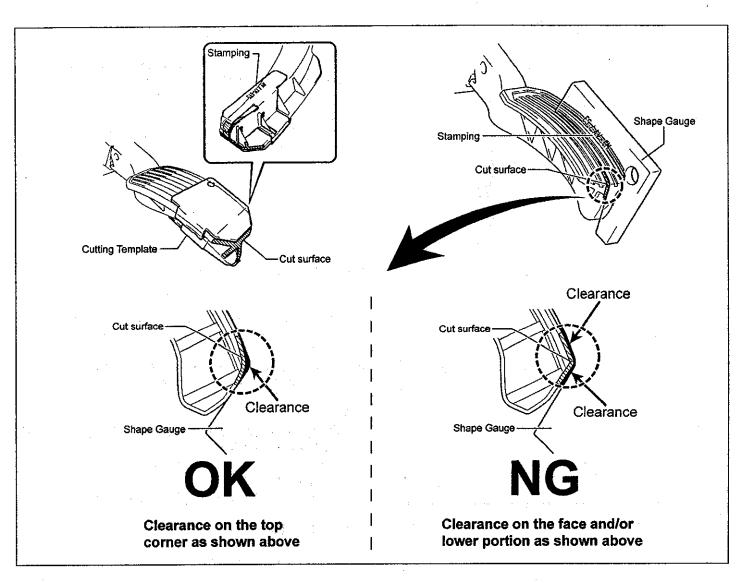
5. CHECK THE SHAPE OF THE PEDAL

a) Using the correct cutting template and shape gauge, check the shape of the pedal.

- Always wear protective eyewear, gloves and dusk mask when sanding or filing.
- A tolerance of -1.0 mm is permissible between the final cut surface and the template.

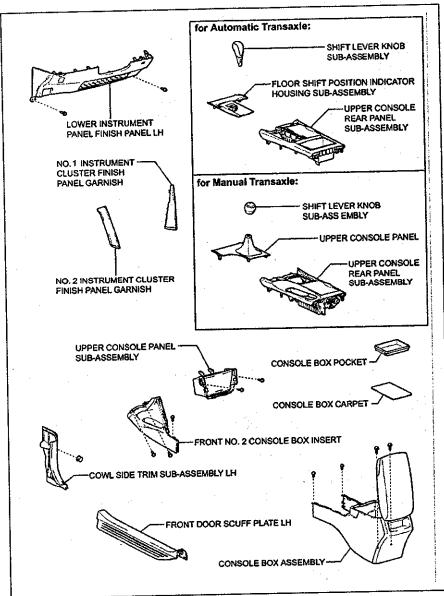
1. REMOVE THE FOLLOWING COMPONENTS

For additional information on removal of the components above, please refer to TIS.

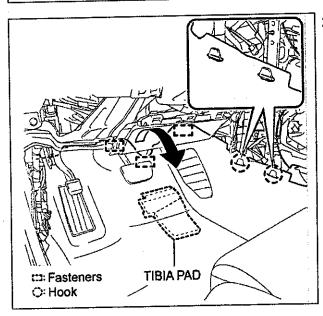
2. PULL BACK THE FLOOR CARPET

a) Disengage the 3 fasteners.

There are some vehicles with a hole, two holes or no hole in the floor carpet for a hook.

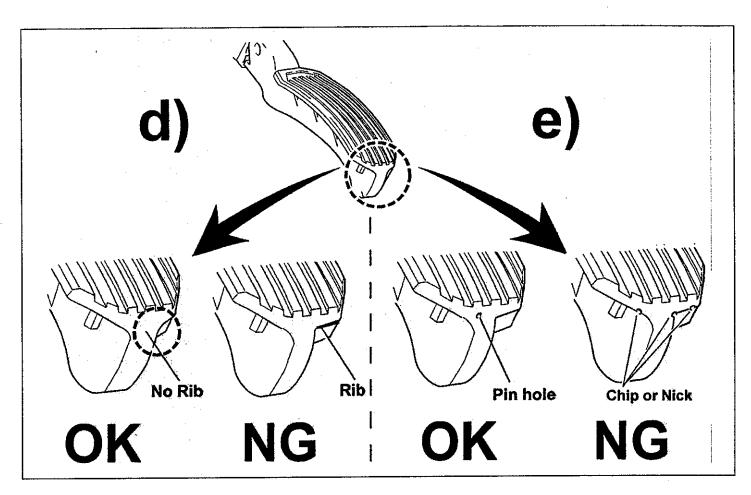
d) Check for a rib as shown. If there is a rib, file it until it is gone.

e) Check for any chips, nicks or sharp edges on the finished surface edge. If there are any chips, nicks or sharp edges file them to make them smooth.

The key point of judgment is a "smooth pedal surface".

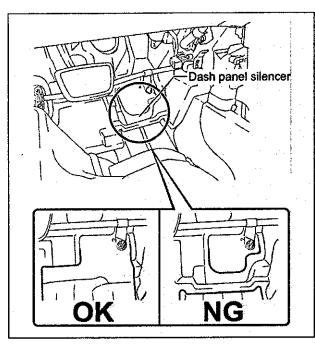
3. INSPECT THE LOWER PORTION OF THE FABRIC FLOOR SILENCING MATERIAL

- a) Inspect the lower portion of the fabric floor silencing material.
 - If OK, proceed to step 4 "RUBBER PAD APPLICATION" below.
 - If NG, please refer to APPENDIX "B" for "CUT THE FLOOR SILENCING MATERIAL"

The fabric floor silencing material is a soft, gray, paper-like material beneath the carpet.

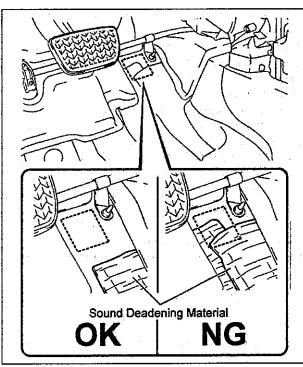
4. RUBBER PAD APPLICATION

- a) Inspect the rubber pad application area for sound deadening material.
 - If OK (no sound deadening material in pad application area), proceed to step "b" below.
 - If NG (sound deadening material found in application area), please refer to APPENDIX "C" for "REMOVE THE SOUND DEADENING MATERIAL".

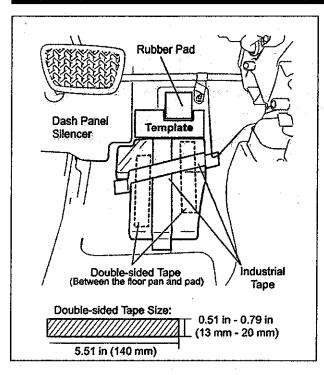
6. INSTALL THE NEW TIBIA PAD

- a) Apply double sided tape to the bottom (floor pan side) of the tibia pad.
- Using the Tibia Pad Placement Template as a guide (Template is located in the Appendix), position and apply the **NEW** Tibia pad to the floor pan.
- c) Remove template.
- d) Apply a piece of industrial adhesive tape from the top to the bottom of the tibia pad.
- e) Apply a second piece of industrial adhesive tape from the left to the right side of the tibia pad.

- Be careful not to detach the tibia pads when placing the carpet back into position.
- There are some vehicles with a hole, two holes or no hole in the floor carpet for a hook. For the vehicles with a hole(s), please be certain to install the hook to the hole(s). If the vehicle has no hole in the floor carpet for a hook, please reset the floor carpet to the original position.

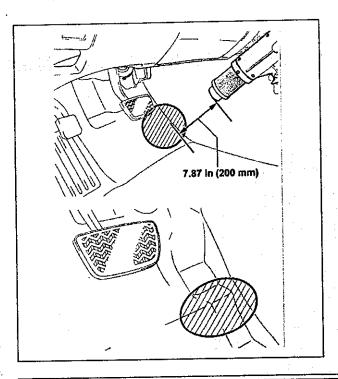
g) Heat the floor carpet area for 2 minutes as shown and smooth it out by pushing it with your hand. Heat the same area again for another minute, and smooth the carpet firmly.

- Always wear protective gloves when heating the floor carpet.
- Keep the hair dryer/low temperature heat gun more than 8 inches (20 cm) away from the floor carpet, and stop after 1 or 2 minute intervals. Continuous heating of the floor carpet may cause damage.
- DO NOT leave hair drier or low temperature heat gun inside the vehicle when it is hot, to prevent unintended heat damage to interior parts.

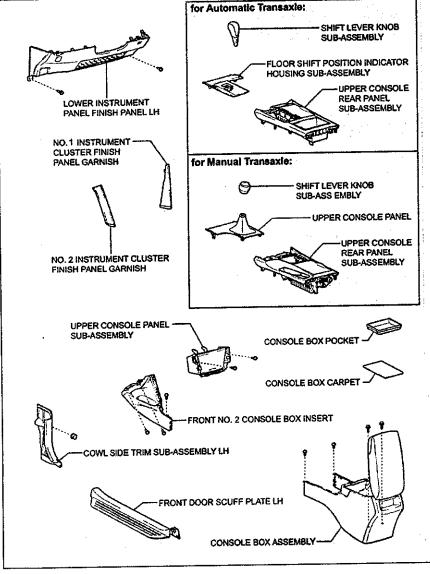
7. REINSTALL THE FOLLOWING COMPONENTS

- Front No. 2 console box insert
- Console box assembly
- Console box carpet
- Console box pocket
- Upper console panel subassembly
- Upper console rear panel subassembly
- Upper console panel (manual transmission ONLY)
- Floor shift position indicator housing sub-assembly (automatic transmission ONLY)
- No. 2 instrument cluster finish panel garnish
- No. 1 instrument cluster finish panel garnish
- Shift lever knob sub-assembly
- Lower instrument panel finish panel LH
- Cowl side trim sub-assembly LH
- Front door scuff plate LH

For additional information on installation of the components above, please refer to TIS.

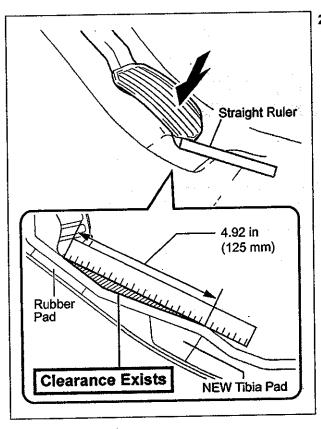
2. INSPECT THE FLOOR CARPET

- a) With the accelerator pedal fully depressed, confirm clearance exists between the floor carpet and the straight ruler as shown.
- b) If no clearance exists, reshape the carpet again.
- c) Confirm the claw and all fasteners of the floor carpet are securely attached.

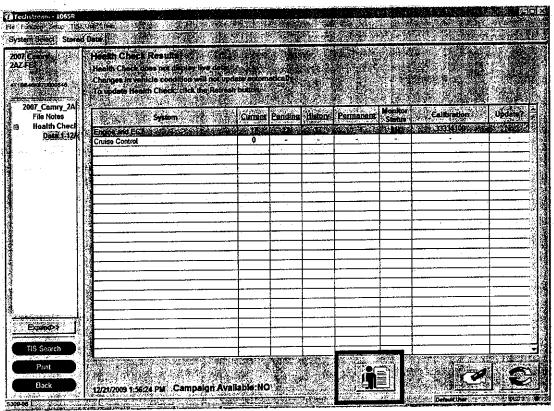
a) From the Health Check Results screen select the Customer Health Check Report button (TIS will launch when button is pressed).

- b) Log in to TIS.
- c) Input Vehicle Mileage and Repair Order number.
- d) Check the "Performed" radio button for the 90L campaign and any other campaigns completed during this service event.
- e) Select the Report button.

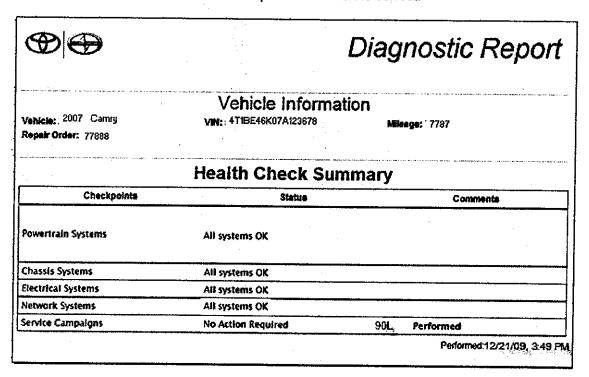
a) Confirm Customer Health Check Report information is correct.

- b) Print Customer Health Check Report from TIS.
- c) Sign and provide to the customer.

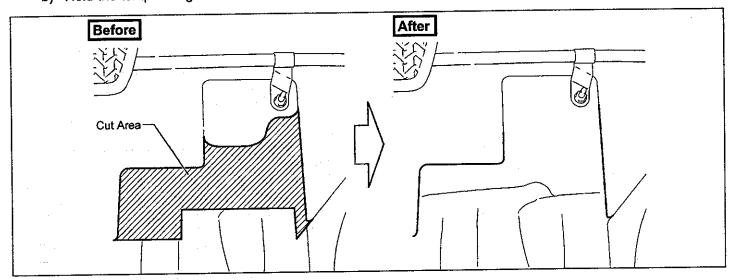
a) Photocopy and cut out the template located at the end of the appendix.

b) Hold the template against the fabric floor silencing material and mark the template outline with a pen.

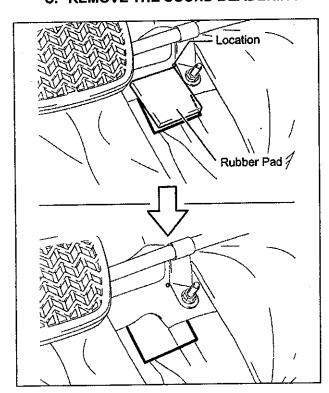
C. REMOVE THE SOUND DEADENING MATERIAL

Temporarily place the rubber pad on the floor panel as shown, and outline the pad on the sound deadening material with a ball point pen.

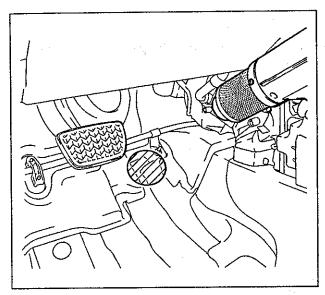
2. Using a hair dryer or low temperature heat gun, warm up the sound deadening material until it becomes soft.

- Make sure not to damage the fabric floor silencing material.
- Pay close attention when using the hair dryer or low temperature heat gun to prevent damage to the carpet.

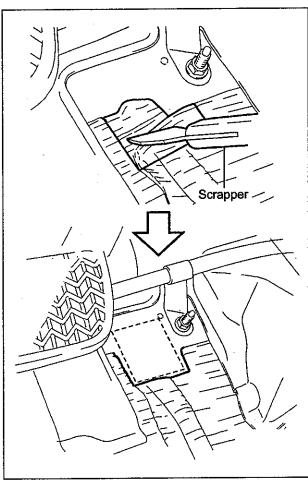
- 3. Using a scraper, remove the sound deadening material from the rubber pad application area.
- 4. Remove any <u>loose</u> sound deadening material from the rubber pad application area.

- Wear protective gloves during the scraping process.
- Warm up the sound deadening material again, if it becomes hard during removal.
- Remove the sound deadening material until the rubber pad application surface is smooth.
- Make sure not to damage the paint film on the floor panel when scraping.
- Apply touch up paint if the paint film was damaged.

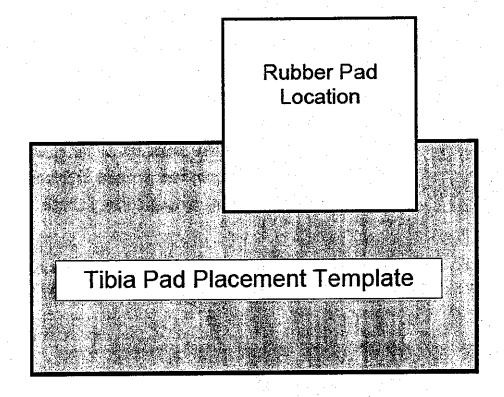
Tibia Pad Placement Template

*Copy and cut out this template. Use this template to correctly position the tibia pad assembly.

*The bottom right guide line is given as a size reference. This line should be 1 inch in size.
