TOYOTA CUSTOMER SERVICES

Subject: Safety Recall – 90L Phase 3
Certain 2005 – 2010 Model Year Avalon Vehicles
Potential Floor Mat Interference with Accelerator Pedal (February, 2010)

Toyota is now launching Phase 3 of Safety Recall 90L on certain 2005 - 2010 Avalon vehicles for potential floor mat interference with the accelerator pedal. All Avalon vehicles are equipped with a CTS pedal. The same templates and gauges provided to dealers for the Camry (Phase 2) will be utilized.

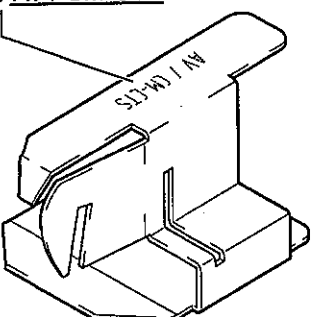
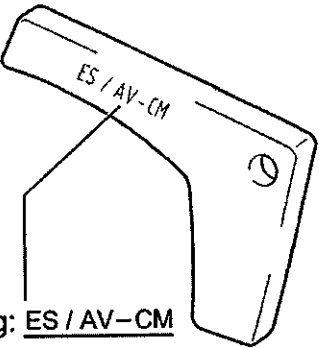
C. ACCELERATOR PEDAL TEMPLATE & GAUGE

Cutting Template (Color: White) **	Shape Gauge (Color: Silver) **
<p>Stamping: <u>AV / CM-CTS</u></p>

<p>Stamping: <u>ES / AV-CM</u></p>

** One cutting template and one shape gauge was provided to each dealership during phase 2 of this Safety Recall.

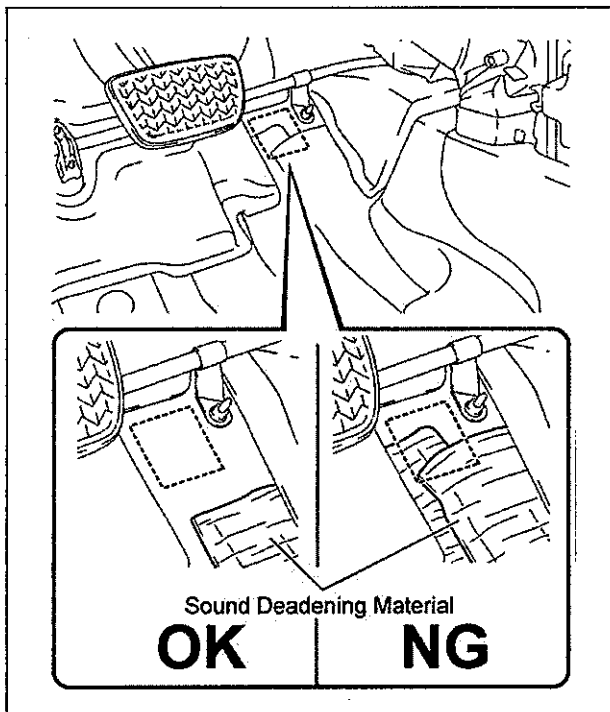
4. RUBBER PAD APPLICATION

- a) Inspect the rubber pad application area for sound deadening material.
 - If OK (no sound deadening material in pad application area), proceed to step "b" below.
 - If NG (sound deadening material found in application area), please refer to APPENDIX "C" for "REMOVE THE SOUND DEADENING MATERIAL".

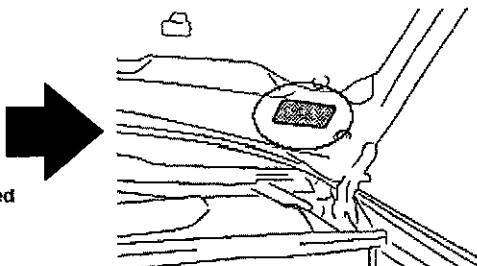
- a) Using a permanent marker or ball point pen, complete the Authorized Modifications Label and attach it to the underside of the hood in front of the driver as shown.
