Safety Recall Circular

Code: **37E5**

**Subject: 2009-2010 A3, TT and TT Roadster
Equipped with an S tronic Direct Shift Gearbox (DSG)
Reprogram Gearbox (Temperature Sensor Software)**

REVISED
November 2009

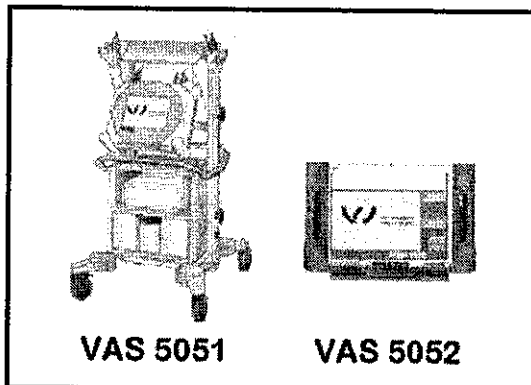
Required Tools

- Only use VAS 5051B or VAS 5052 Diagnostic tester. **Do not use 5051A**
- PSC 550S or INC 940 Battery charger

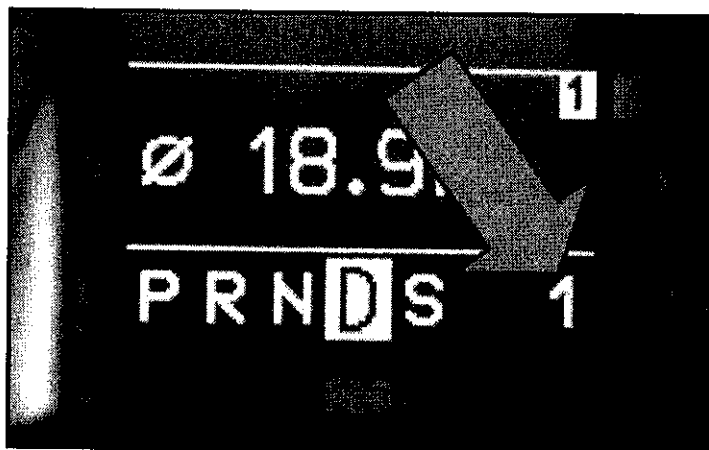
- NEW**
- On MY 2009 vehicles, please inform customer that after the update, the gear display feature in the MFI -arrow- while in Drive "D" or Sport "S" (e.g. 1,2,3,4,5,6) will no longer appear
- This update is not reversible
The feature cannot be turned back on
- **If customer refuses repair**, fax repair order as indicated on SAGA Claim Entry Procedure

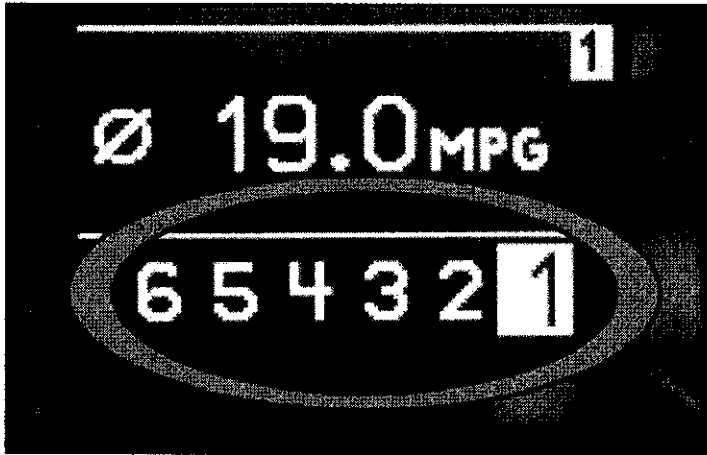
Tip: Gear recognition can be observed in the MFI -circle- by placing selector lever into the Tiptronic position

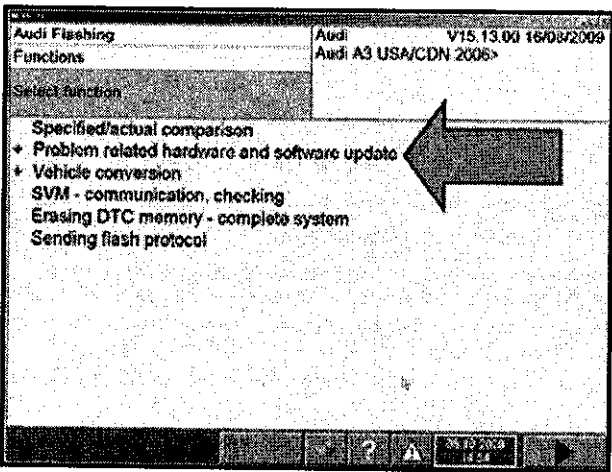
- ⇐ Select "Problem related hardware and software update" -arrow-

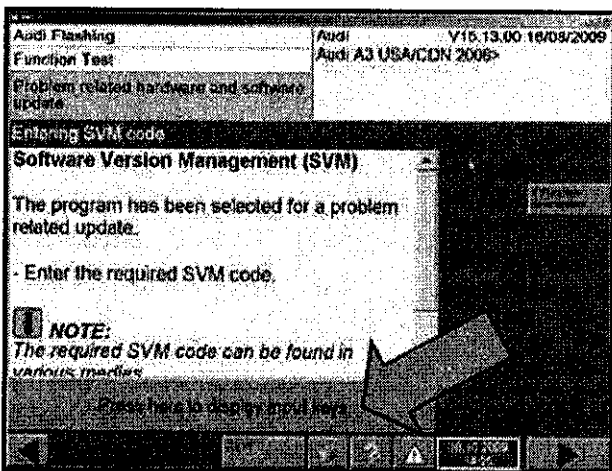
⇐ Select "Press here to display input keys" -arrow-

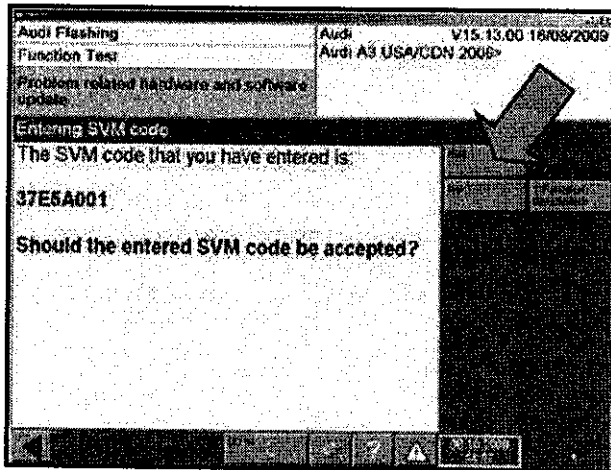
← Select "Yes" -arrow-

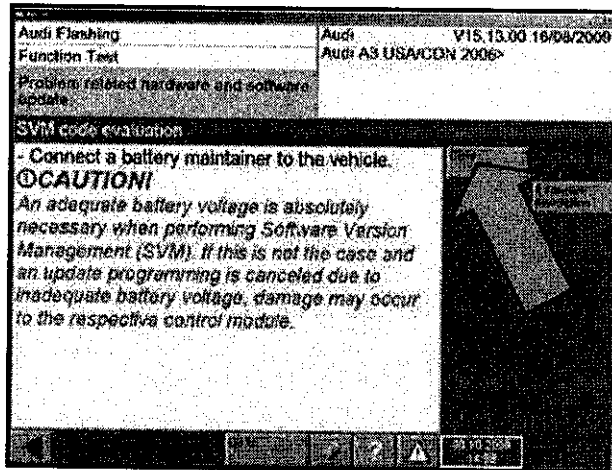
← Read the information, take any necessary steps to comply then, select "Done" -arrow-
