# TOYOTA

Subject: Safety Recall – A0B  
Certain 2010 Model Year Prius Vehicles  
ABS Actuator ECU Update

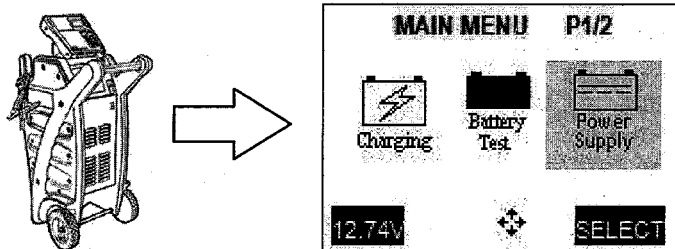
- a) Connect the GR8 Battery Diagnostic Station to the vehicle and turn it ON, then select Power Supply Mode as shown below.

- The GR8 Battery Diagnostic Station **MUST** be used in Power Supply Mode to maintain battery voltage at 13.5 volts while flash reprogramming the vehicle.
- For details on how to use the GR8 Battery Diagnostic Station, refer to the GR8 Instruction Manual located on TIS, *Diagnostics – Battery*.
- If the GR8 Battery Diagnostic Station is unavailable, the PSC Power Supply Charger / Maintainer (MTRPSC550SKT) may be used.
