Toyota Motor Sales, U.S.A., Inc.
19001 South Western Avenue
Torrance, CA 90501
(310) 468-4000

Subject: Safety Recall – A0B
Certain 2010 Model Year Prius Vehicles
ABS Actuator ECU Update

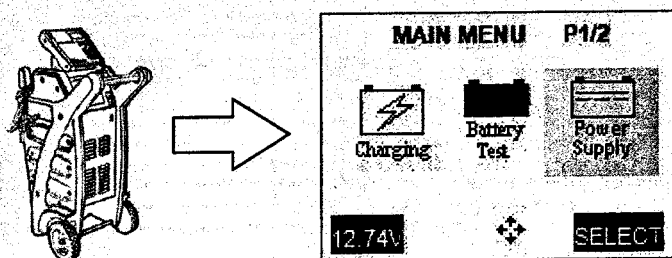
- a) Connect the GR8 Battery Diagnostic Station to the vehicle and turn it ON, then select Power Supply Mode as shown below.

- The GR8 Battery Diagnostic Station **MUST** be used in Power Supply Mode to maintain battery voltage at 13.5 volts while flash reprogramming the vehicle.
- For details on how to use the GR8 Battery Diagnostic Station, refer to the GR8 Instruction Manual located on TIS, *Diagnostics – Battery*.
- If the GR8 Battery Diagnostic Station is unavailable, the PSC Power Supply Charger / Maintainer (MTRPSC550SKT) may be used.

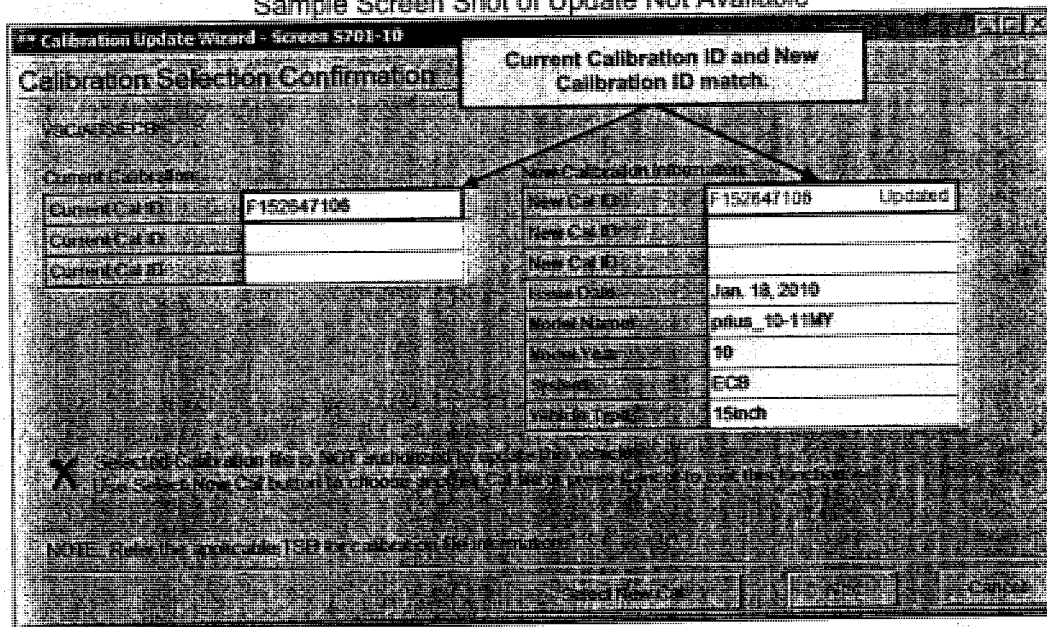
Sample Screen Shot of Update Not Available

7. If the Current Calibration ID and the New Calibration ID match the update has already been performed. Proceed with filing an Inspection Claim.

The screenshot shows a software window titled "Calibration Update Wizard - Screen S701-10". The main heading is "Calibration Selection Confirmation". A message box at the top right states "Current Calibration ID and New Calibration ID match." Below this, there are two sections: "Current Calibration" and "New Calibration Information".

Current Calibration		New Calibration Information	
Current Cal ID:	F152647106	New Cal ID:	F152647106 Updated
Current Cal ID:		New Cal ID:	
Current Cal ID:		New Cal ID:	
		Issue Date:	Jan. 18, 2010
		Model Name:	plus_10-11MY
		Model Year:	10
		System:	ECB
		Master Tech:	15inch
