TOYOTA CUSTOMER SERVICES

INTEROFFICE MEMORANDUM

Subject: Safety Recall – A0D
Certain 2010 Model Year Tacoma 4WD Vehicles
Front Propeller Shaft Inspection

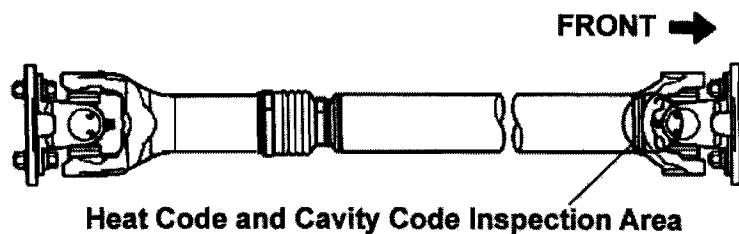
Toyota dealers will be requested to inspect the front propeller shaft. Based upon the inspection results, the dealership may need to replace the front propeller shaft. The inspection and, if necessary, the propeller shaft replacement, will be performed at **NO CHARGE** to the vehicle owner.

On some 2010 Model Year Tacoma 4WD vehicles, the joint portion of the propeller shaft may include a component that contains cracks that developed during the manufacturing process. As those vehicles are used, the cracks may eventually lead to the separation of the propeller shaft at the joint portion. In the worst case, the separated shaft may come into contact with the road surface and result in a loss of vehicle control, increasing the risk of a crash.

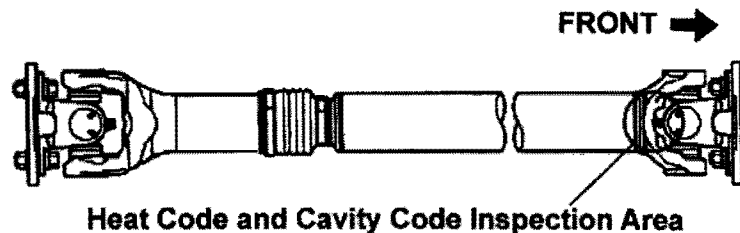
Toyota dealers will be requested to inspect the front propeller shaft. Based upon the inspection results, the dealership may need to replace the front propeller shaft. The inspection and, if necessary, the propeller shaft replacement, will be performed at **NO CHARGE** to the vehicle owner.

On some 2010 Model Year Tacoma 4WD vehicles, the joint portion of the propeller shaft may include a component that contains cracks that developed during the manufacturing process. As those vehicles are used, the cracks may eventually lead to the separation of the propeller shaft at the joint portion. In the worst case, the separated shaft may come into contact with the road surface and result in a loss of vehicle control, increasing the risk of a crash.
