This Service Information bulletin supersedes SI B72 02 10 dated August 2010.

Recall Campaign 10V-254: Replace Safety Belt and Modify Sound Insulation

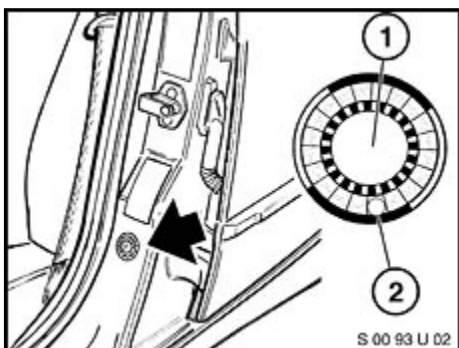
LABEL INSTRUCTIONS

This Recall Campaign has been assigned code number **565**. After the vehicle has been checked and/or corrected, obtain a label (SD 92-380) and:

- Emboss your BMW center warranty number in the middle of the label (1);
- Punch out code number **565** (2), printed on the label; and
- Affix the label to the **B**-pillar as shown.
