TECHNICAL INSTRUCTIONS
FOR
SAFETY RECALL ALA
ABS ACTUATOR ECU UPDATE
2010 MODEL YEAR HS 250h
REVISED FEBRUARY 18, 2010

2010 MODEL YEAR HS 250h

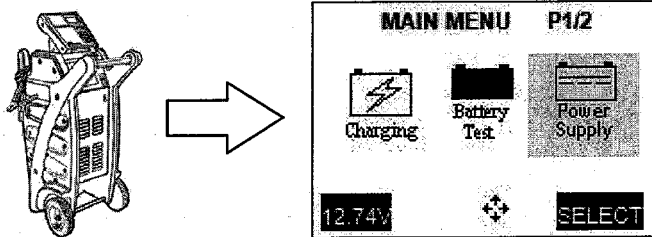
- a) Connect the GR8 Battery Diagnostic Station to the vehicle and turn it ON, then select Power Supply Mode as shown below.

- The GR8 Battery Diagnostic Station **MUST** be used in Power Supply Mode to maintain battery voltage at 13.5 volts while flash reprogramming the vehicle.
- For details on how to use the GR8 Battery Diagnostic Station, refer to the GR8 Instruction Manual located on TIS, *Diagnostics – Battery*.
- If the GR8 Battery Diagnostic Station is unavailable, the PSC Power Supply Charger / Maintainer (MTRPSC550SKT) may be used.

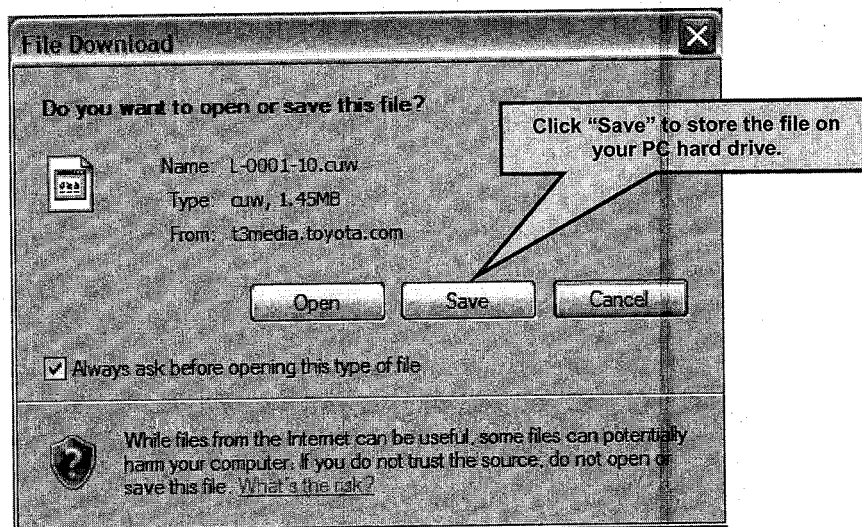
1. SAVE THE CALIBRATION FILE TO THE PC HARD DRIVE (before you leave the dealership)

- Click on the New CID shown in the above table.
- When prompted, select Save.

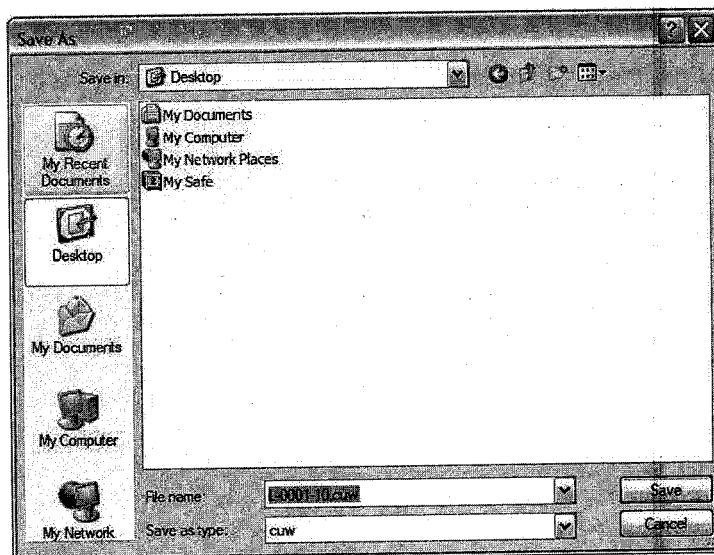
- Save the *L-0001-10.cuw* file to your desktop for easy access.

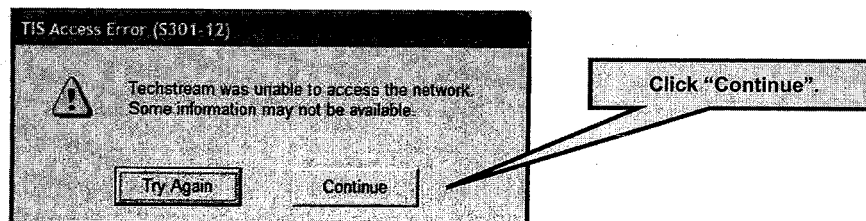
- The Health Check function can not be used to confirm ALA applicability when the Techstream is operated outside of dealership network range.
- When outside of dealership network range, you may see the following error screen.
