SUBJECT: Safety Recall 11S16 - Supplement #5

Certain 1999-2003 Model Year Windstar Vehicles Operated in Corrosion States Subframe Front Lower Control Arm Rear Attaching Flanges and Rear Body Mount

Attachments Inspection and Repair

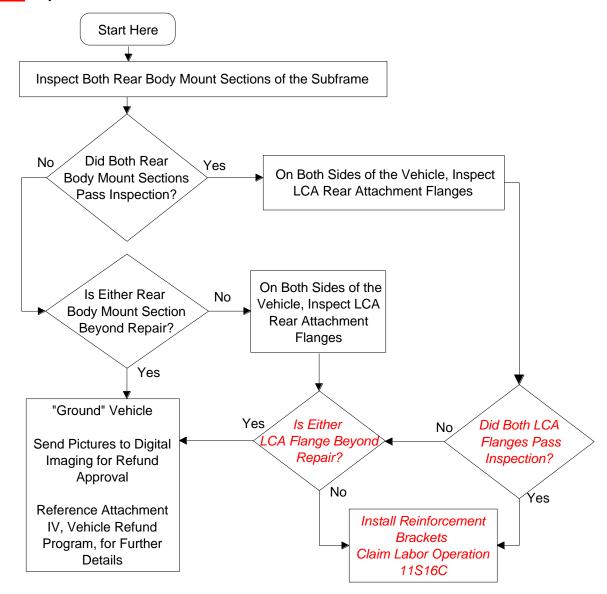
# New! Repair Flow Chart

Many of the vehicles affected by Safety Recall 11S16, Windstar Subframe Inspection and Repair, are also part of Safety Recall 10S13, Rear Axle Inspection and Repair. If the subframe CAN be repaired, proceed with axle replacement or reinforcement bracket installation as appropriate. If the subframe CANNOT be repaired, send pictures to the Special Service Support Center (SSSC) using Digital Imaging for vehicle refund consideration before performing any axle related repairs.
