Toyota Motor Sales, U.S.A., Inc.
 19001 South Western Avenue
 Torrance, CA 90501
 (310) 468-4000

Subject: Safety Recall – 90L **Phase 10**
 2003 Through Certain 2009 Model Year 4Runner Vehicles
 Potential Floor Mat Interference with Accelerator Pedal (February, 2011)

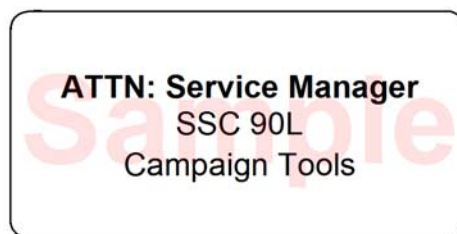
In a shipment scheduled to arrive July 19, 2010, your dealership was sent a Toyota Tacoma accelerator pedal template and gauge. When received, the package displayed a fluorescent (green, orange, yellow or pink) label like the sample seen below for easy identification.

2003 – 2009 4Runners covered by this Safety Recall will utilize the same template as Tacoma.
