**Updated: 5/19/2011 – Operation Code Update
9/06/2011 – Inadvertent Deployment Handling Instructions Added**

Subject: Safety Recall B0E – (B1E) **Interim Notification**
Certain 2007-2008 Model Year RAV4 Vehicles
Certain 2008 Model Year Highlander/Highlander HV Vehicles
Curtain Shield Airbag (CSA) Sensor

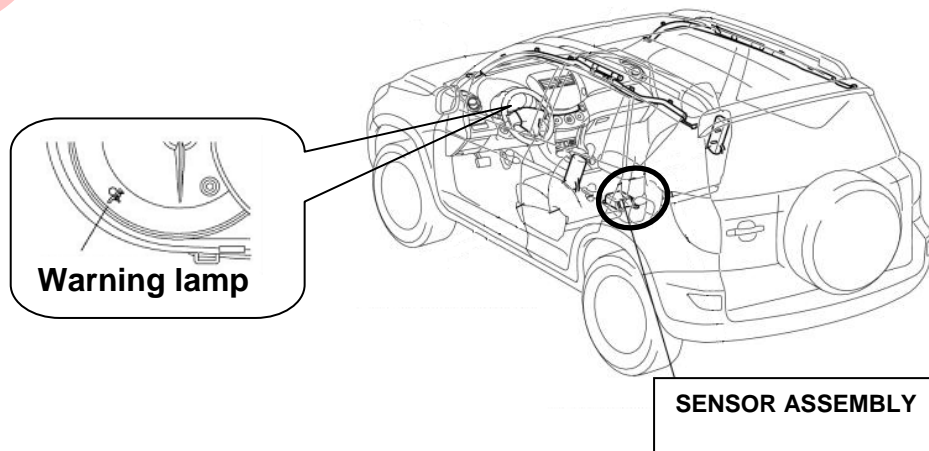
In addition, please pay close attention to the air bag warning light. The air bag warning light is designed to come on, during the ignition cycle check function, when the engine switch is turned to the "ON" position. The light then goes off after about 6 seconds. ***This means the system is operating as designed.*** If the airbag warning light (1) illuminates or remains illuminated ***after*** this 6 second check period, or (2) comes on while driving, or (3) at times previously stayed illuminated while driving, please contact your local Toyota dealer immediately for diagnosis and appropriate repair. If the problem is related to the issue addressed by this recall, the repair will be performed at **no charge** to you.
