**Recall Campaign 11V-332: Replace Alternator Drive Belt Tensioner**

E70 (X5 xDrive35d) with M57Y engine

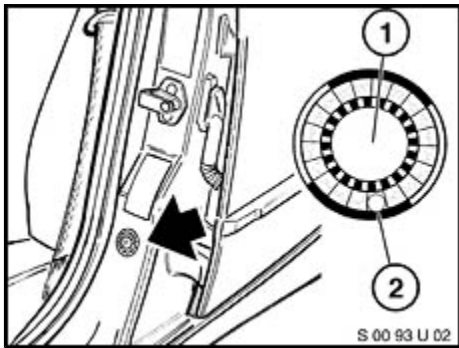
This Recall Campaign has been assigned code number **594**. After the vehicle has been checked and/or corrected, obtain a label (SD 92-380) and:

- A. Emboss your BMW center warranty number in the middle of the label (1);
- B. Punch out code number **594** (2), printed on the label; and
- C. Affix the label to the **B**-pillar as shown.

In order to determine whether a specific vehicle has had this Recall Campaign completed or is affected by this Recall Campaign, first check the B-pillar label for code number **594**. If code number **594** has been punched out, the campaign has already been performed. If code number **594** has not been punched out, it will be necessary to utilize the "Service Menu" of DCSnet (Dealer Communication System) or the Key Reader. Based on the response of the system, either proceed with the corrective action or take no further action.
