TO	Hyundai Service Managers Hyundai Parts Managers	SUBJECT	Campaign 103 – Clock Spring Replacement (TSB#11-01-052)
FROM	Hyundai Motor America National Service Department	MODELS	2007-2008 Santa Fe 2007-2008 Veracruz
DATE	November 3, 2011

**Santa Fe (CM)
Veracruz (EN)****Subject:****CLOCK SPRING REPLACEMENT (Campaign 103)****★ IMPORTANT******* Retail Vehicles *****

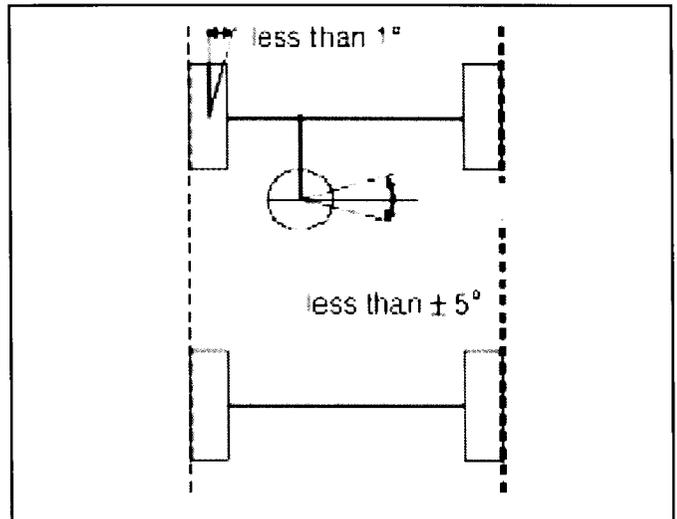
1. Turn the steering wheel to the straight ahead position, and then hold the steering wheel within $\pm 5^\circ$ of straight ahead position.

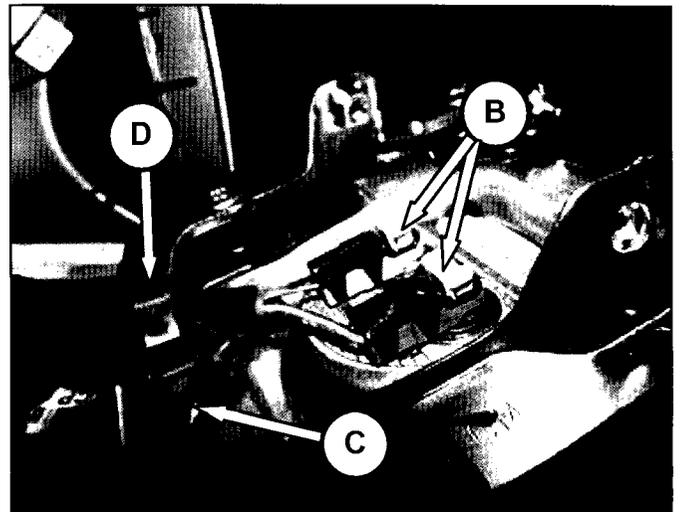
4. Disconnect the airbag connectors (B) after releasing the locking pins. Disconnect the horn connector (C), and then unclip the wiring mounting clip (D). Then remove the driver airbag module.

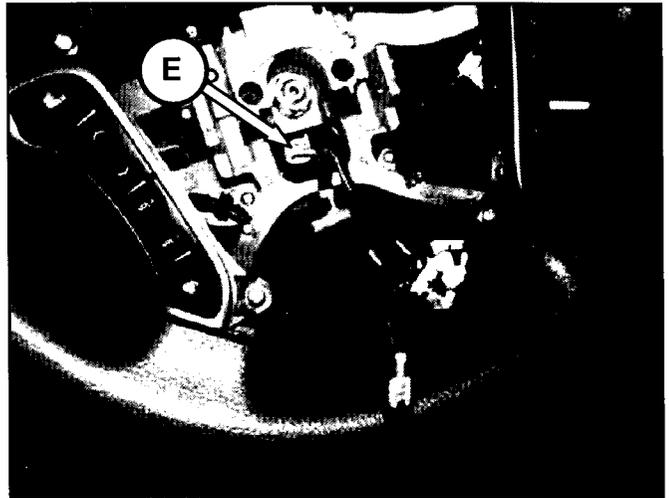
5. Disconnect the steering wheel control switch connector (E).

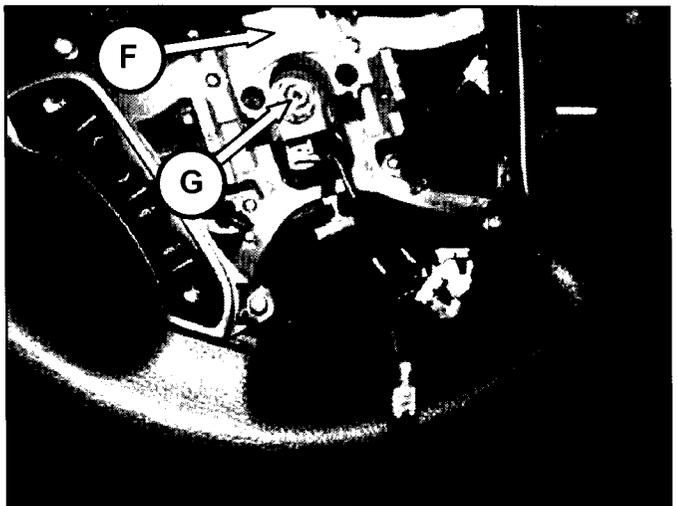
6. Remove the dynamic damper (F).
Remove the steering wheel lock nut (G).

Tightening Torque: 29 ~ 36 lb-ft (40 ~ 50 Nm)

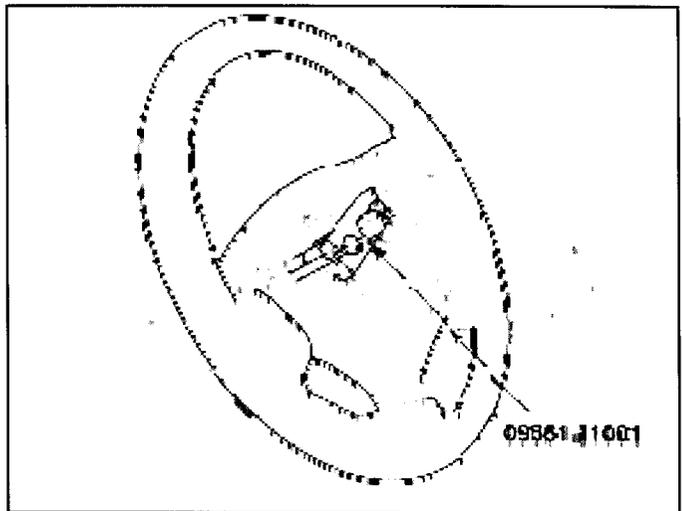
7. After making alignment marks on the steering wheel and shaft for reinstallation, remove the steering wheel using SST 09561-11001 or a generic steering wheel removal tool.

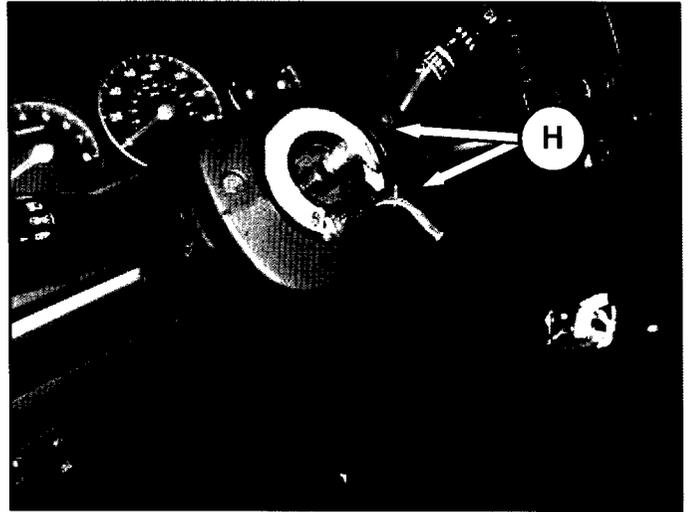
8. Remove the steering column upper/lower shrouds (H) after loosening the mounting screws (5 EA).

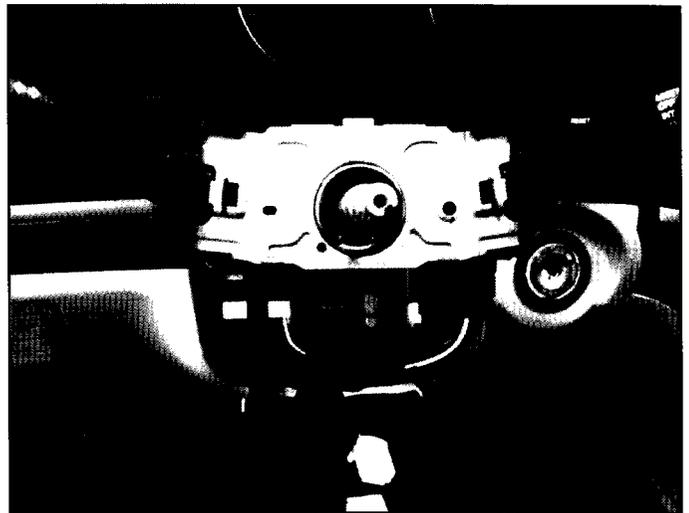
11. Unlock the clock spring upper mounting hook (L) and remove the clock spring from the column shaft.

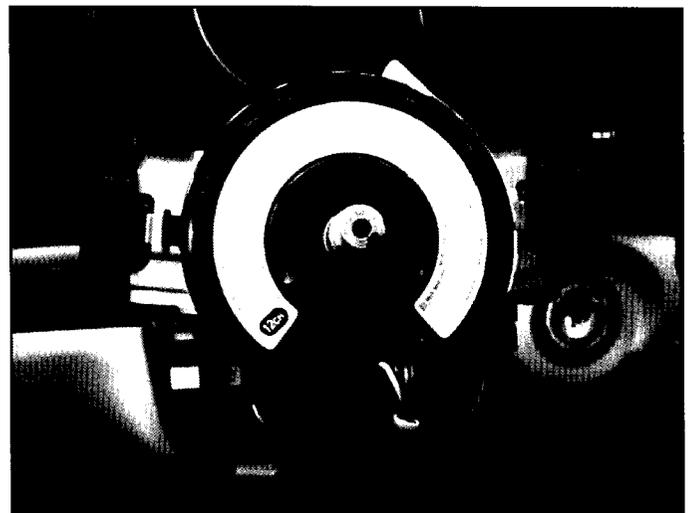
12. Install a new clock spring to the steering column assembly. Connect the clock spring connectors under the clock spring.

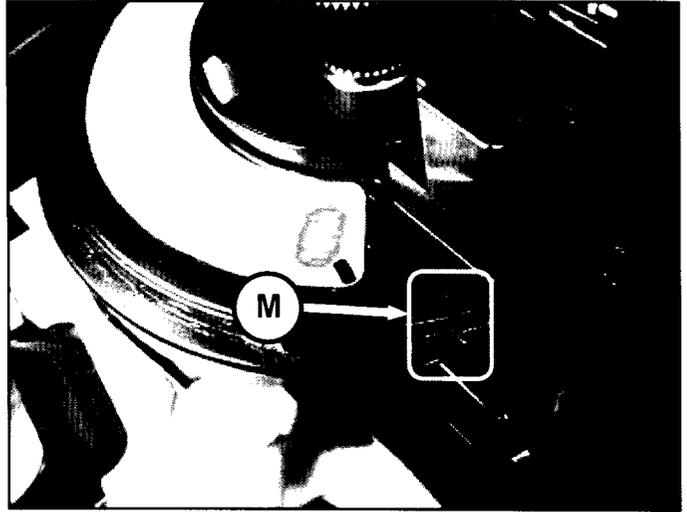
13. When installing the clock spring, make sure to set the center position by aligning the marks between the clock spring and the cover. Align the marks (M) (▶ ◀) by turning the clock spring clockwise to the stop and then 2.0 revolutions counterclockwise.

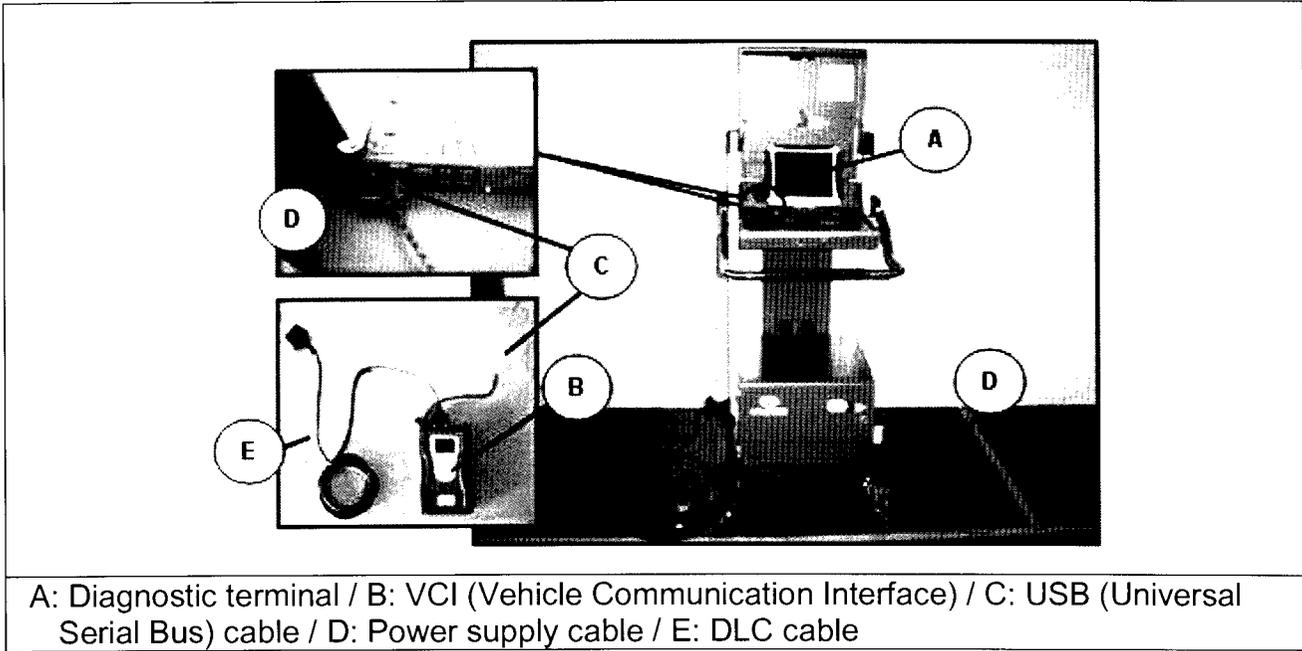
- a) Connect the power supply cable to the diagnostic terminal.
- b) Connect the USB cable between the VCI and the diagnostic terminal.
- c) Connect the 16-pin DLC cable from the VCI into the vehicle's 16-pin connector under the driver side instrument panel.
- d) Turn on the VCI and the GDS diagnostic terminal with the ignition key in the ON position.
- e) Click to select **Data Treatment** under the **Vehicle S/W Management** section and the GDS will Auto VIN Detect.

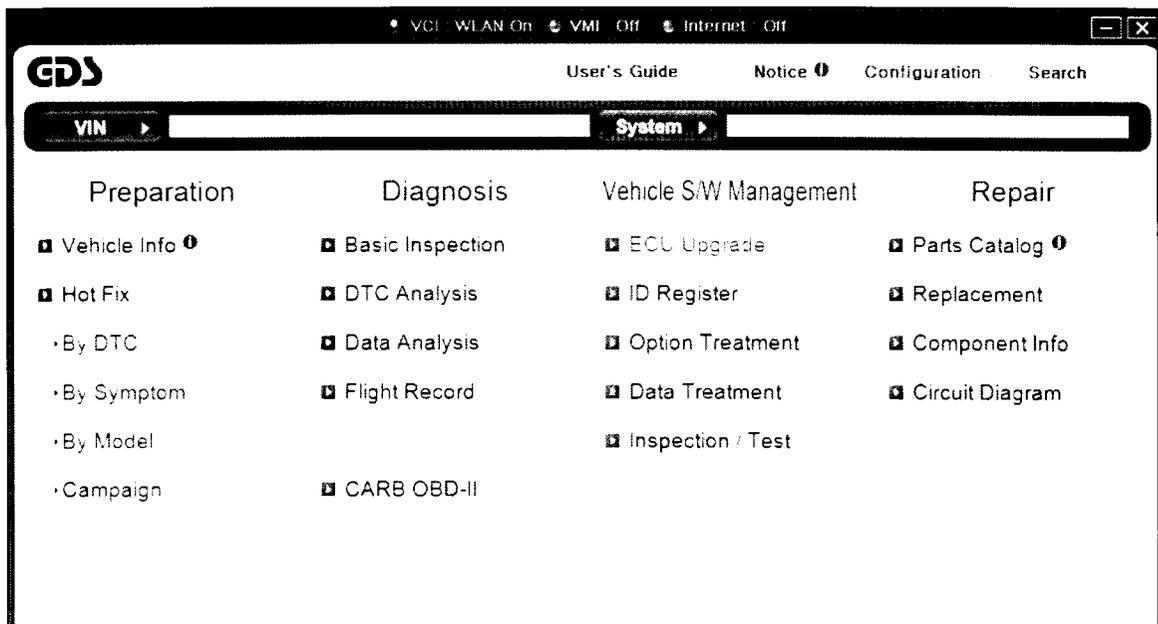
f) Click to select **ABS/ESC** as the system and then click **OK**.

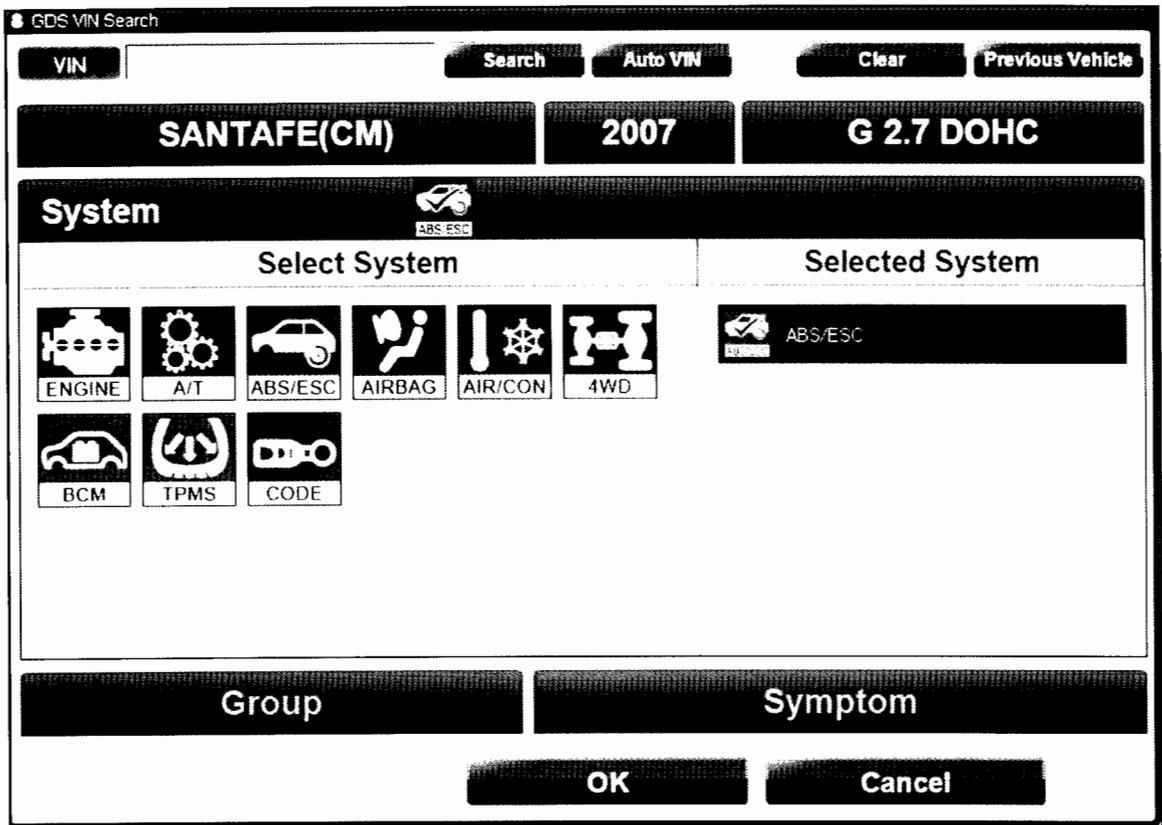
g) Click to select **Steering Angle Sensor**.

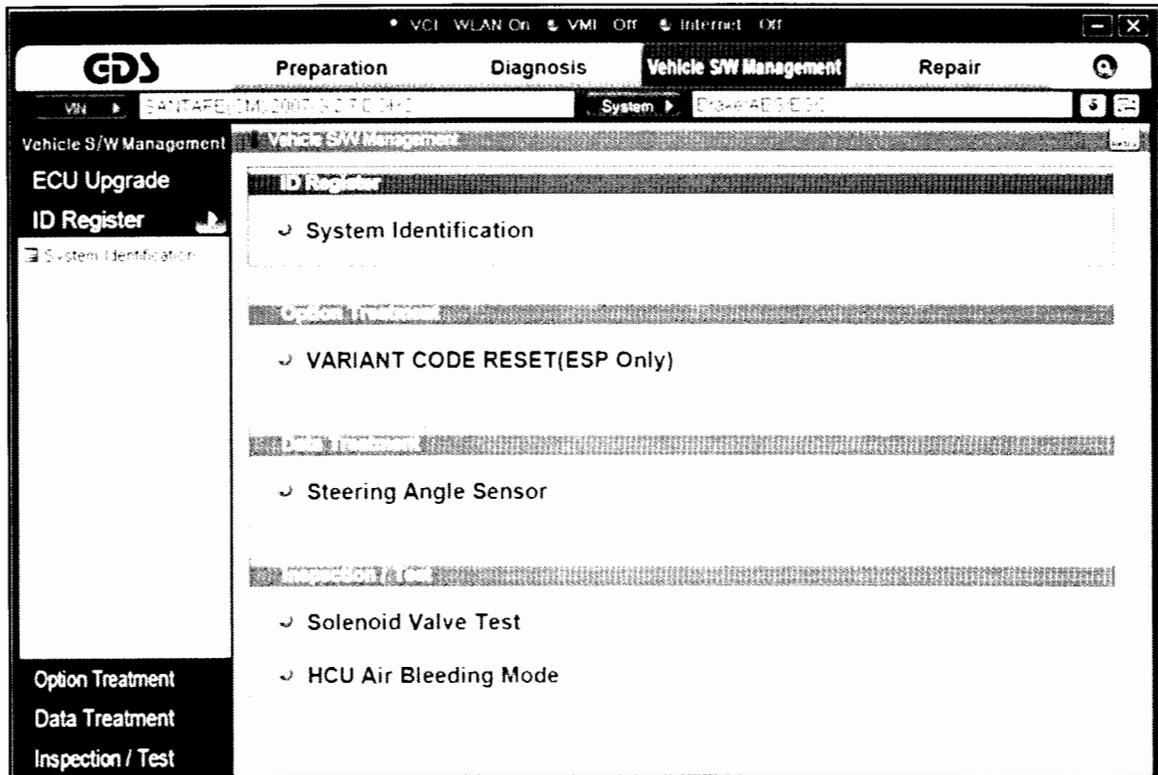
- h) Make sure that calibration conditions are met. Click **Reset** button to calibrate and then click **OK** to proceed with the calibration.

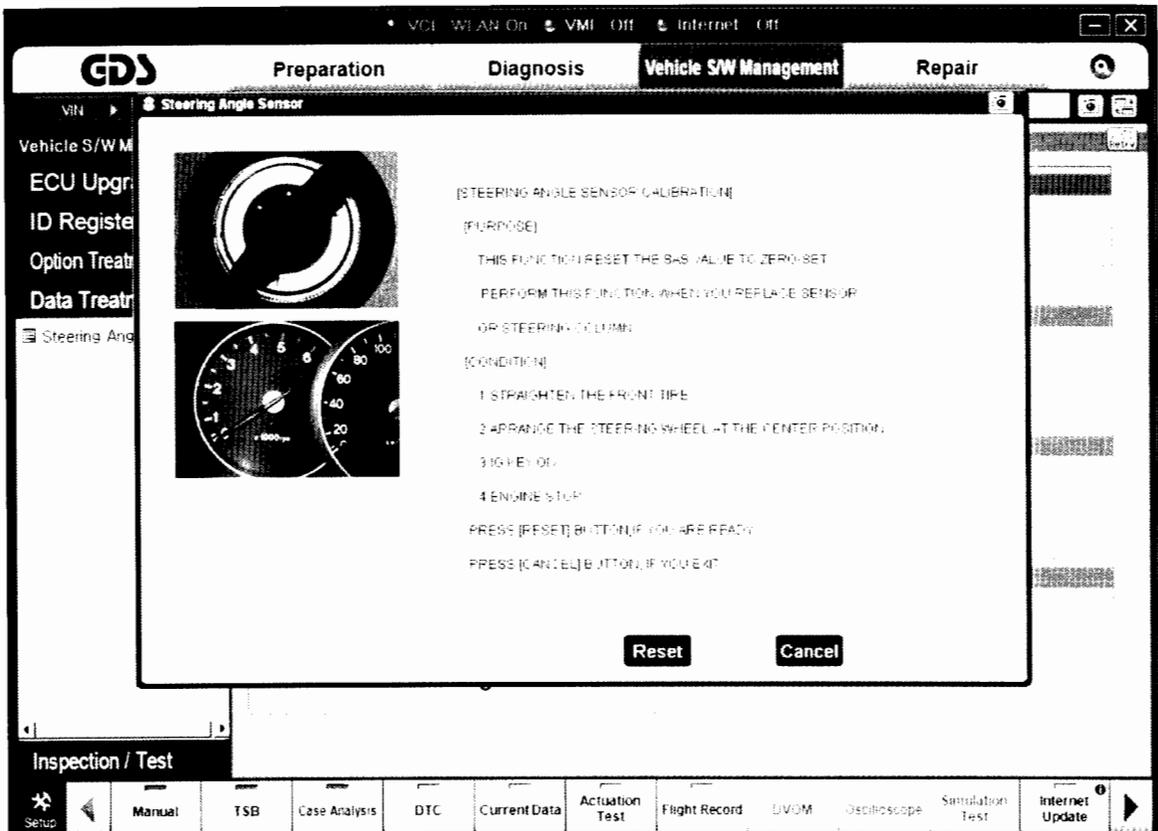
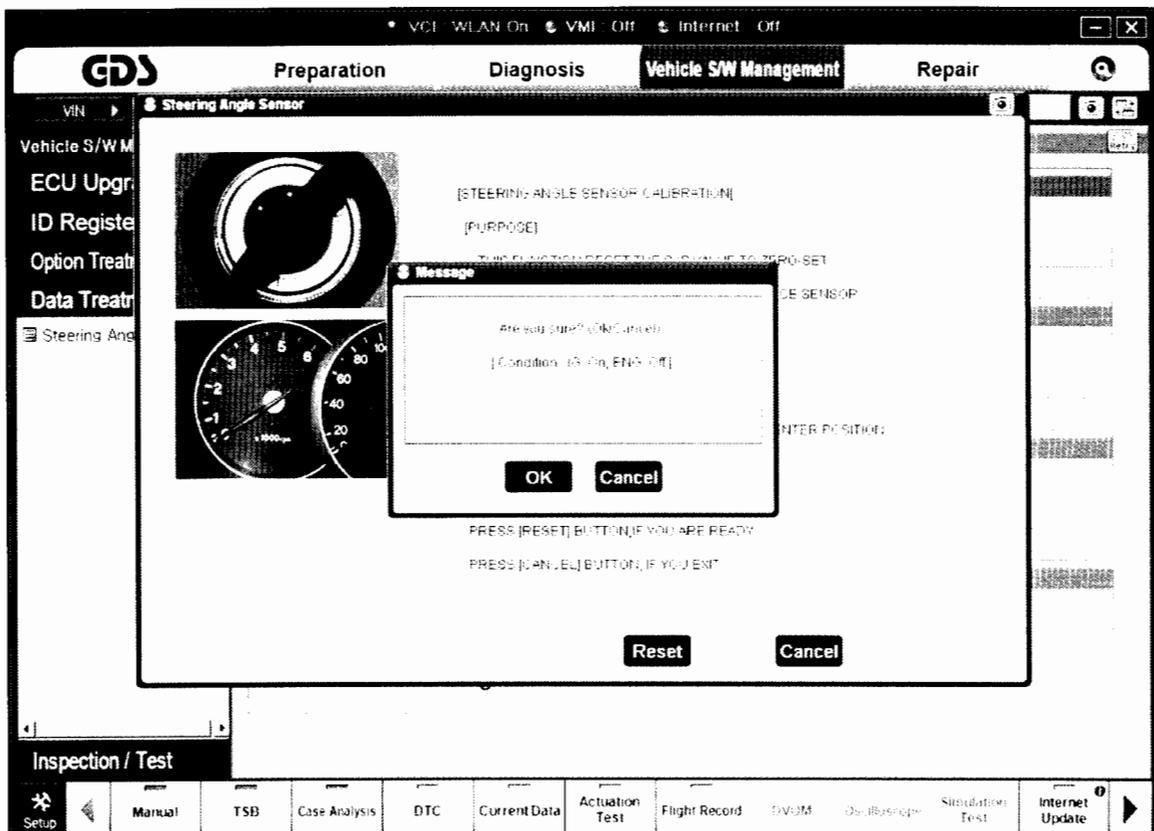
- i) After calibration is completed, click OK and turn the ignition OFF for 10 seconds.

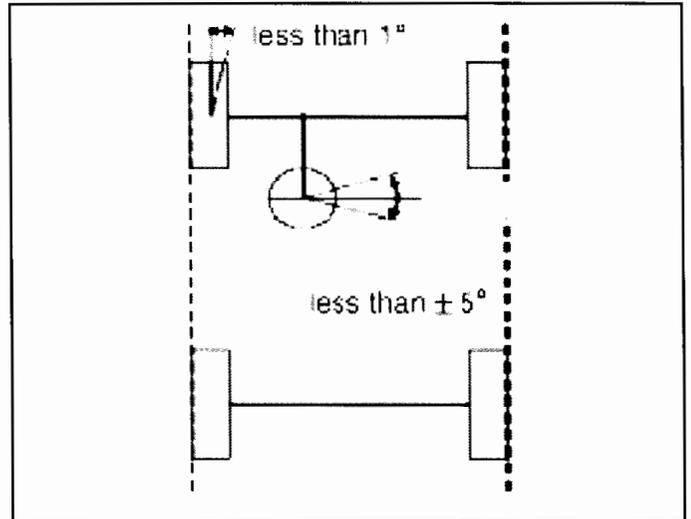
1. Turn the steering wheel to the straight ahead position, and then hold the steering wheel within $\pm 5^\circ$ of straight ahead position.

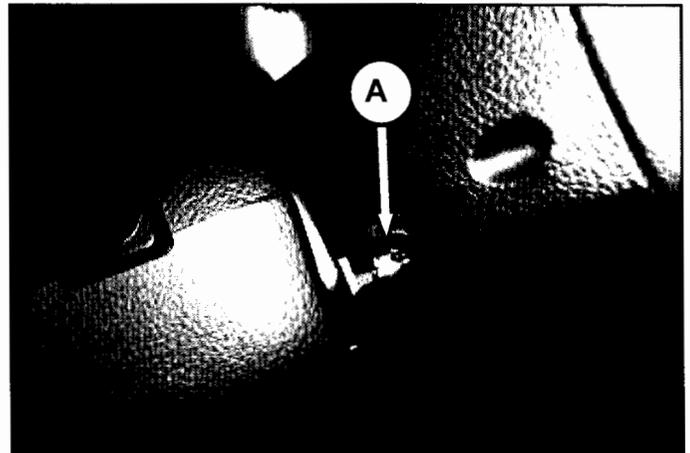
3. Loosen and remove the steering wheel air bag mounting bolts (A) on both sides.

Tightening Torque :
5.7~7.9 lb-ft (7.9~10.7 Nm)

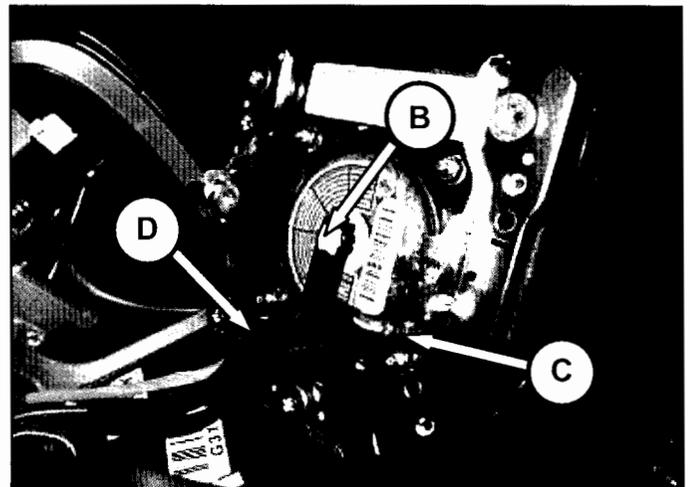
4. Disconnect the airbag connector (B) after releasing the locking pin. Disconnect the horn connector (C), and then unclip the wiring mounting clip (D). Then remove the driver airbag module.

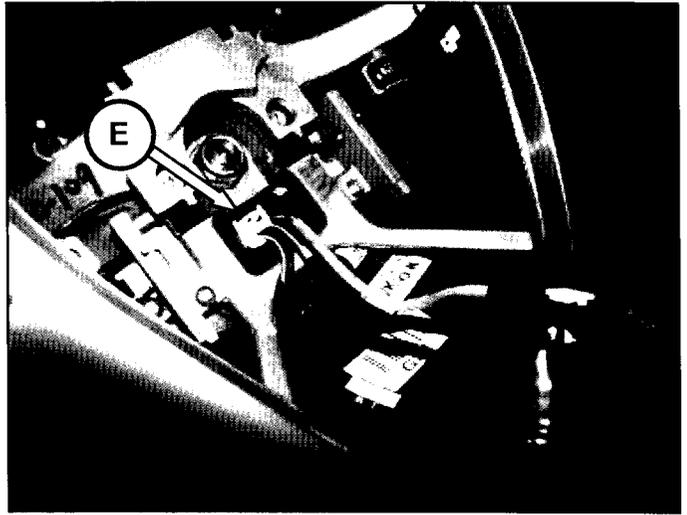
5. Disconnect the steering wheel control switch connector (E).

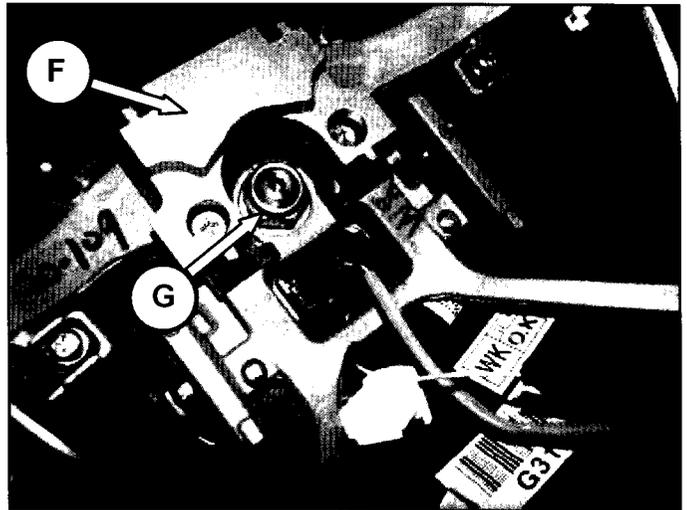
6. Remove the dynamic damper (F).
Remove the steering wheel lock nut (G).

Tightening Torque:
29 ~ 36 lb-ft (40 ~ 50 Nm)

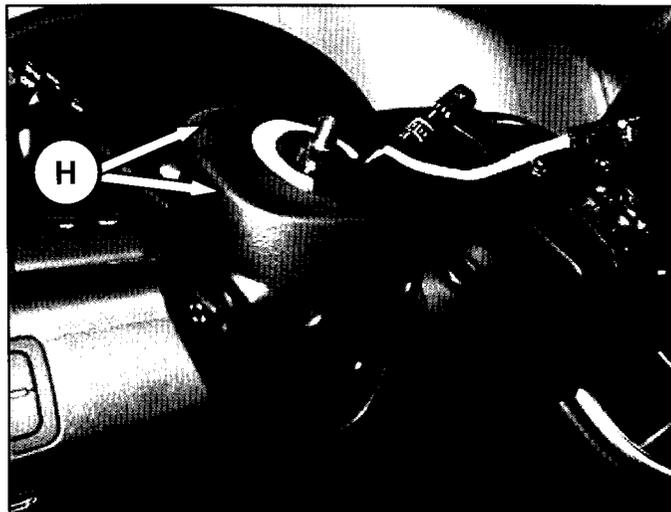
8. Separate the steering column upper and lower shrouds (H) by loosening the mounting screws.

Remove the steering column upper shroud.

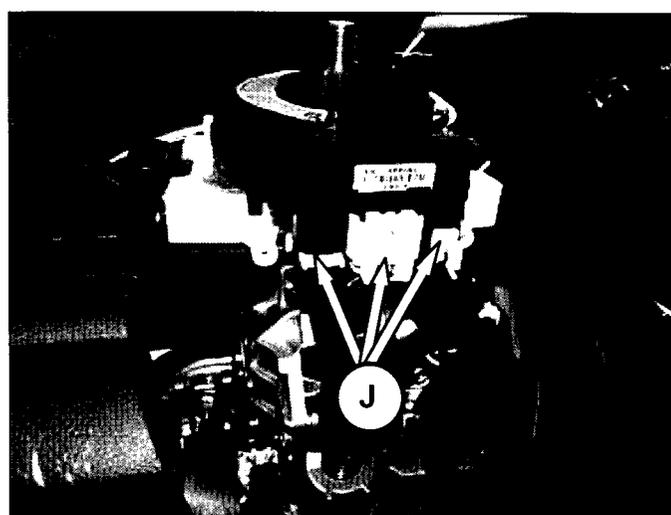
10. Disconnect the connectors (J) under the clock spring.

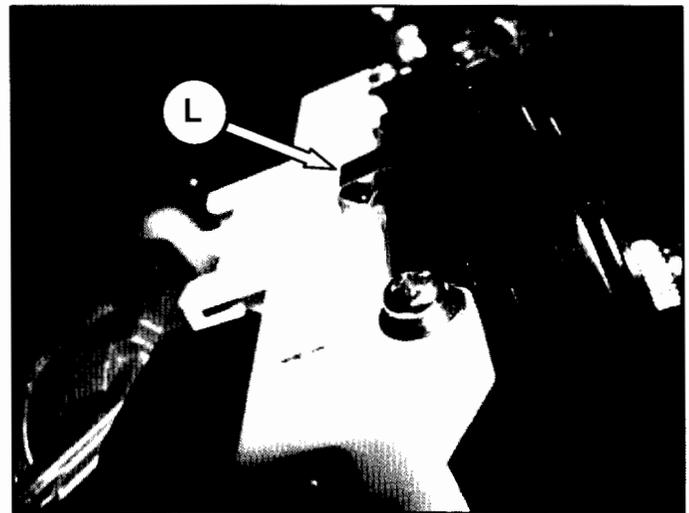
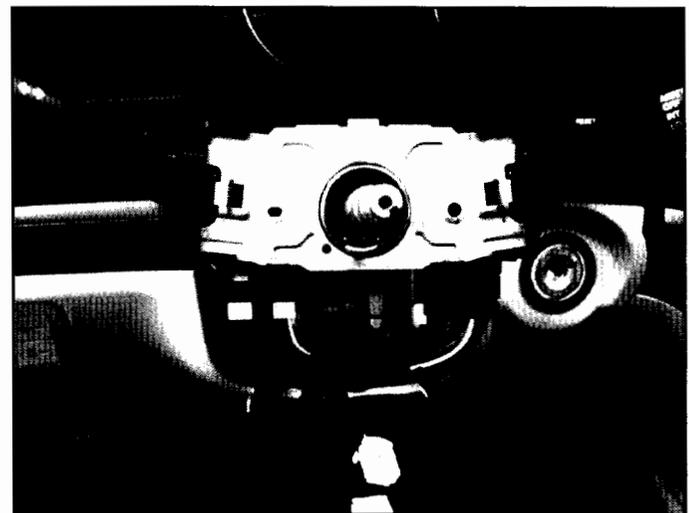
12. Unlock the clock spring upper mounting hook (L) and remove the clock spring assembly from the column shaft.

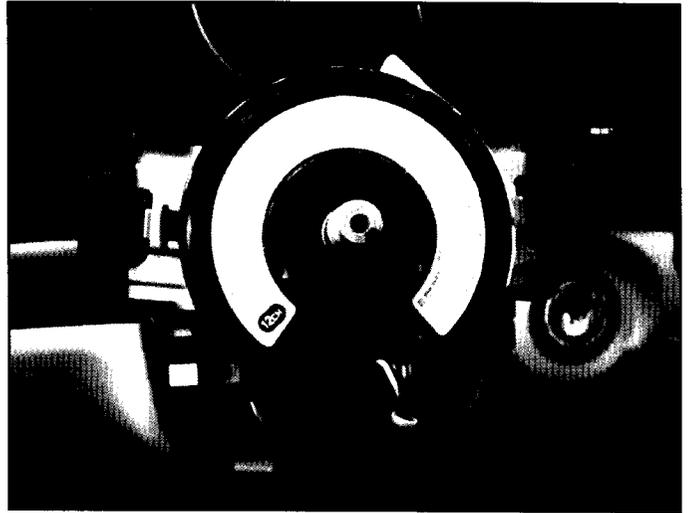
13. Install a new clock spring to the steering column assembly. Connect the clock spring connectors under the clock spring.

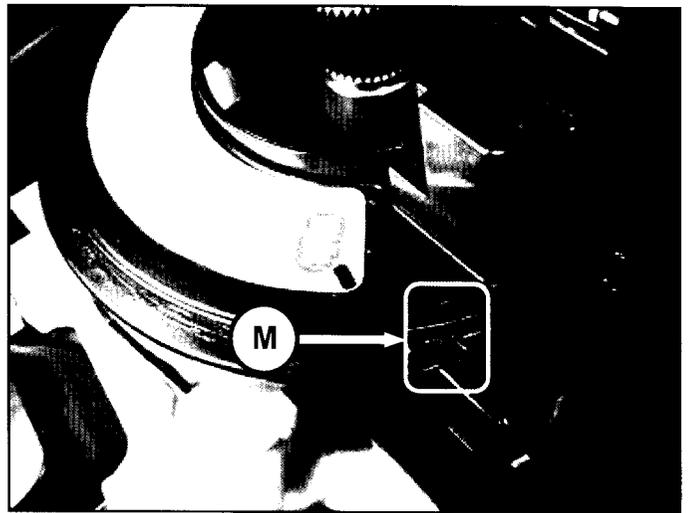
14. When installing the clock spring, make sure to set the center position by aligning the marks between the clock spring and the cover. Align the marks (M) (▶ ◀) by turning the clock spring clockwise to the stop and then 2.0 revolutions counterclockwise.
