Recall Campaign 11V-521: Replace the Auxiliary Coolant Pump for Turbocharger

F01 and F02 (7 Series) with N63 engine (including Alpina B7/B7L) or N74 engine

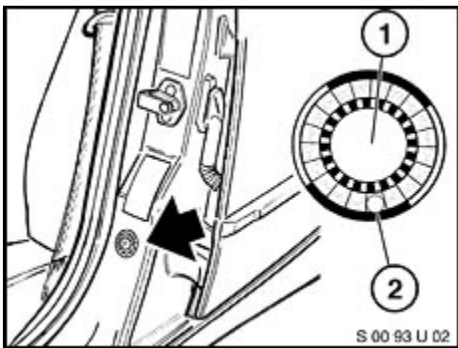
LABEL INSTRUCTIONS

This Recall Campaign has been assigned code number **604**. After the vehicle has been checked and/or corrected, obtain a label (SD 92-403) and:

- A. Emboss your BMW center warranty number in the middle of the label (1);
- B. Punch out code number **604** (2), printed on the label; and
- C. Affix the label to the **B**-pillar as shown.
