Recall Bulletin

PRODUCT SAFETY RECALL

SUBJECT: Power Steering System Overheat - Install New Power Steering Fluid Cooler

MODELS: 2011-2012 Chevrolet Captiva
Equipped with V6 Engine (LF1)

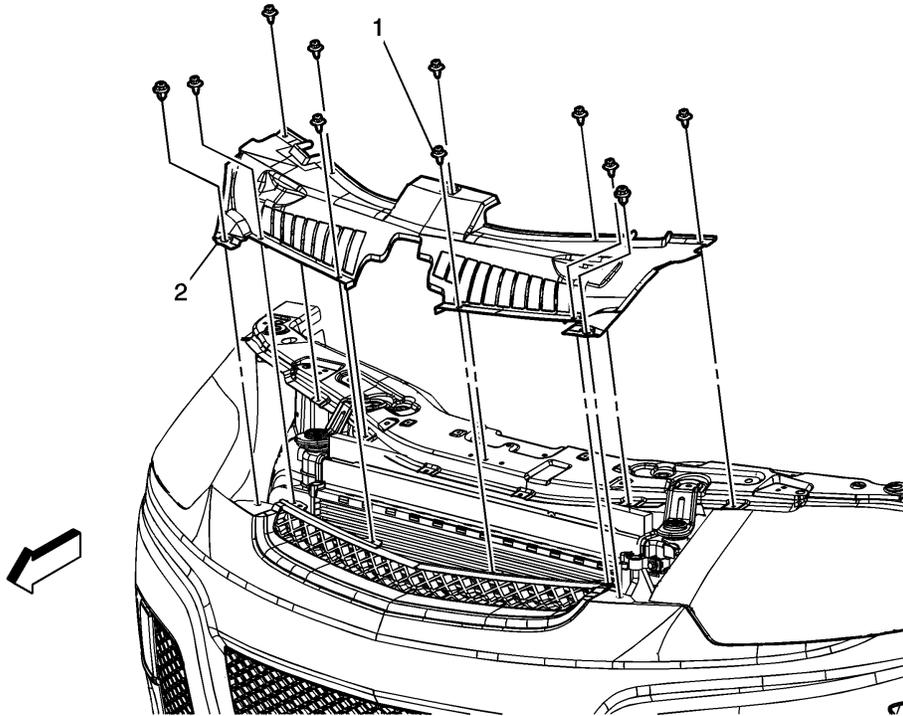
1862371

- 5.1 Remove the radiator opening upper cover retainers (1) and cover (2).
- 5.2 Remove the front tire and wheel assemblies.

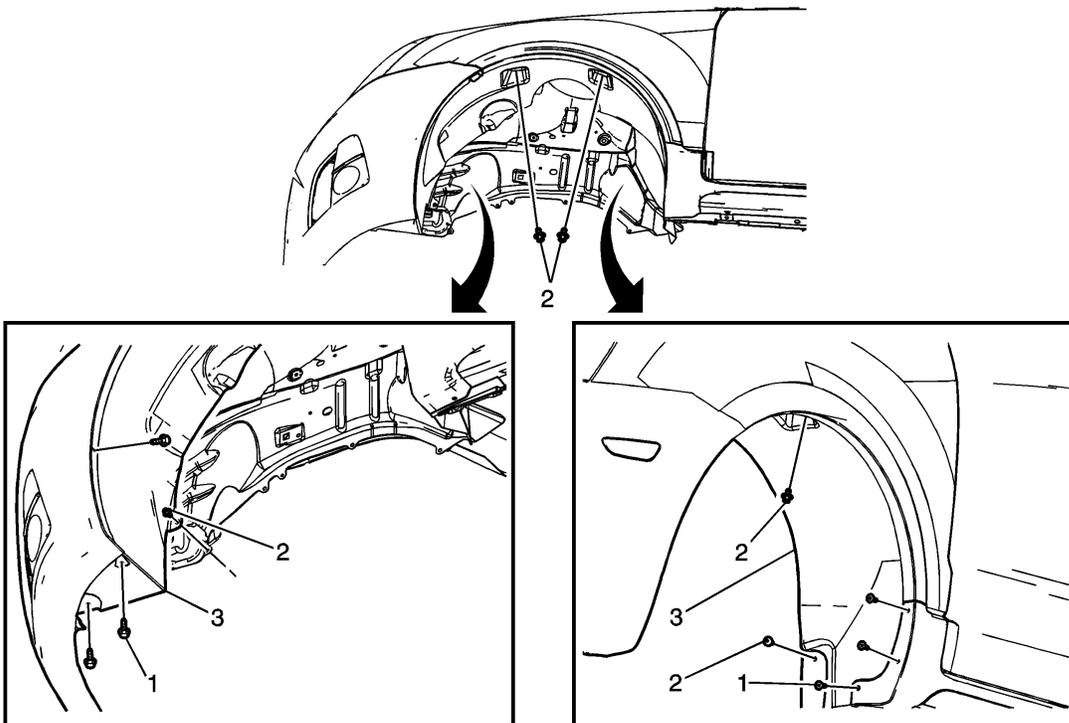
1868866

- 5.3 Remove the driver side front wheelhouse liner screws (1), retainers (2) and liner (3) from the vehicle.
- 5.4 Remove the passenger side front wheelhouse liner screws, retainers and liner from the vehicle.

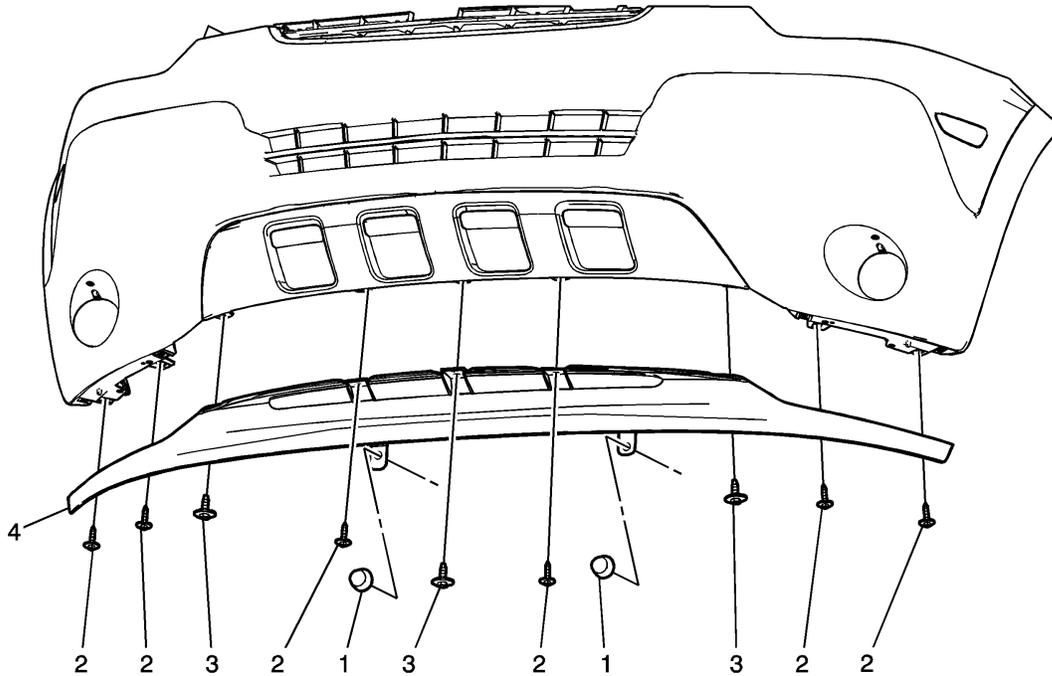
2015954

5.5 Remove the retainers (1) and screws (3) attaching the front bumper air deflector (4) to the body. The remaining screws (2) do not need to be removed for fascia removal.

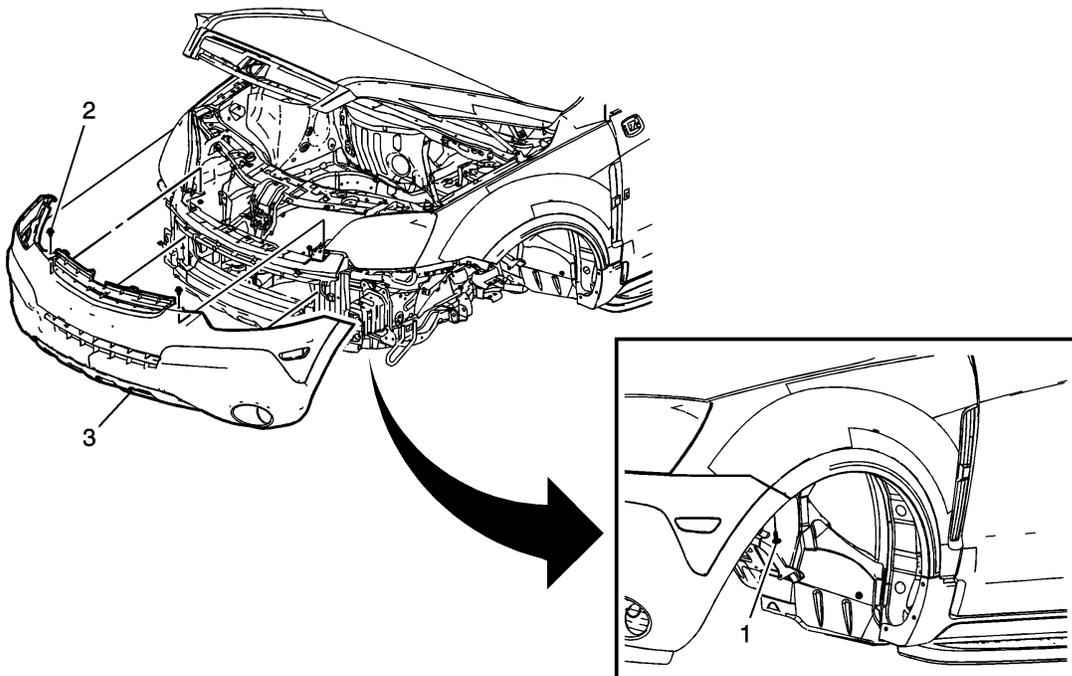
1868396

5.6 Remove the front bumper fascia bolts (1), retainers (2) and fascia (3) from the vehicle.

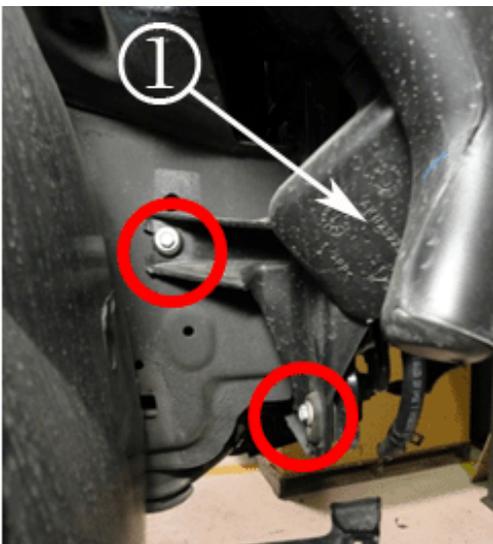
2755078

6. Remove the air cleaner resonator assembly (1).

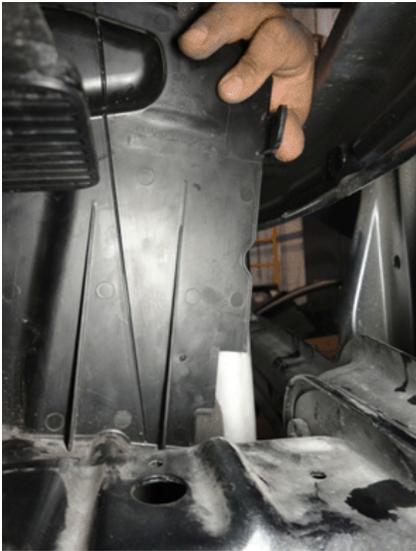
2755212

7. Remove the 2 retainers from the front end guard (1) and move rearwards to increase clearance to remove the power steering loop cooler.

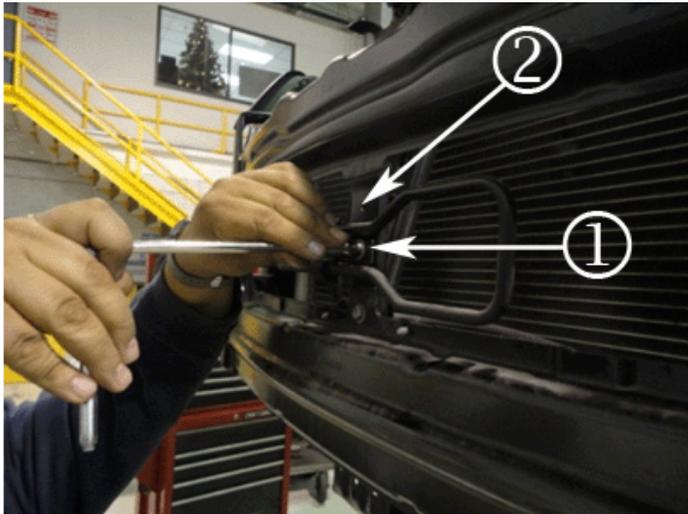
2755213

8. Remove the power steering loop cooler bolt (1) from the bracket (2).

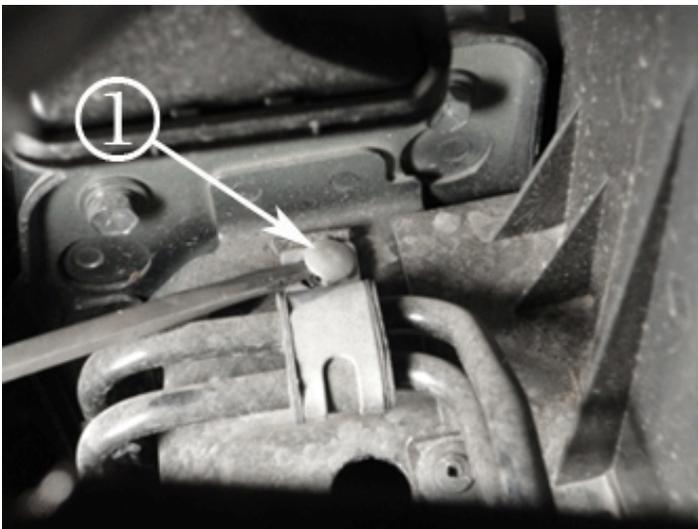
2755215

9. Disconnect the power steering loop cooler clip (1) from the bracket.

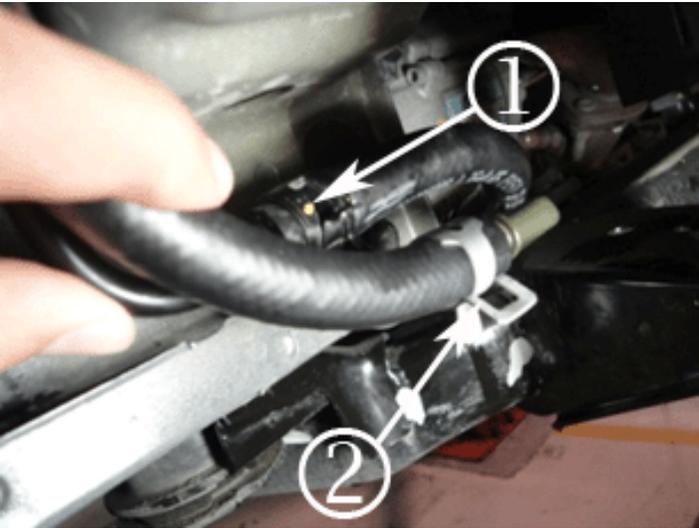
2755218

- 10. Remove the clamp (1) from the power steering return line.
- 11. Remove the clamp (2) from the power steering loop cooler.

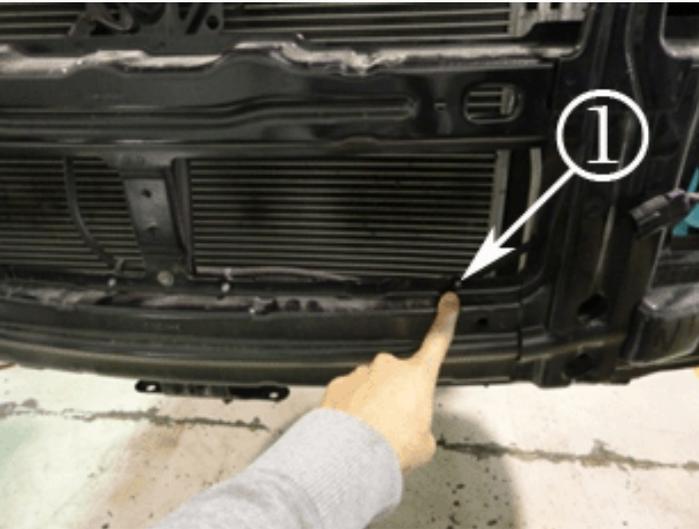
2766221

- 12. Remove the wiring harness push pin (1) from the tie bar.

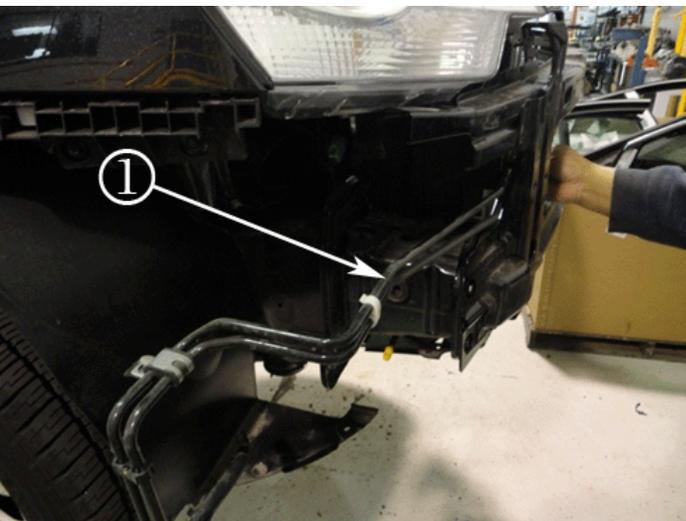
2755223

- 13. Remove the power steering loop cooler (1) from the vehicle.

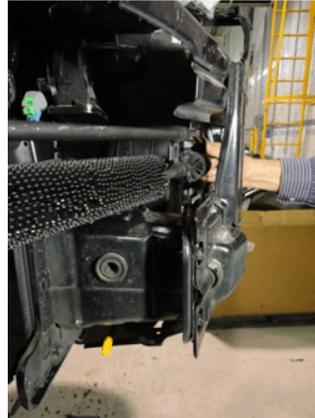
2755228

14. Position the power steering brush (1) cooler in the vehicle.

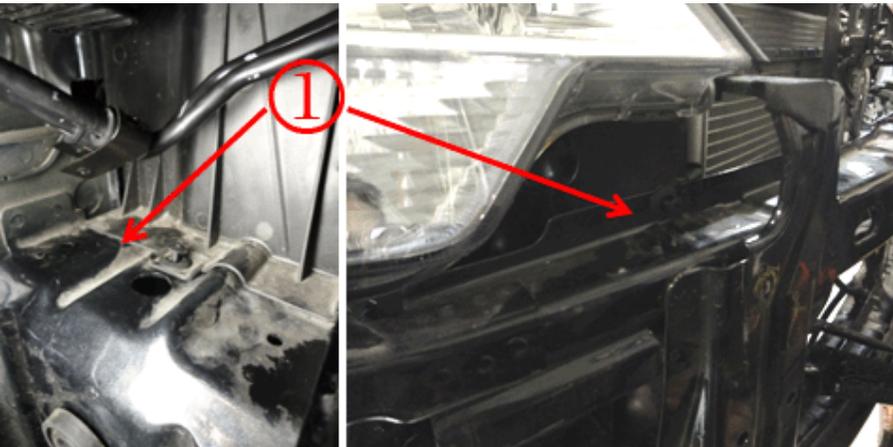
2755229

15. Reinstall the 2 retainers to the front end guard (1).

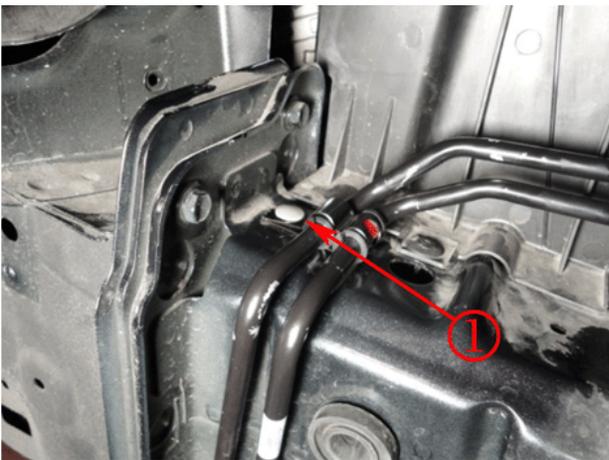
2755232

16. Connect the power steering brush cooler clip (1) to the bracket.

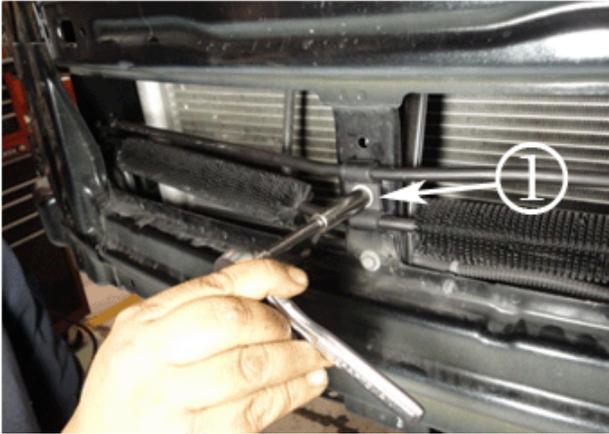
2755235

- 17. Reinstall the power steering loop cooler bolt (1) to the front bumper impact bar support. Tighten the bolt to 9 Nm (80 lb in).

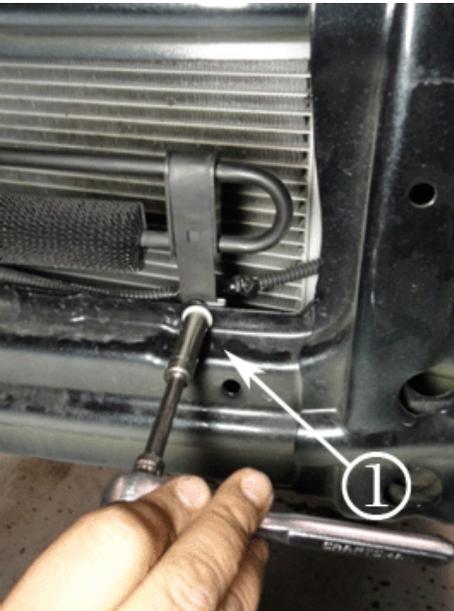
2755236

- 18. Install the driver side steering brush cooler bolt (1) to the bumper impact bar support. Tighten the bolt to 9 Nm (80 lb in).

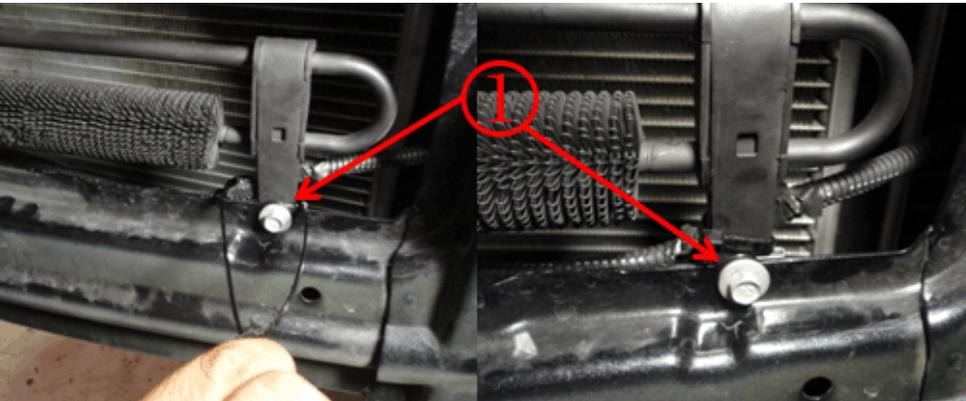
2755237

- 19. Secure the wiring harness with a tie strap to the steering brush cooler driver side bracket (1).
- 20. Reconnect the power steering brush cooler hose (2) to the return line.

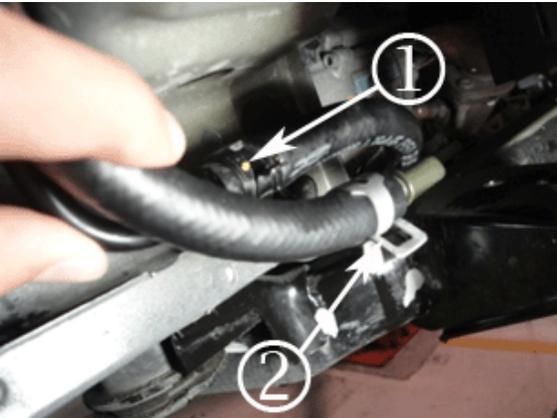
2755218

21. Reconnect the return line hose (1) to the power steering brush cooler.

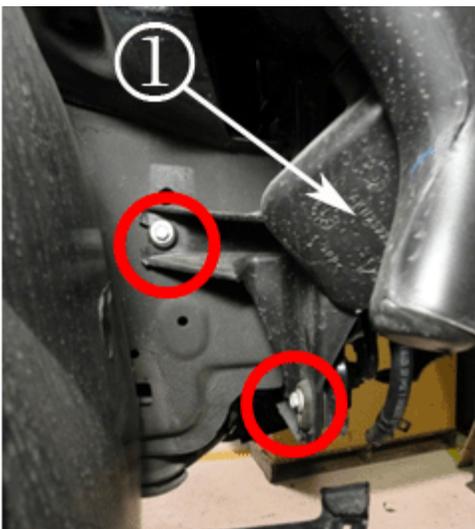
2755078

22. Reinstall the air cleaner resonator assembly (1).

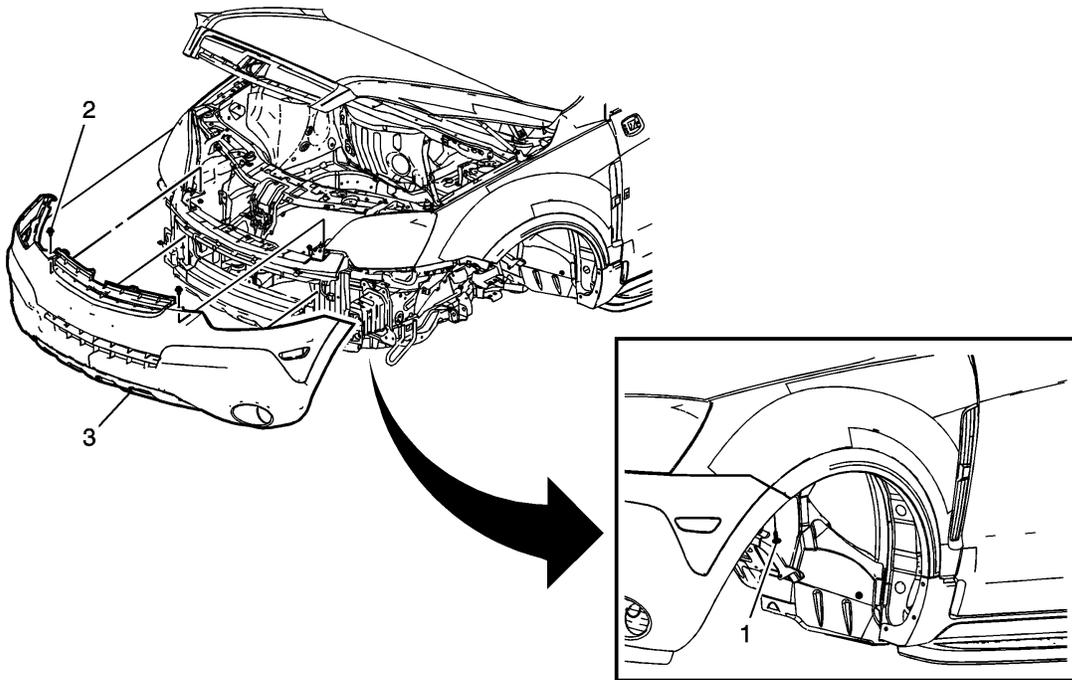
1868396

23.1 Install the front bumper fascia (3), retainers (2), and bolts (1). Tighten the bolts to 10 Nm (89 lb in).

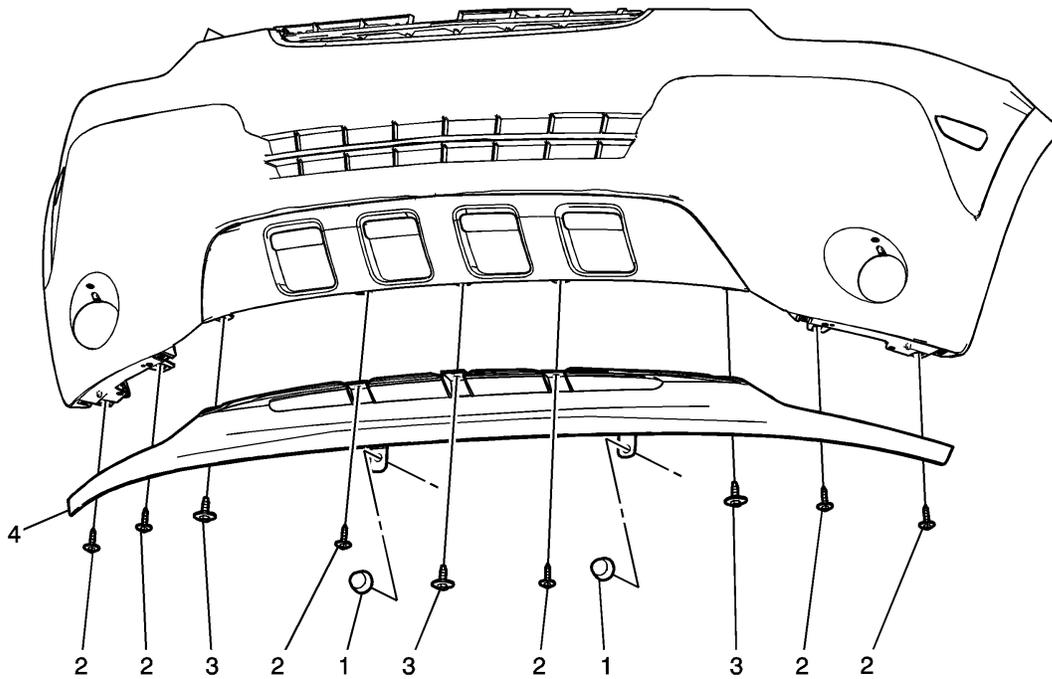
2015954

23.2 Install the retainers (1) and screws (3) attaching the front bumper air deflector (4) to the body. Tighten the screws to 2 Nm (18 lb in).

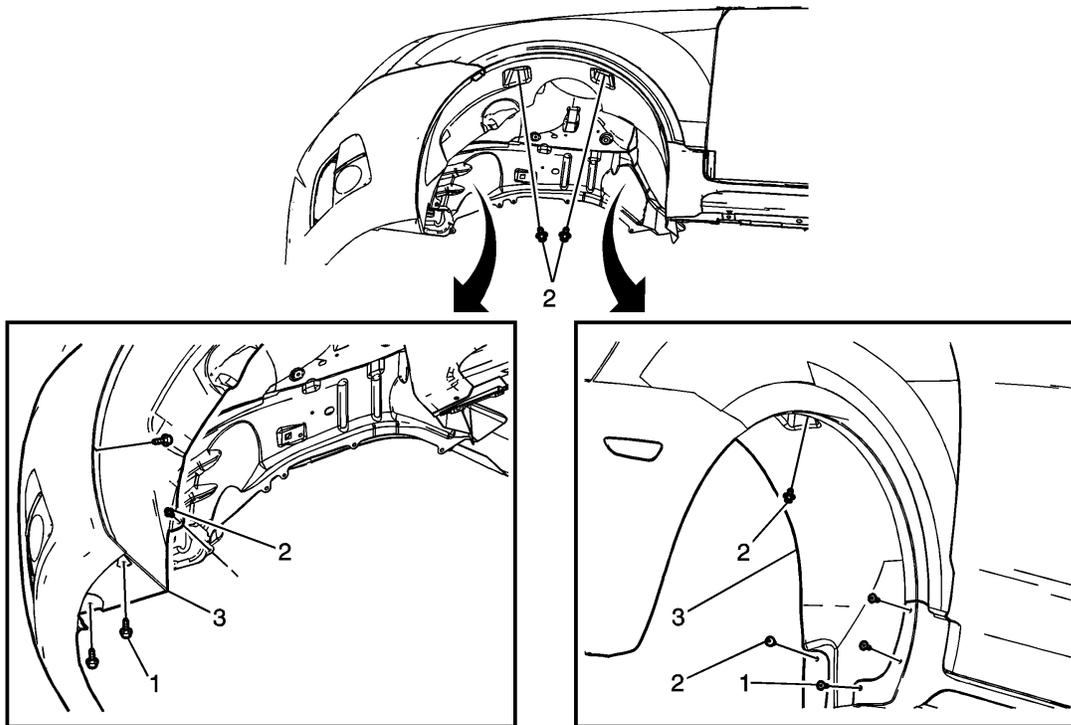
1868866

23.3 Install the driver side front wheelhouse liner (3), screws (1) and retainers (2). Tighten the screws to 2.5 Nm (22 lb in).

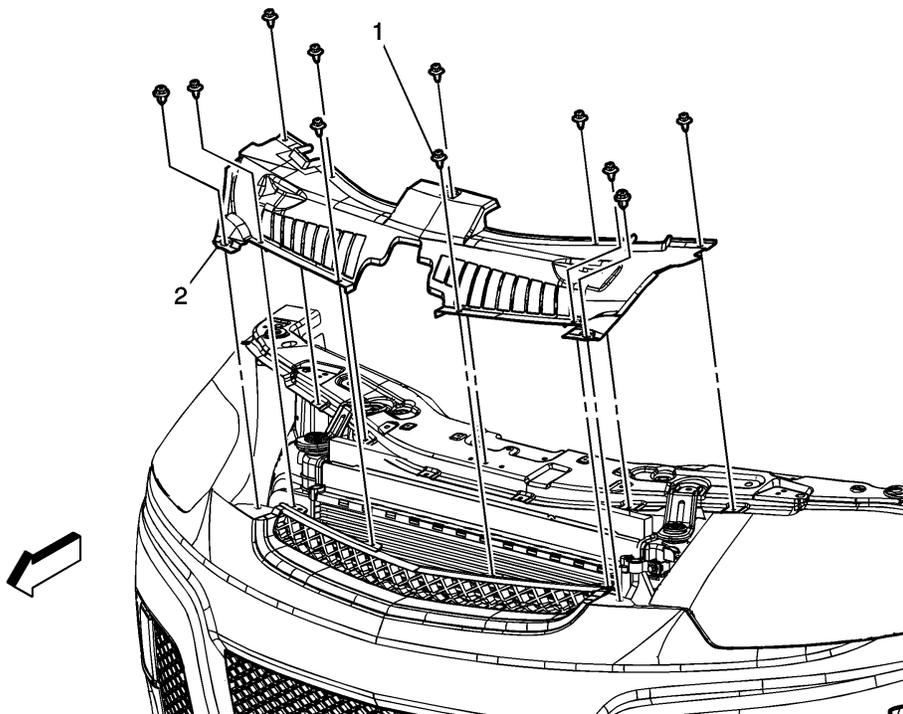
1862371

23.6 Install the radiator opening upper cover (2) and retainers (1).
