SUBJECT: **Safety Recall 11S25**
Certain 2004 and 2005 Model Year Freestar/Monterey Vehicles
Torque Converter Replacement

CERTAIN 2004 AND 2005 MODEL YEAR FREESTAR/MONTEREY VEHICLES — TORQUE CONVERTER REPLACEMENT

Some of the affected vehicles may exhibit a loss of forward and reverse power while driving due to worn pump drive insert splines within the torque converter. Dealers are to replace the torque converter.

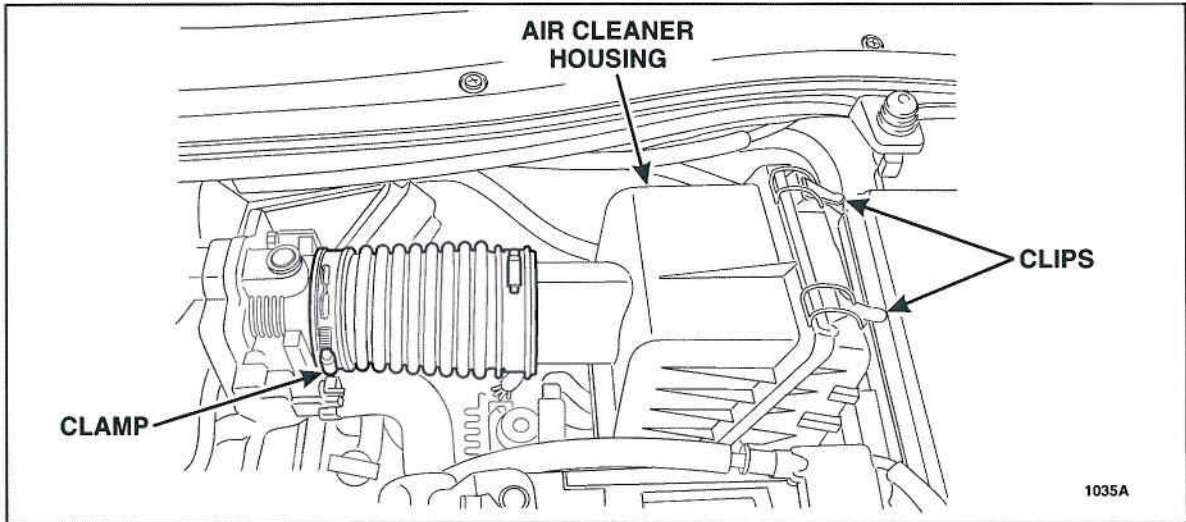
FIGURE 1

7. Remove the air cleaner housing. See Figure 1.
- Loosen the clamp.
 - Release the clips at the air cleaner housing.
 - Disconnect and remove the air cleaner housing.

50. Install the air cleaner housing. See Figure 1.
 - a. Connect and install the air cleaner housing.
 - b. Install the clips at the air cleaner housing.

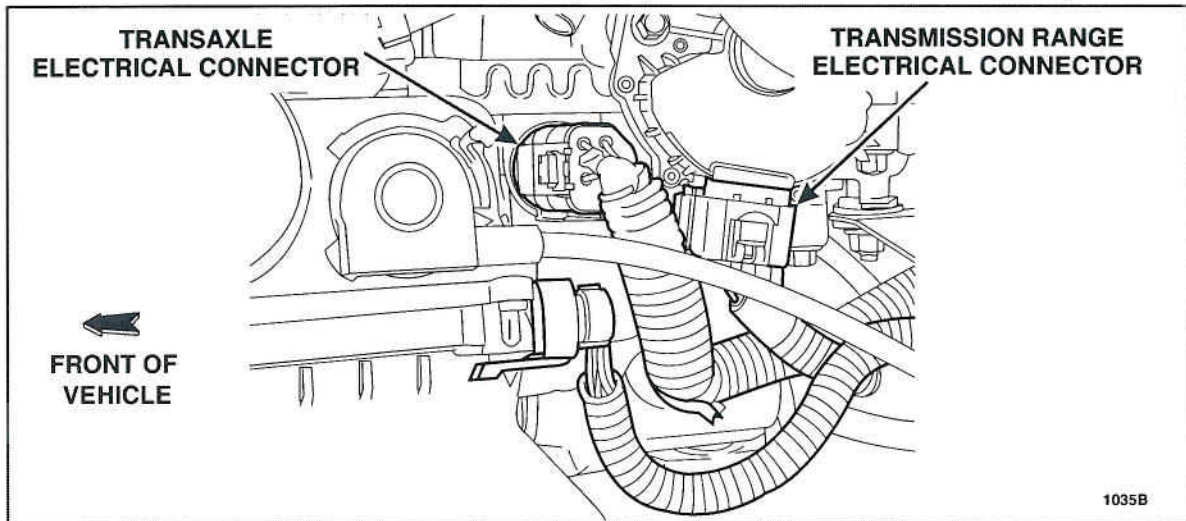
FIGURE 2

8. Disconnect the transaxle and Transmission Range (TR) sensor electrical connectors. See Figure 2.

- b. Connect the transmission selector cable end to the manual lever.
49. Connect the transaxle and Transmission Range (TR) sensor electrical connectors. See Figure 2.

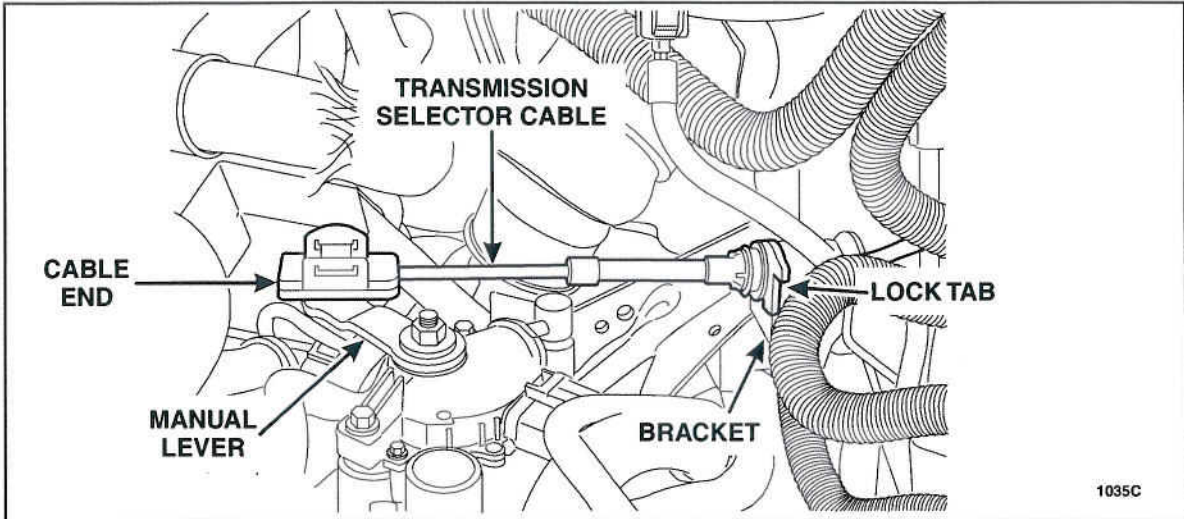
FIGURE 3

9. Remove the transmission selector cable from the bracket and position it out of the way.
See Figure 3.
- a. Disconnect the transmission selector cable end from the manual lever.
 - b. Push the lock tab and separate the transmission selector cable from the bracket.

47. Connect the wire harness to the bracket. See Figure 4.
48. Install and connect the transmission selector cable. See Figure 3.
 - a. Connect the transmission selector cable to the bracket.

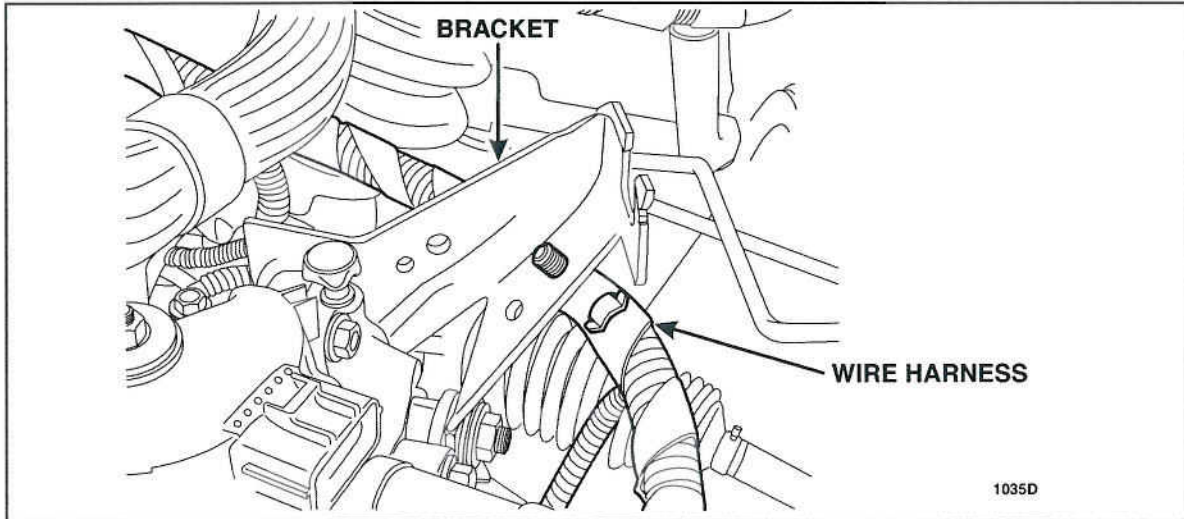
FIGURE 4

10. Disconnect the wire harness from the bracket. See Figure 4.

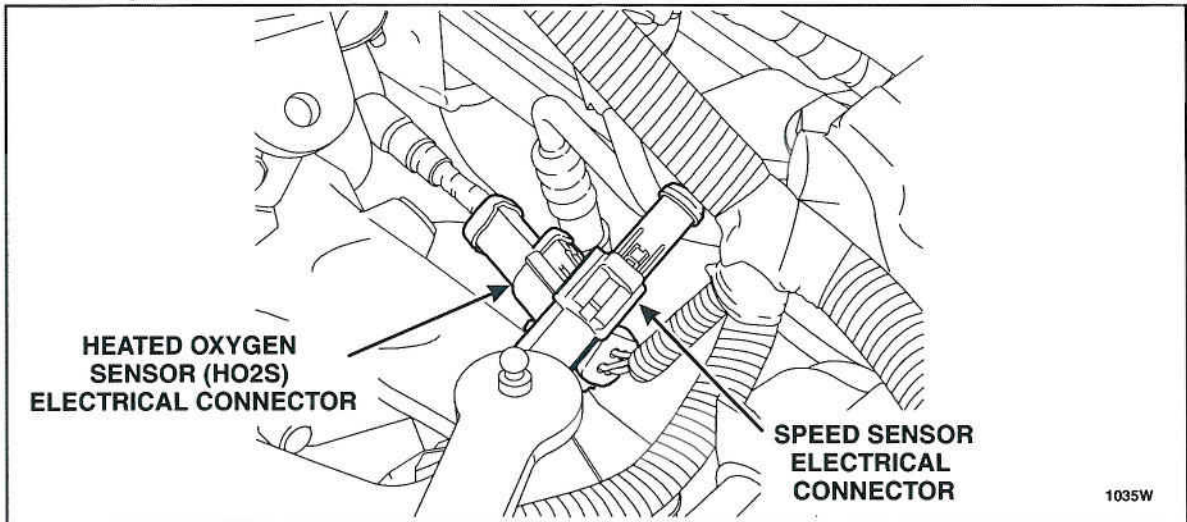
FIGURE 5

11. Disconnect the speed sensor and rear heated oxygen sensor (HO2S) electrical connectors.
See Figure 5.

- Tighten the LH upper generator bolt to 47 Nm (35 lb-ft).
46. Connect the speed sensor and rear heated oxygen sensor (HO2S) electrical connectors. See Figure 5.

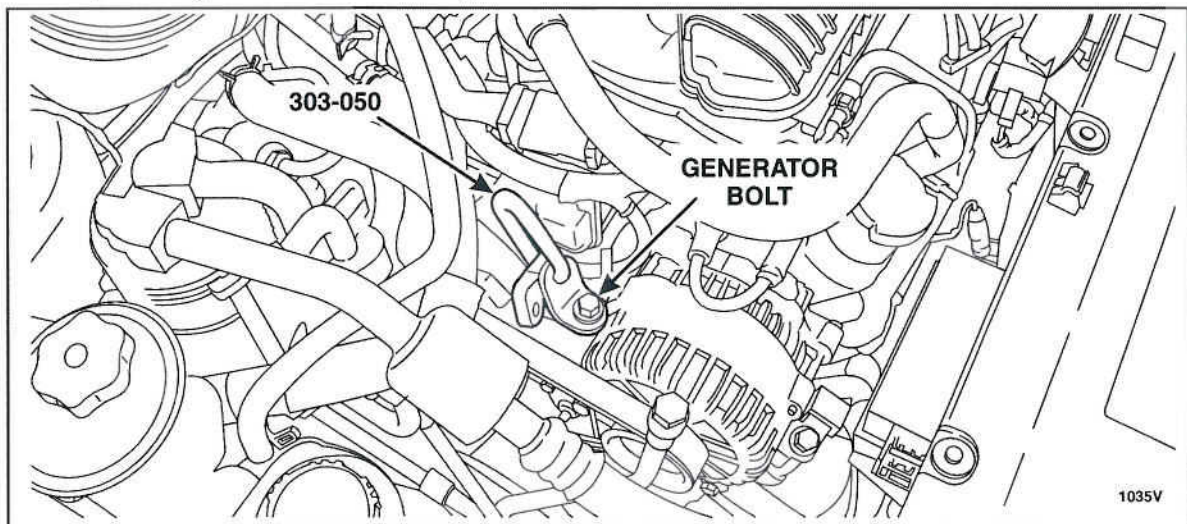
FIGURE 6

12. Remove the LH upper generator bolt and install the Engine Lifting Bracket special tool 303-050, using the previously removed bolt. See Figure 6.

- Attach the push pin retainers.
 - Tighten to 14 Nm (10 lb-ft).
44. Remove the Three Bar Engine Support Kit.
45. Remove the Engine Lifting Brackets and reinstall the LH upper generator bolt. See Figures 6 and 7.

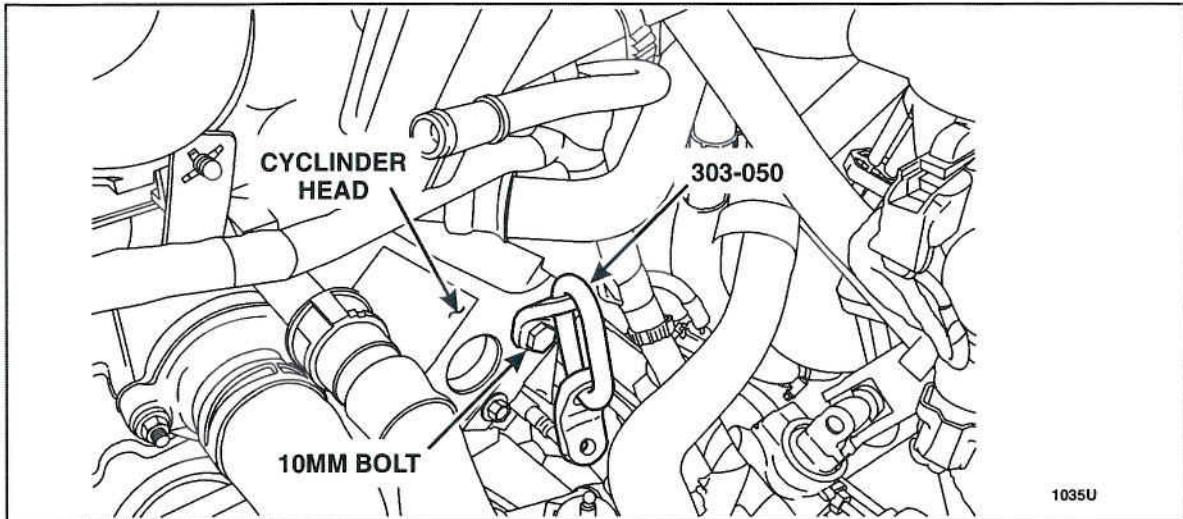
FIGURE 7

13. Install the Engine Lifting Bracket special tool 303-050 onto the cylinder head, using a suitable 10mm bolt. See Figure 7.

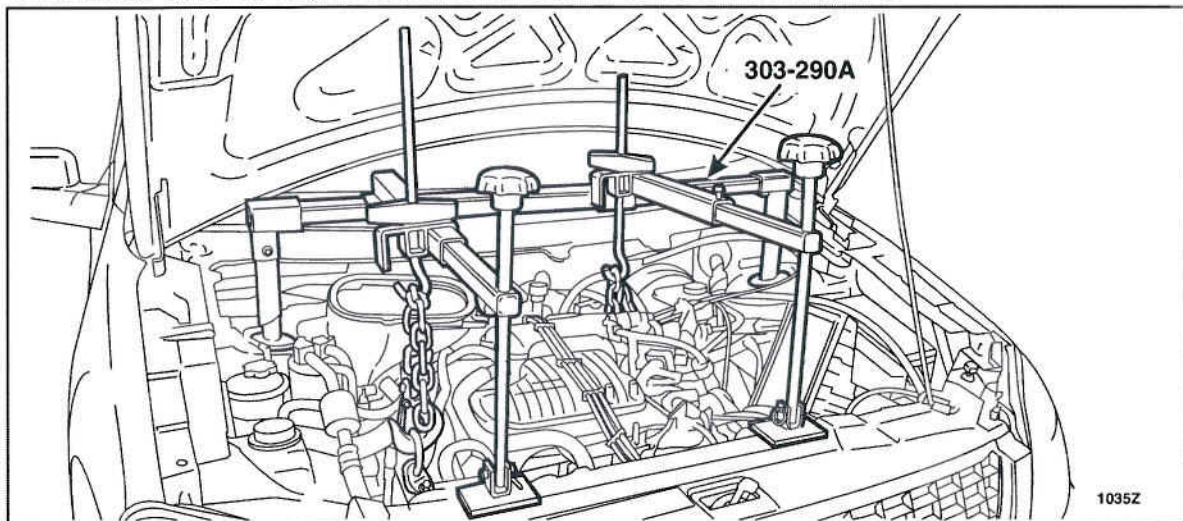
FIGURE 8

14. Install the Three Bar Engine Support Kit special tool 303-290A. See Figure 8.

15. Connect the chain hooks to the previously installed Engine Lifting Brackets. See Figure 8.
16. Tighten the lifting hooks and support the engine.
17. Remove the bolt and the upper transmission fluid filler tube.
 - Detach the push-pin retainers.

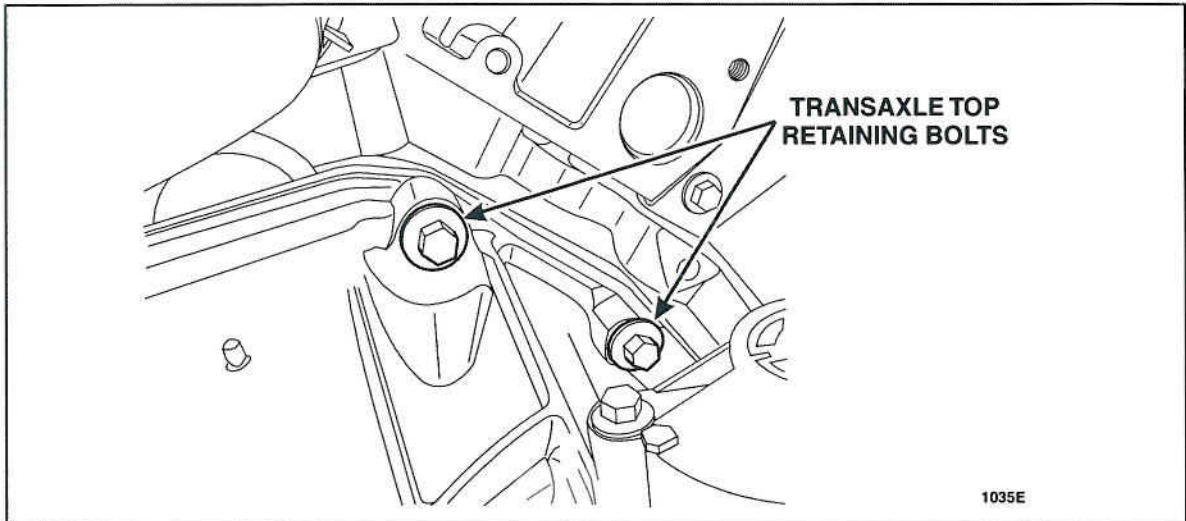
FIGURE 9

18. Remove the two transaxle top retaining bolts. See Figure 9.

42. Install the two transaxle top retaining bolts. See Figure 9.
 - Tighten to 62 Nm (46 lb-ft).
43. Install the upper transmission fluid filler tube and the bolt.

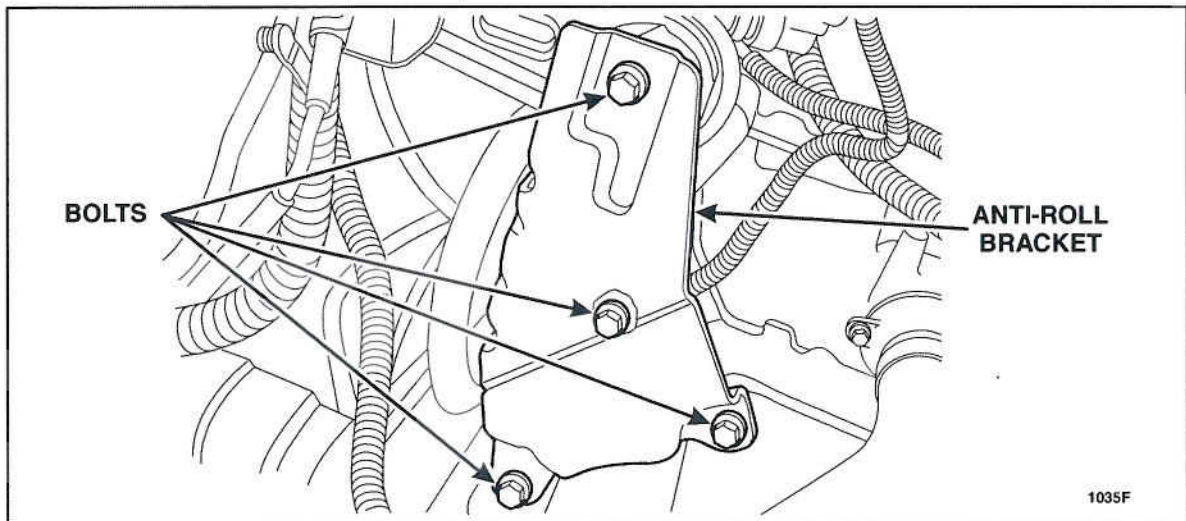
FIGURE 10

19. Remove the bolts and remove the anti-roll bracket. See Figure 10.

- Detach the 2 wire harness push pin retainers.

41. Install the anti-roll bracket and install the bolts. See Figure 10.

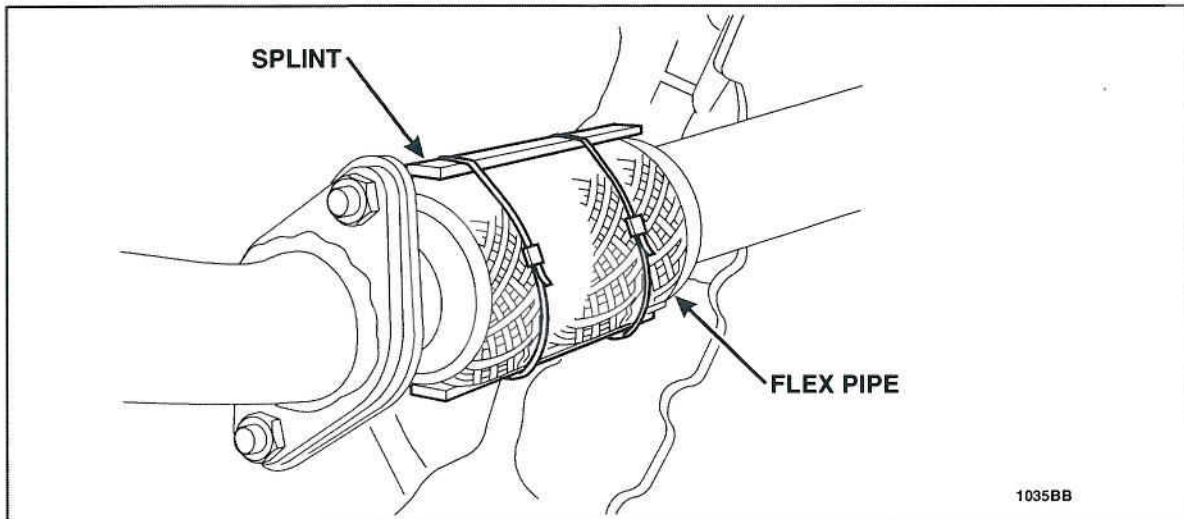
FIGURE 11

26. **NOTICE:** Do not excessively bend or twist the flex pipe.

Using a splint the length of the flex pipe and tie straps, support the flex pipe. See Figure 11.

35. Remove the tie straps and splint from the flex pipe. See Figure 11.

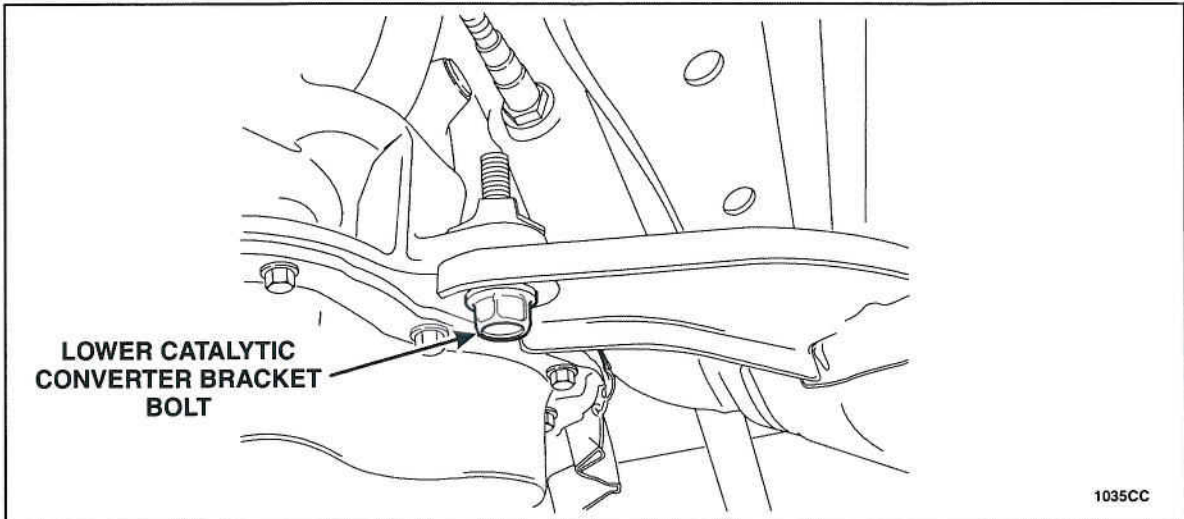
FIGURE 12

28. **NOTE:** Support the catalytic converter near the rear outlet. Use caution removing the catalytic converter. Make sure not to damage the manifold outlet flare, the converter inlet flare, or the studs.

Remove the lower catalytic converter bracket bolt. See Figure 12.

33. Install the lower catalytic converter bracket bolt. See Figure 12.

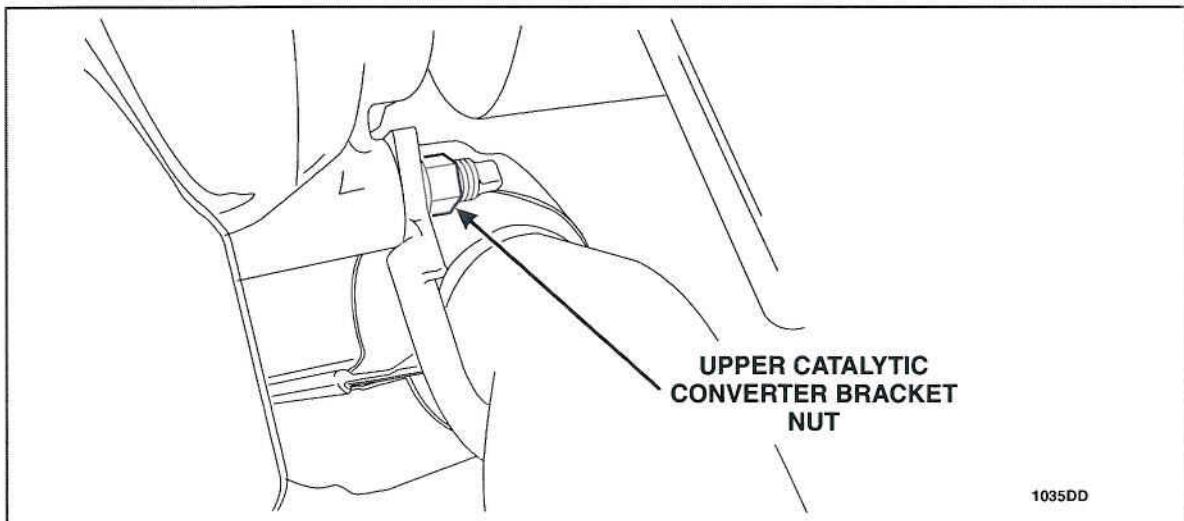
FIGURE 13

29. Remove the upper catalytic converter bracket nut. Figure 13.

32. Install the upper catalytic converter bracket nut. See Figure 13

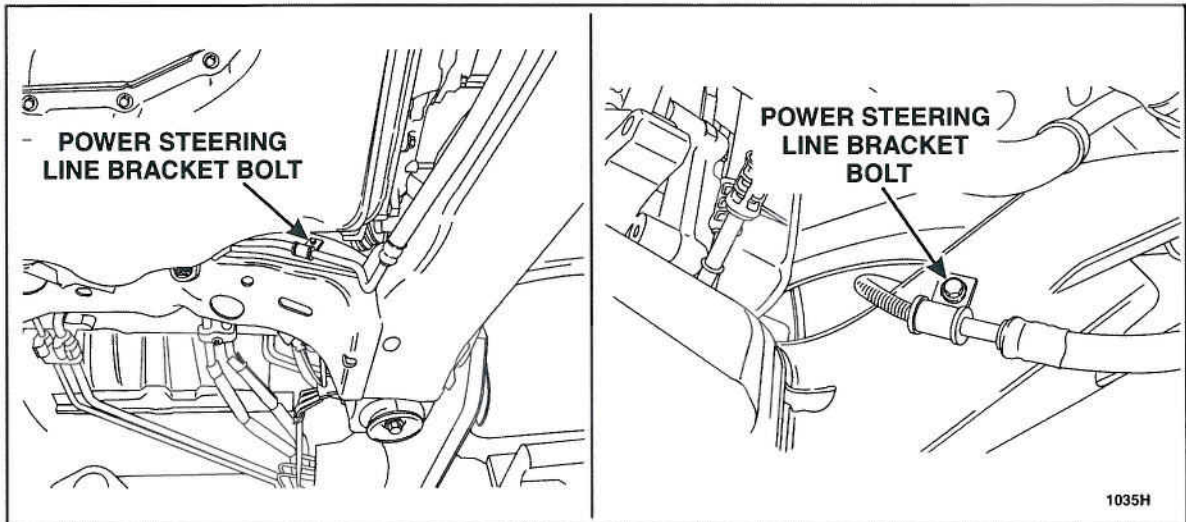
FIGURE 14

30. Remove and discard the 4 catalytic converter-to-exhaust manifold nuts.
31. Remove the catalytic converter assembly.
32. Remove the 2 nuts for the power steering rack.
33. Remove the bolts for the power steering line brackets. See Figure 14.

27. Install the bolts for the power steering line brackets. See Figure 14.

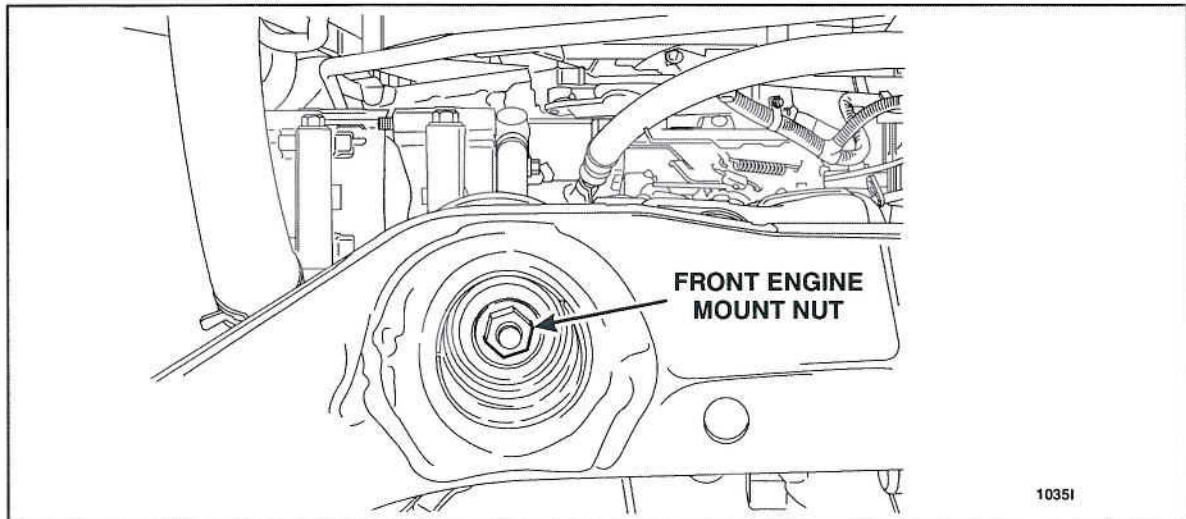
FIGURE 15

34. Detach the power steering hose push pin retainer from the subframe.
35. Remove the front engine mount nut. See Figure 15.

25. Install the front engine mount nut. See Figure 15.

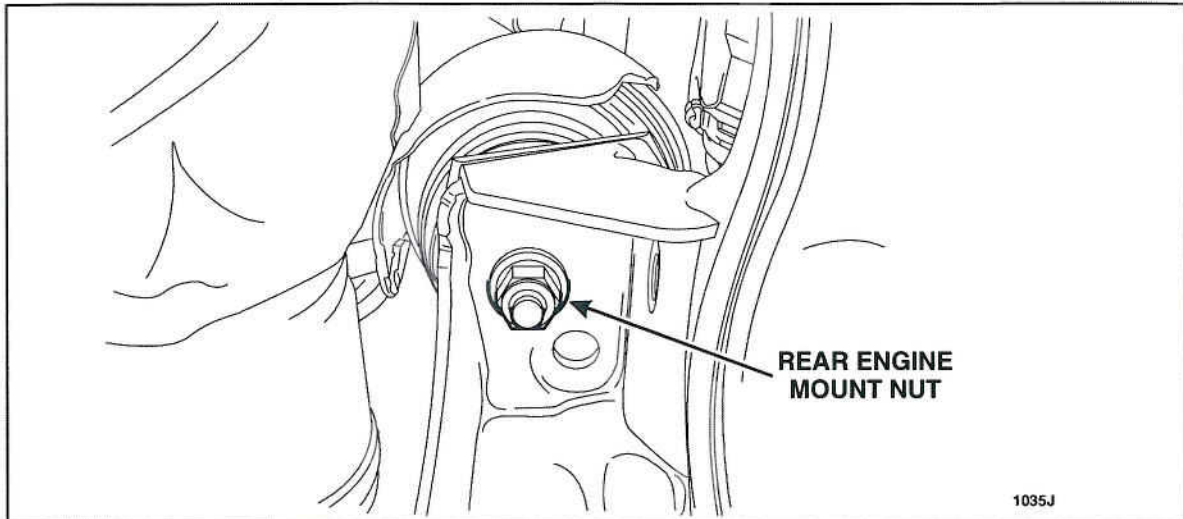
FIGURE 16

36. Remove the rear engine mount nut. See Figure 16.

24. Install the rear engine mount nut. See Figure 16.

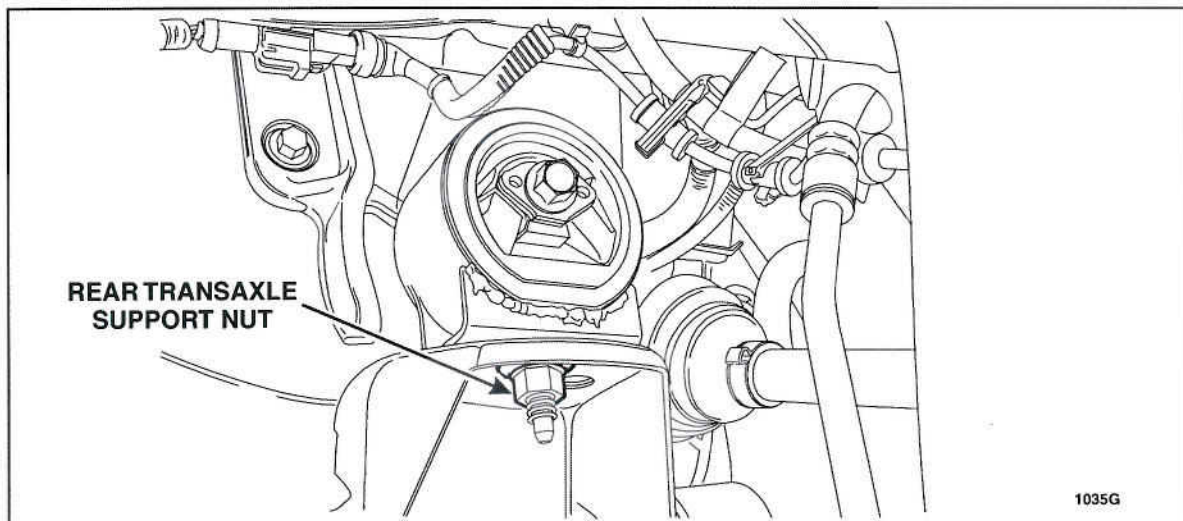
FIGURE 17

37. Remove the rear transaxle support nut. See Figure 17.

23. Install the rear transaxle support nut. See Figure 17.

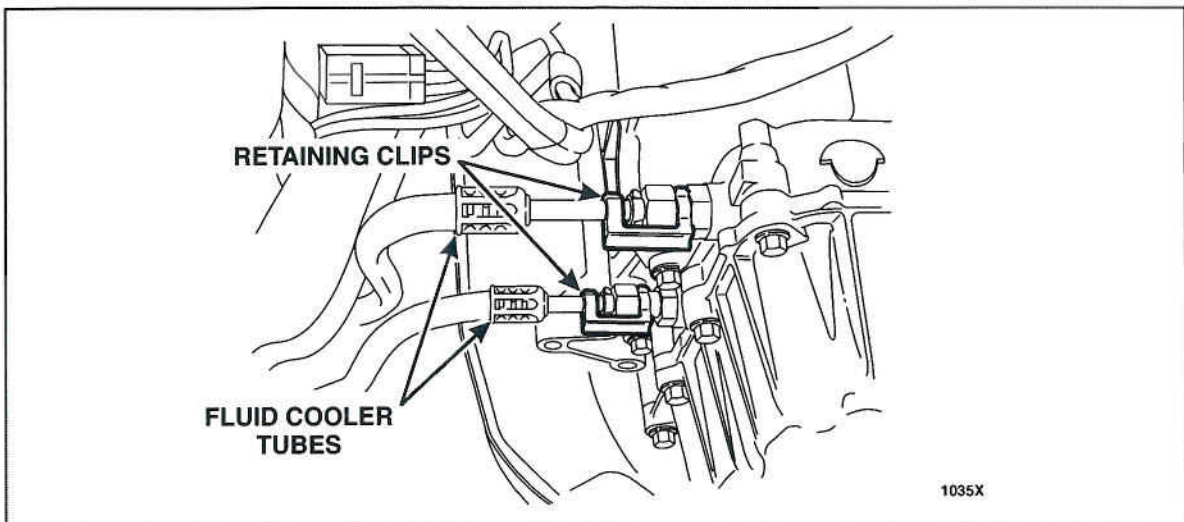
FIGURE 18

42. Remove the fluid cooler tube retaining clips. See Figure 18.

17. Connect the fluid cooler tubes. See Figure 19.
18. Install the fluid cooler tube retaining clips. See Figure 18.
19. Using a suitable lift, raise the subframe assembly into position.

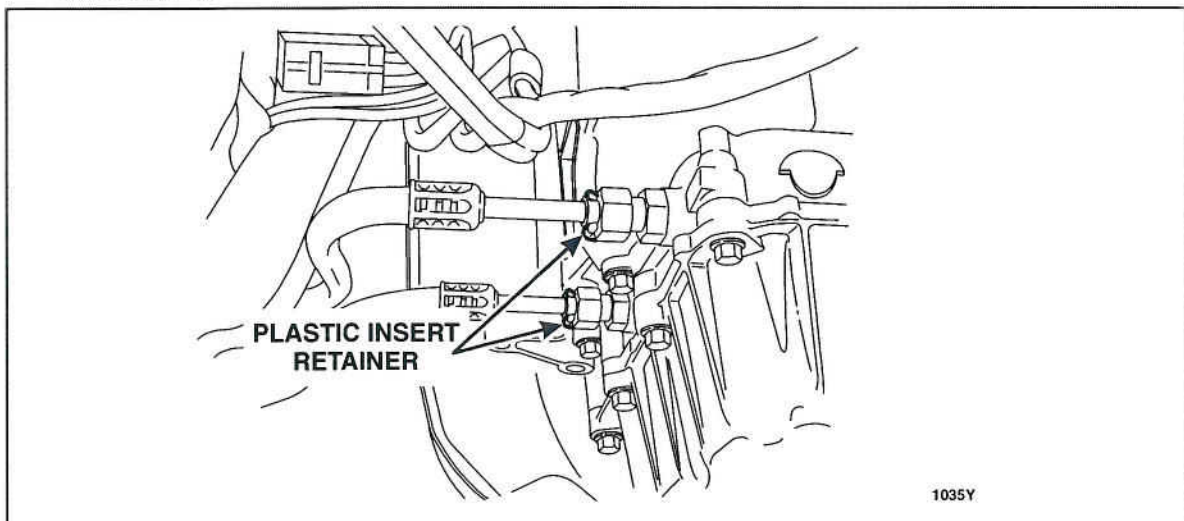
FIGURE 19

43. Depress the tabs on the plastic insert retainer and remove the cooler lines from the fittings. See Figure 19.

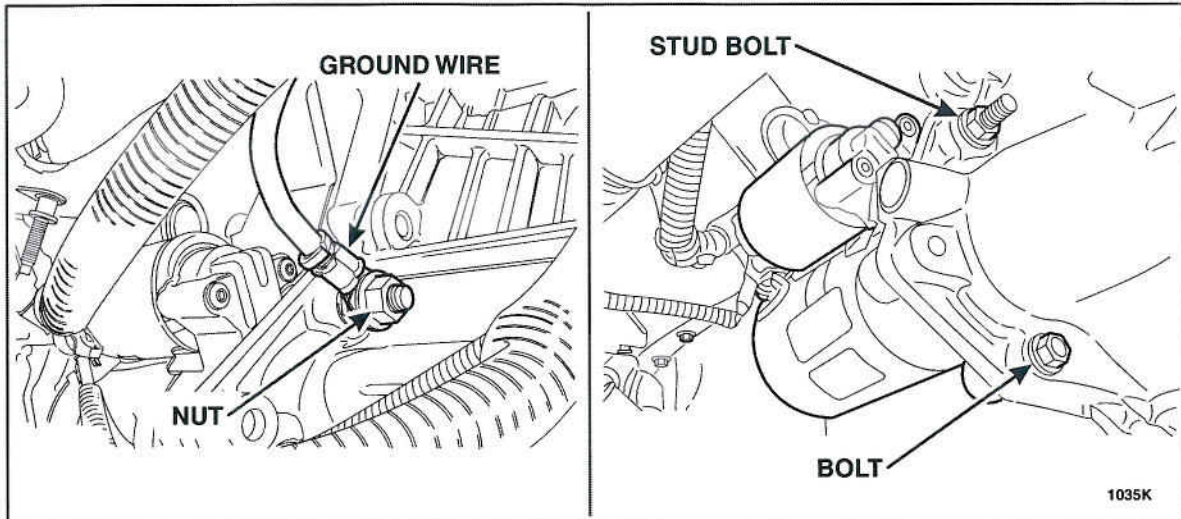
FIGURE 20

44. Position aside the starter. See Figure 20.

- a. Remove the nut and ground wire.
- b. Remove the bolt and the stud bolt.
- c. Support the starter with mechanics wire.

14. Reinstall the starter. See Figure 20.
 - a. Install the bolt and stud bolt.
 - b. Tighten the bolt and stud bolt to 25 Nm (18 lb-ft).
 - c. Install the ground wire and nut.

- d. Tighten the nut to 20 Nm (15 lb-ft).
15. Connect the turbine shaft speed (TSS) sensor connector. See Figure 21.
16. Install the RH and LH halfshafts into the transaxle.

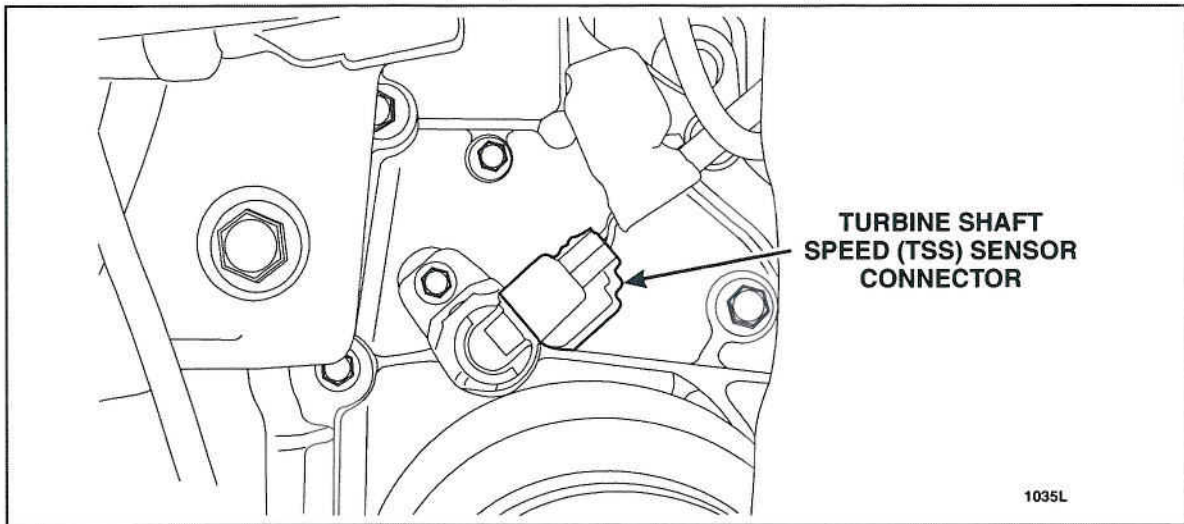
FIGURE 21

48. Disconnect the turbine shaft speed (TSS) sensor connector. See Figure 21.

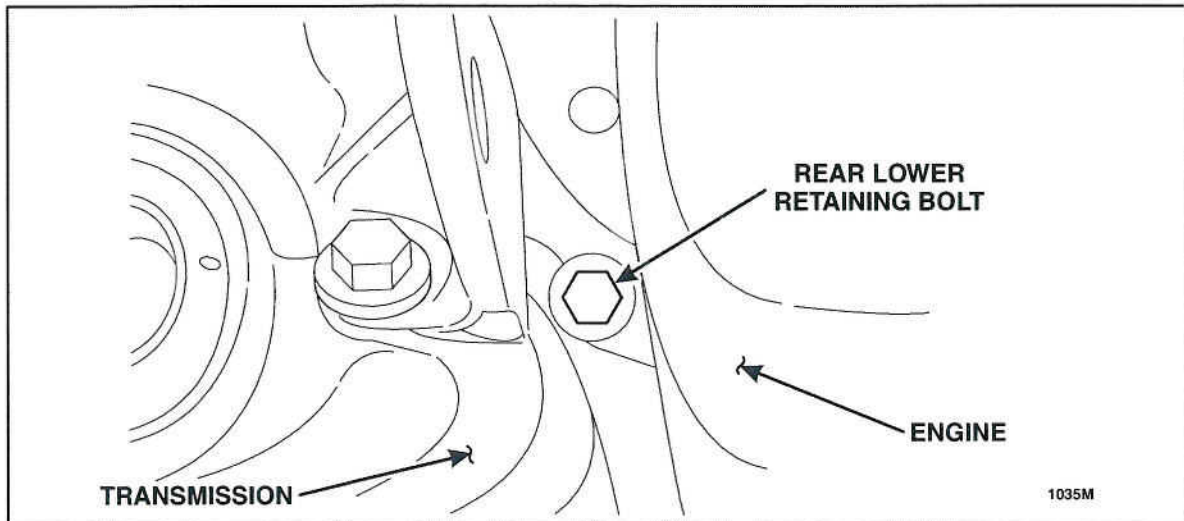
FIGURE 22

50. Remove the rear lower retaining bolt. See Figure 22.

9. Install the front lower retaining bolt. See Figure 23.
 - Tighten to 62 Nm (46 lb-ft).
10. Install the rear lower retaining bolt. See Figure 22.
 - Tighten to 62 Nm (46 lb-ft).

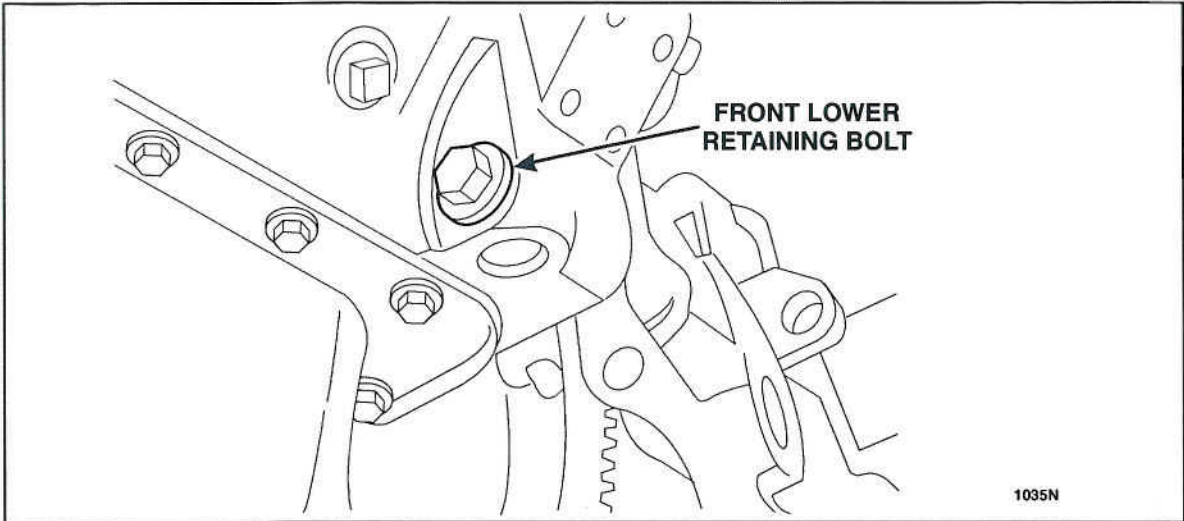
FIGURE 23

51. Remove the front lower retaining bolt. See Figure 23.

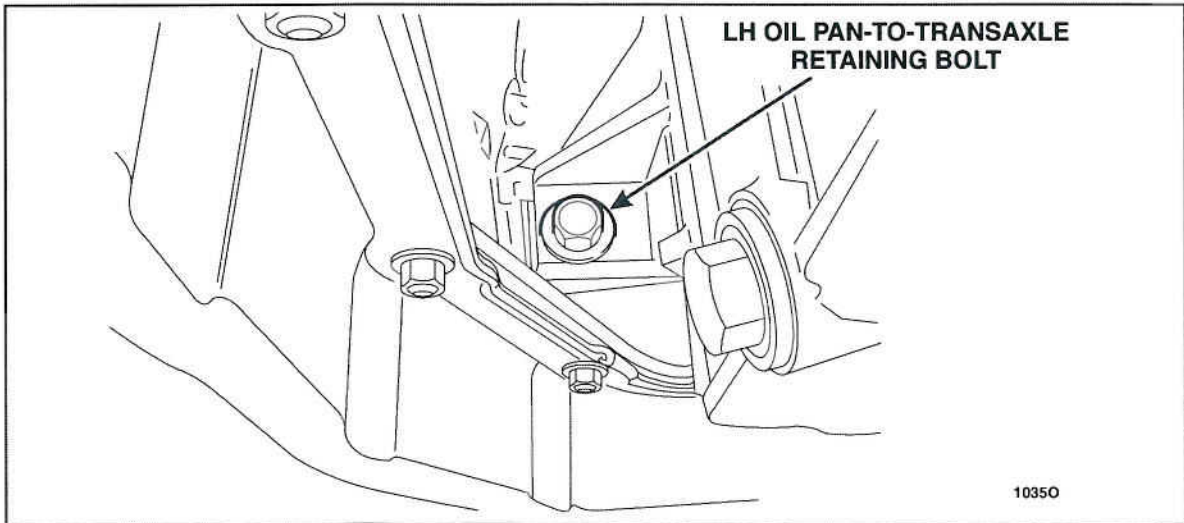
FIGURE 24

52. Remove the LH oil pan-to-transaxle retaining bolt. See Figure 24.

5. Align the torque converter studs with the flexplate.
6. Install the transaxle bracket retaining bolts. See Figure 26.
 - Tighten to 47 Nm (35 lb-ft).
7. Install the RH oil pan-to-transaxle retaining bolt. See Figure 25.
 - Tighten to 62 Nm (46 lb-ft).
8. Install the LH oil pan-to-transaxle retaining bolt. See Figure 24.
 - Tighten to 62 Nm (46 lb-ft).

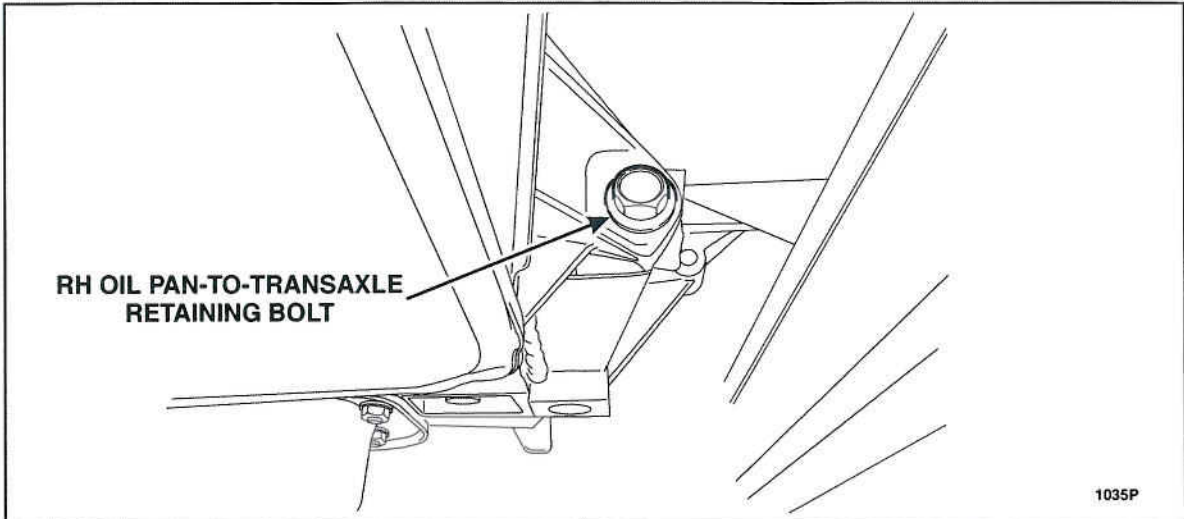
FIGURE 25

53. Remove the RH oil pan-to-transaxle retaining bolt. See Figure 25.

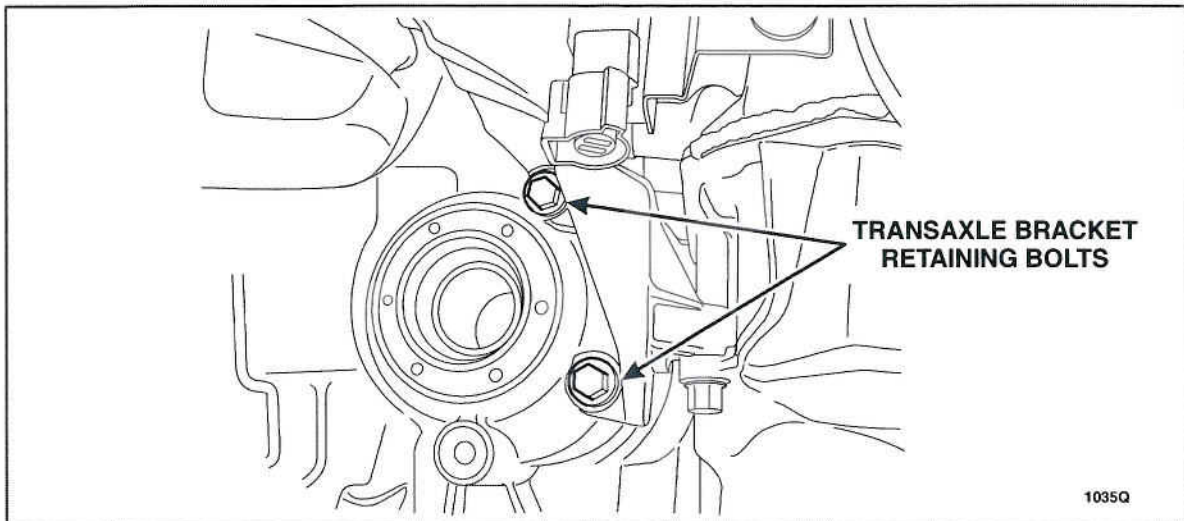
FIGURE 26

54. Remove the transaxle bracket retaining bolts. See Figure 26.

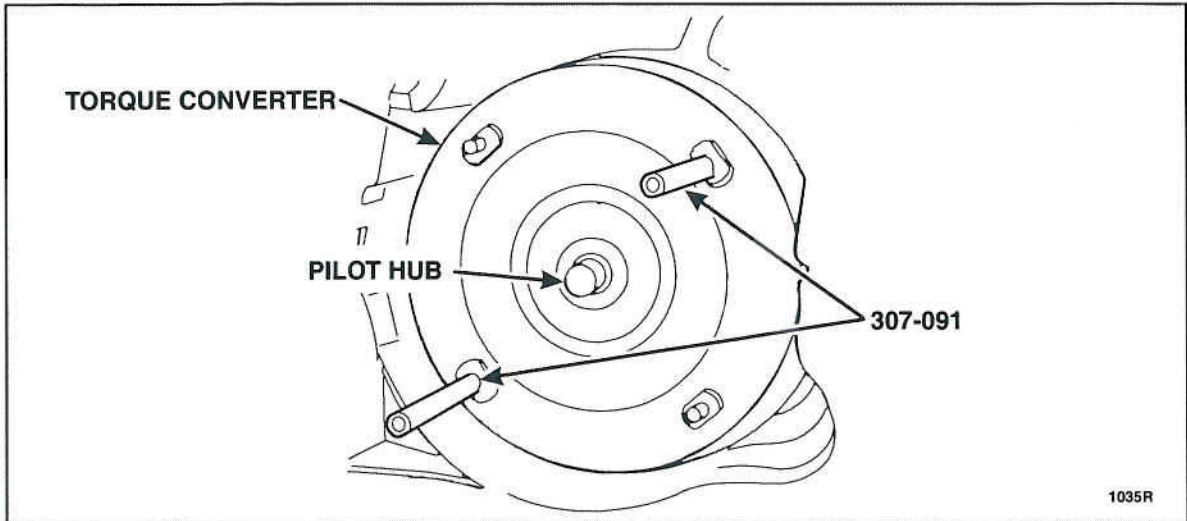
FIGURE 27

56. Using special tool 307-091 remove the torque converter. See Figure 27.

2. Using special tool 307-091 install the *new* torque converter. See Figure 27.
3. Apply multi-purpose grease to the torque converter pilot hub. See Figure 27.
4. **NOTICE: The torque converter can fall out from the transmission. Use caution not to tip the transmission at an angle that would allow the torque converter to fall out.**

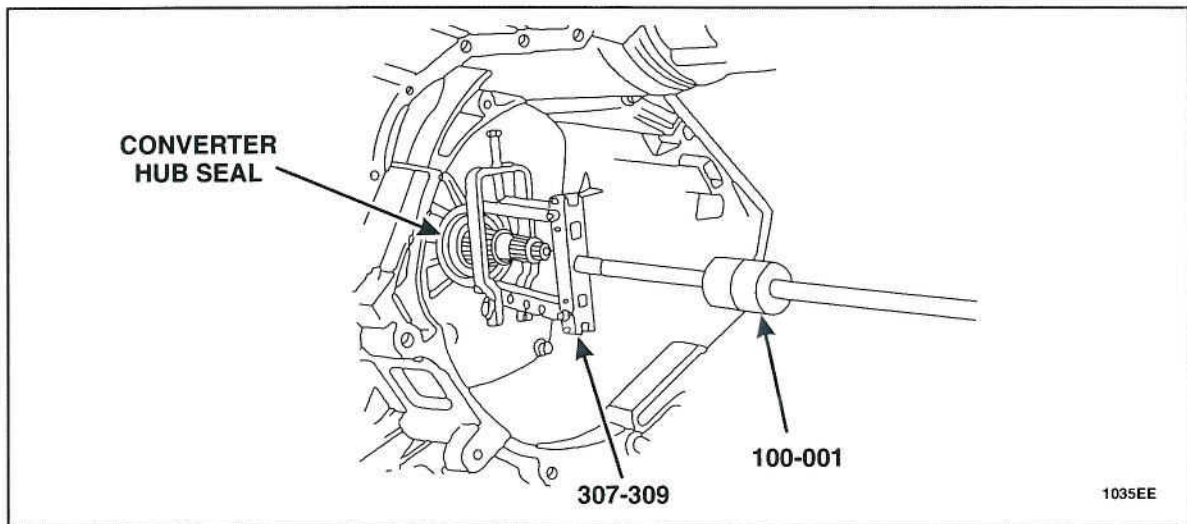
FIGURE 28

57. **NOTICE:** Use special tool 307-309 to remove the converter hub seal. Stator support surface will be damaged if any other type tool is used.

Use special tools 307-309 and 100-001 remove and discard the converter hub seal. See Figure 28.

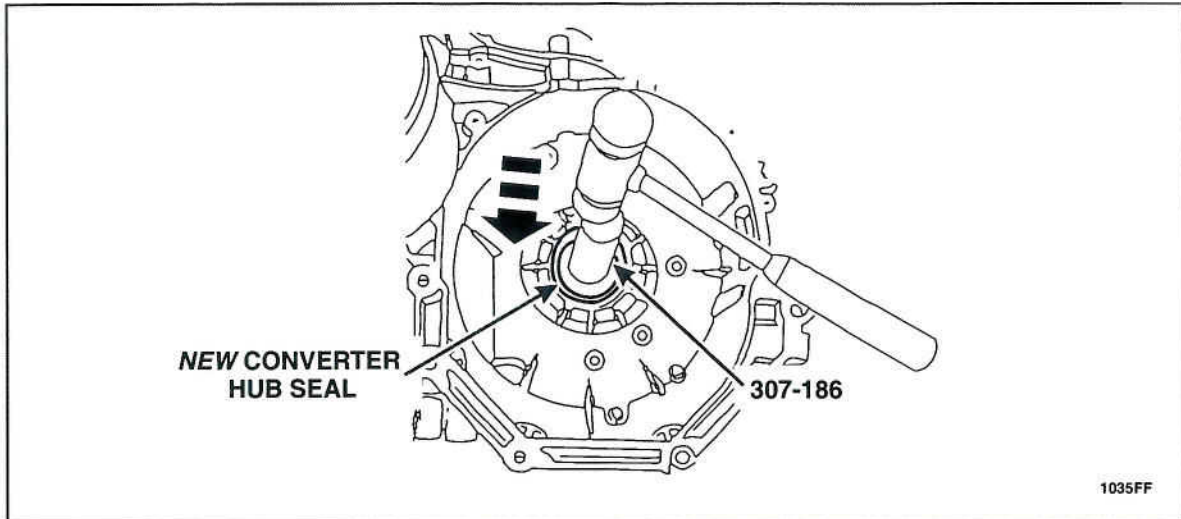
FIGURE 29

1. Using special tool 307-186 install a *new* converter hub seal. See Figure 29.

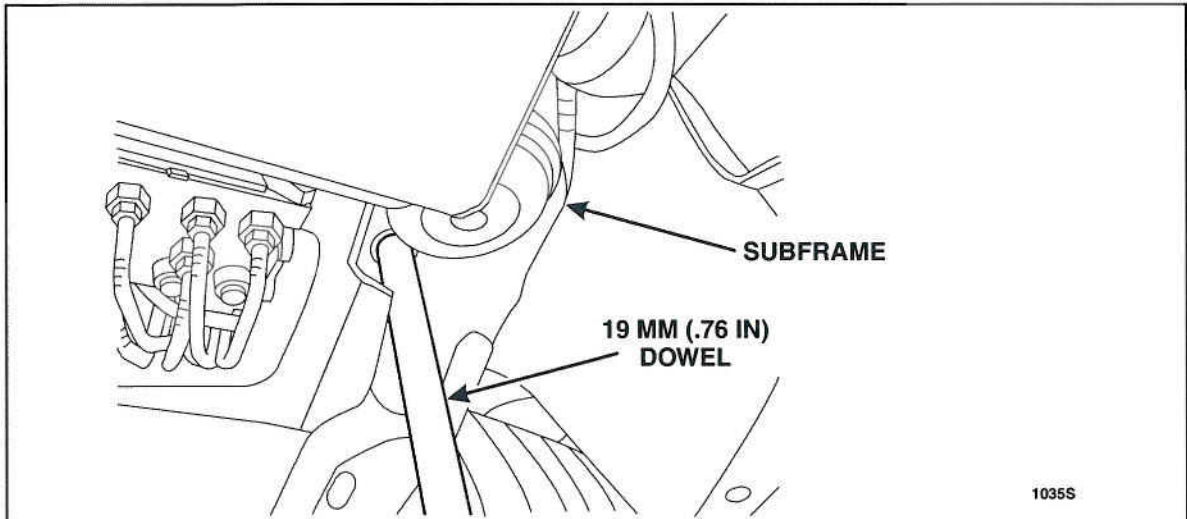
FIGURE 30

20. Using a 19 mm (0.76 in) dowel, check the front subframe alignment. See Figure 30.

- The dowel should slide directly through the front subframe and body on both the LH and RH sides, without tilting.
- Adjust the subframe as required.

NOTE: LH shown, RH similar.
