SI B65 12 13  
Audio, Navigation, Monitors, Alarms, SRS

May 2013  
Technical Service

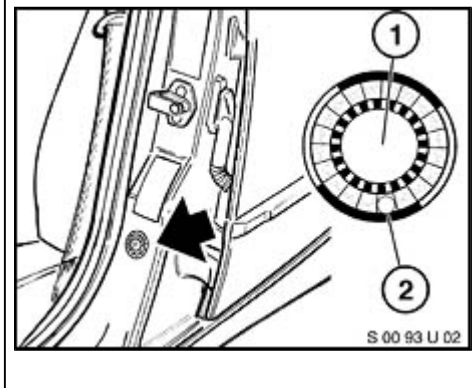
## LABEL INSTRUCTIONS

<p>This Recall Campaign has been assigned code number <b>644</b>. After the vehicle has been checked and/or corrected, obtain a label (SD 92-420) and:</p> <ol style="list-style-type: none"> <li>A. Emboss your BMW center warranty number in the middle of the label (1);</li> <li>B. Punch out code number <b>644</b> (2), printed on the label; and</li> <li>C. Affix the label to the <b>B</b>-pillar as shown.</li> </ol>
--	---

If the vehicle already has a label from a previous Service Action/Recall Campaign, affix the new label next to the old one. Do not affix one label on top of another one, because a number from an underlying label could appear in the punched-out hole of the new label.
