This Service Information bulletin supersedes SI B51 32 12 **dated October 2012.**

#### **SUBJECT**

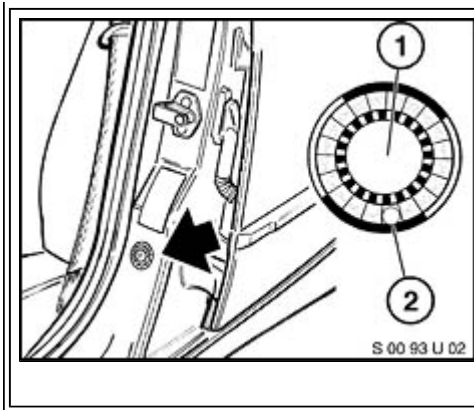
#### LABEL INSTRUCTIONS

This Recall Campaign has been assigned code number **629**. After the vehicle has been checked and/or corrected, obtain a label (SD 92-417) and:

- A. Emboss your BMW center warranty number in the middle of the label (1);
- B. Punch out code number **629** (2), printed on the label; and
- C. Affix the label to the **B**-pillar as shown.
