Recall Campaign 12V-008: Replace the Auxiliary Coolant Pump for the Turbocharger

All models with the N14 and N18 engine built from 11/2006 to 1/2011

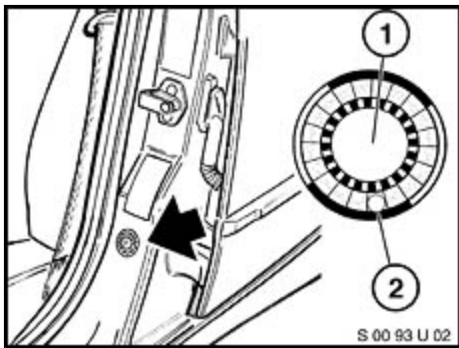
LABEL INSTRUCTIONS

This Recall Campaign has been assigned code number **48**. After the vehicle has been checked and/or corrected, obtain a label (MD20-040) and:

- A. Emboss your BMW center warranty number in the middle of the label (1);
- B. Punch out code number **48** (2), printed on the label; and
- C. Affix the label to the **B**-pillar as shown.
