# RECALL CAMPAIGN BULLETIN

NTB12-022a

## VOLUNTARY SAFETY RECALL CAMPAIGN 2011 - 2012 QUEST FUEL PUMP CONTROL MODULE

**APPLIED VEHICLE:** 2011 - 2012 Quest (E52)

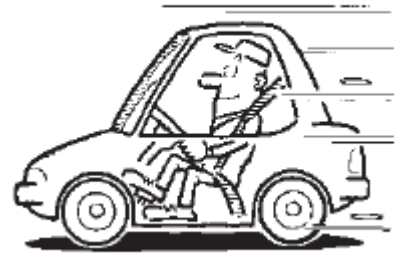
Figure 1

- A screen print for warranty documentation can be done from the CONSULT PC during this process while still connected to the vehicle.
- **No DTCs stored.**
  - Use C-III plus to perform Self Diagnosis for all systems.
  - If there are any DTCs, diagnose, perform repairs, and erase DTCs **before** continuing.
- **For in-stock vehicles only: Extended Storage Switch engaged (pushed in).**
- Confirm the following conditions are met (the vehicle may need to be driven to meet these conditions):
  - Engine coolant temperature: 70 - 100°C (158 - 212°F)
  - Battery voltage: More than 12.9V (At idle)
  - Transmission: Warmed up

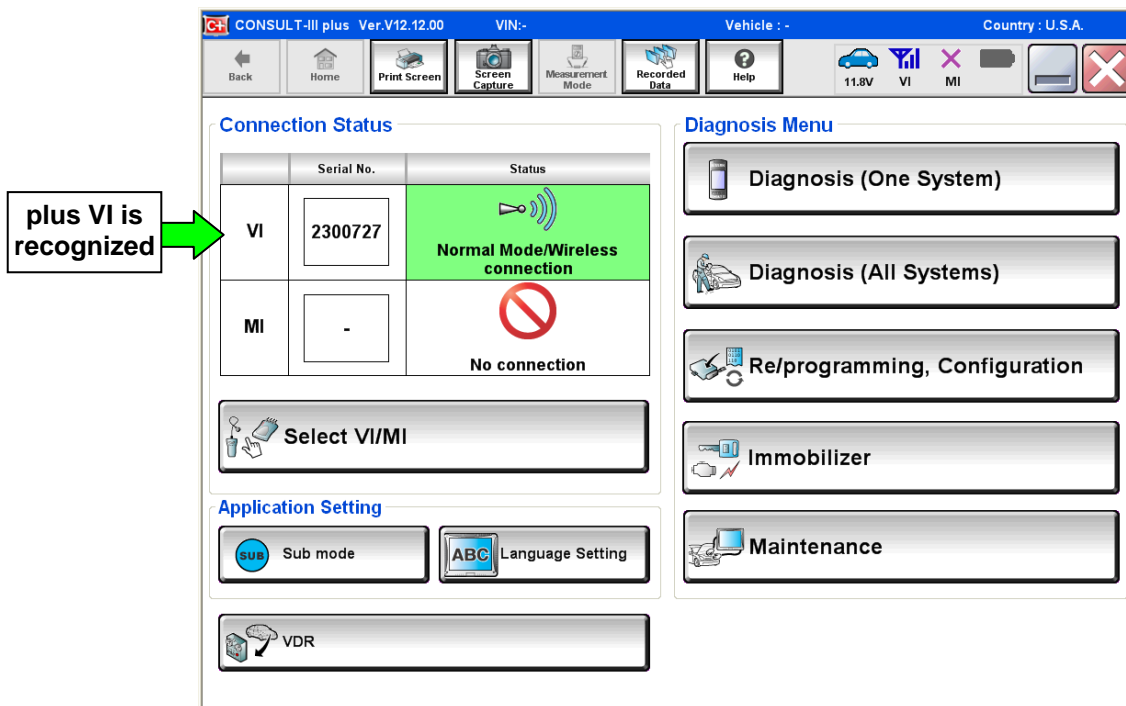
Figure 2

11. Wait for the plus VI to be recognized / connected.

- The serial number will display when the plus VI is recognized / connected.

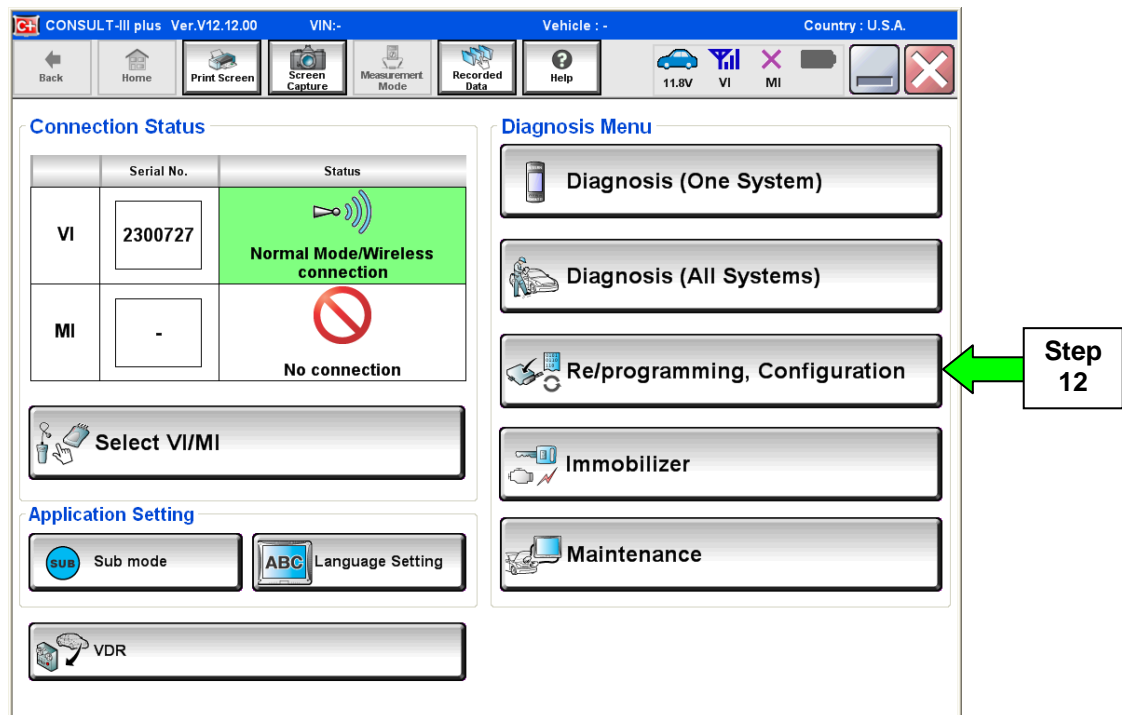
Figure 3

12. Select **Re/programming, Configuration**.

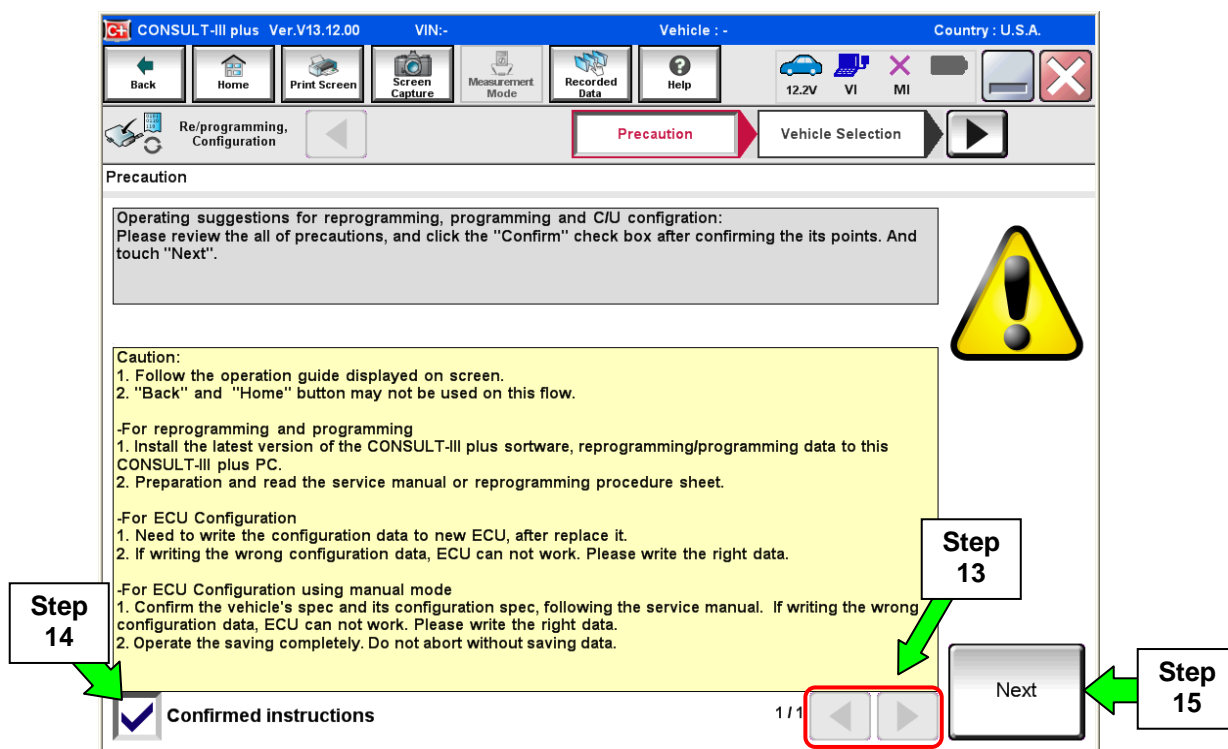
Figure 4

13. Use arrows (if needed) to view and read all precautions.
14. Check the box confirming the precautions have been read.
15. Select **Next**.

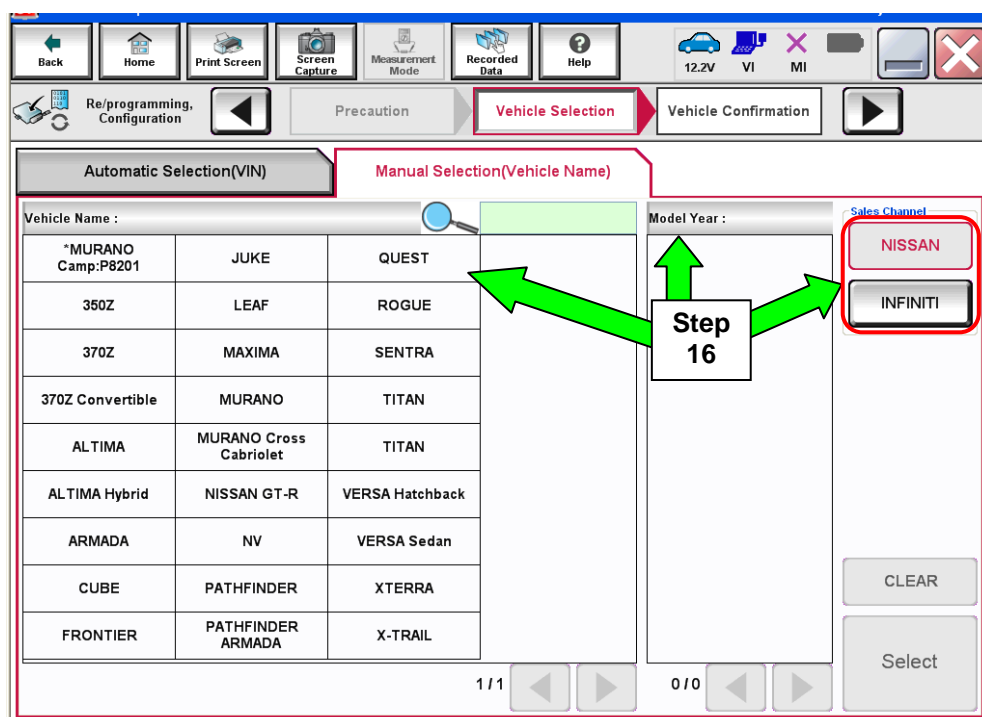
16. Select **Nissan**, **Quest**, and then the correct **Model Year**.
  - If the screen in Figure 5 does not display, skip to step 17.

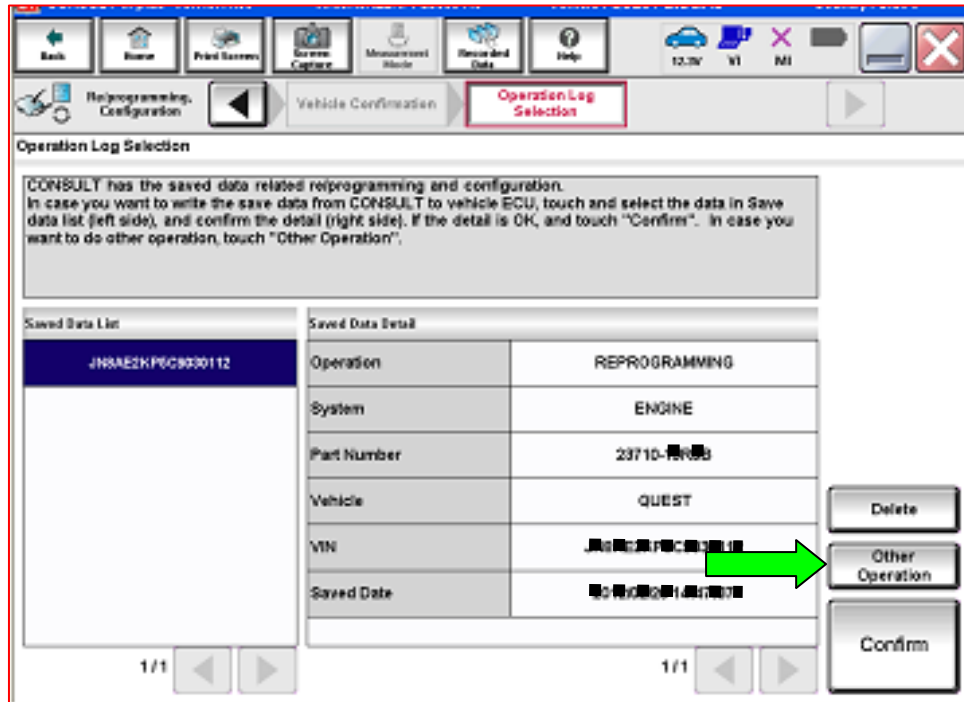
- If the screen in Figure 8 displays, select **Other Operation**, and then go to step 20.

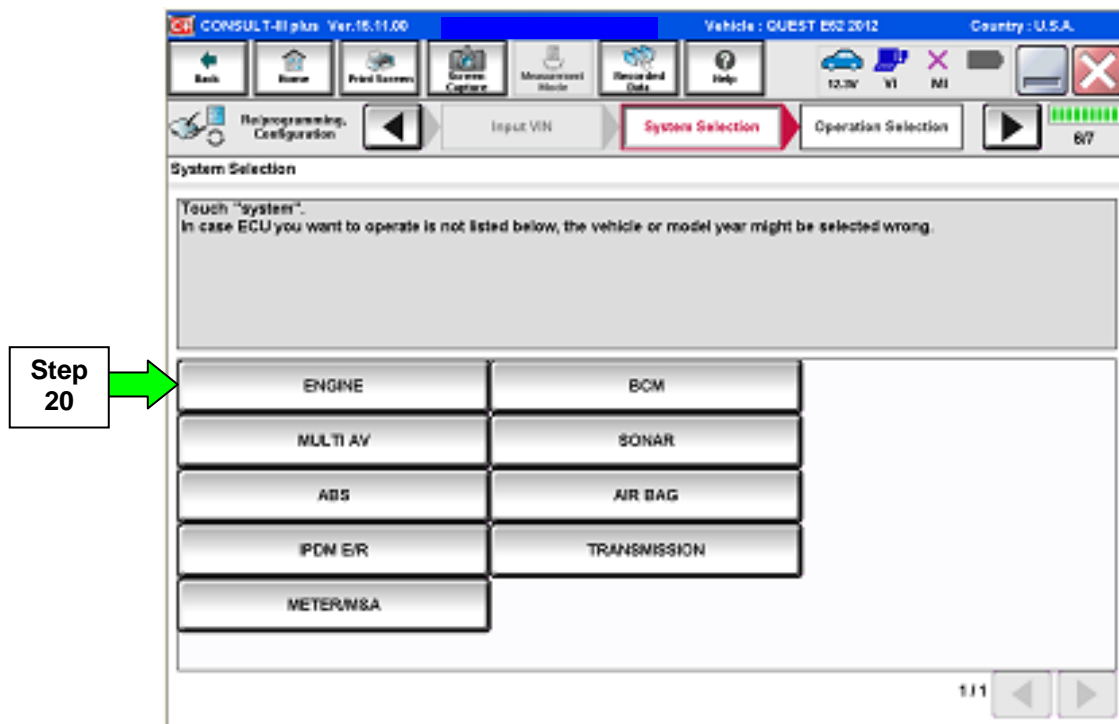
Figure 9

20. Select **ENGINE**.

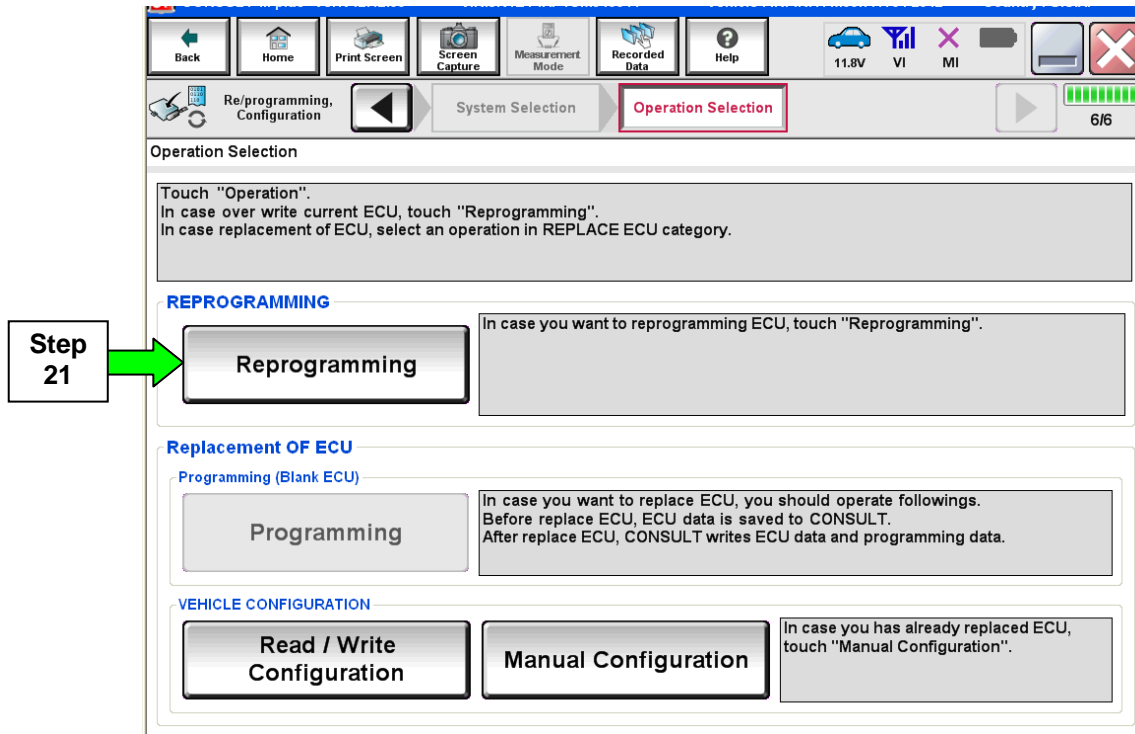
Figure 10

## 21. Select Reprogramming.

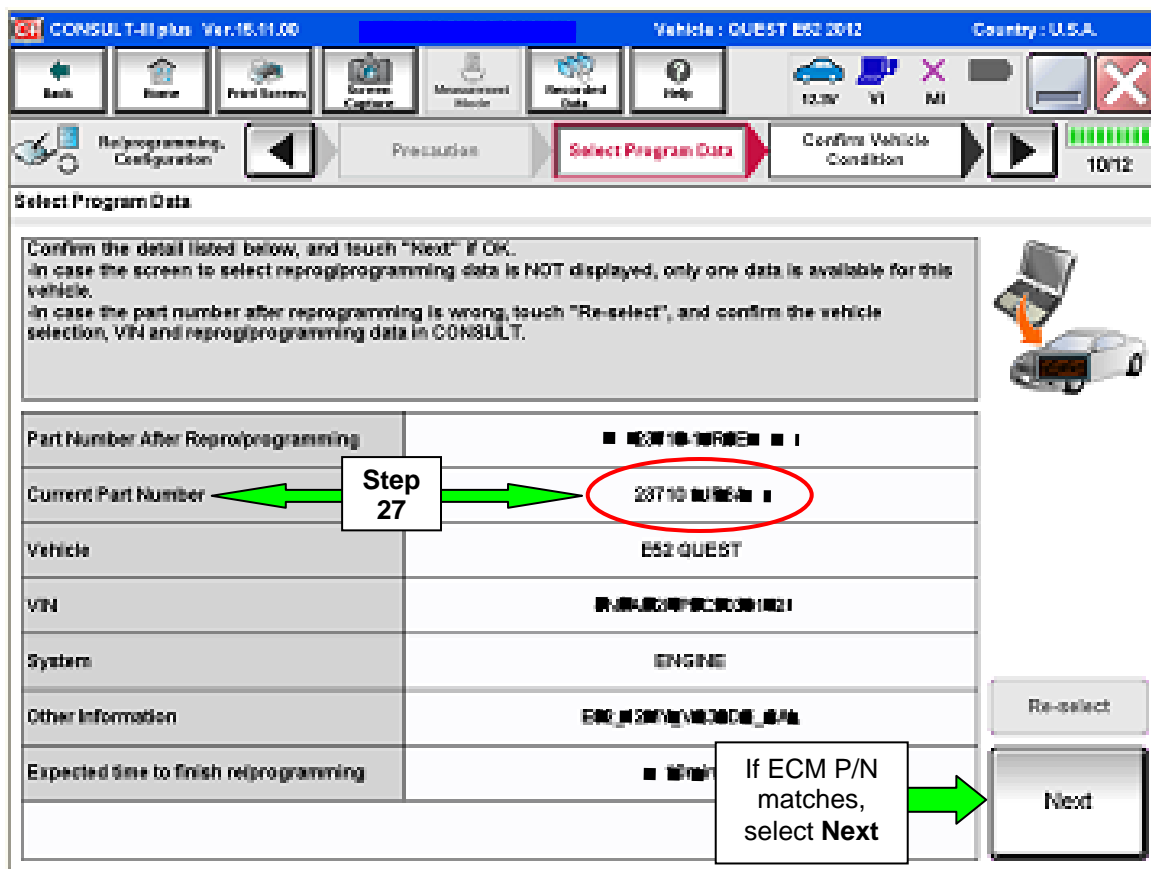
Figure 14

27. Find the ECM's **Current Part Number** (see Figure 14) and write it on the repair order.

**NOTE:** This is the ECM's current Part Number (P/N).

- Compare the P/N you wrote down to the P/N in the **Current ECM Part Number** list in **Table A** below.
  - If there is a match, this bulletin applies. Continue with the reprogramming procedure by selecting **Next**.
  - If there is not a match, this campaign does not apply or it has already been done. Close C-III plus and disconnect from the vehicle, and then recheck Service Comm for campaign eligibility.

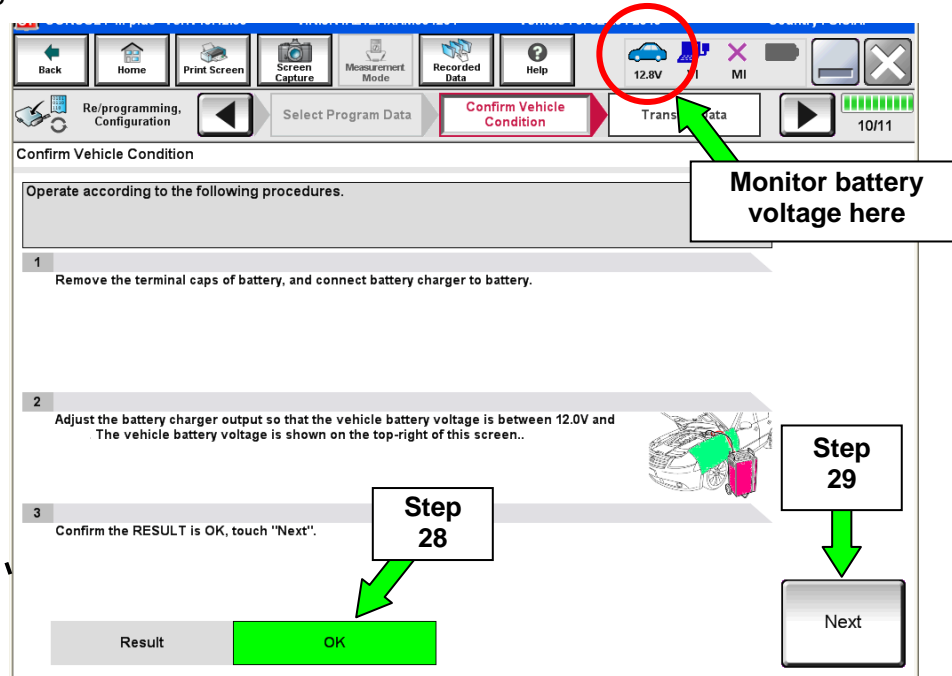
Figure 15

28. Make sure **OK** is highlighted **green** (battery voltage must be between **12.0 and 15.5 Volts**).

29. Select **Next**.

**IMPORTANT:** Battery voltage must stay between **12.0 and 15.5 Volts** during reprogramming or ECM reprogramming may be interrupted and the ECM may be damaged.

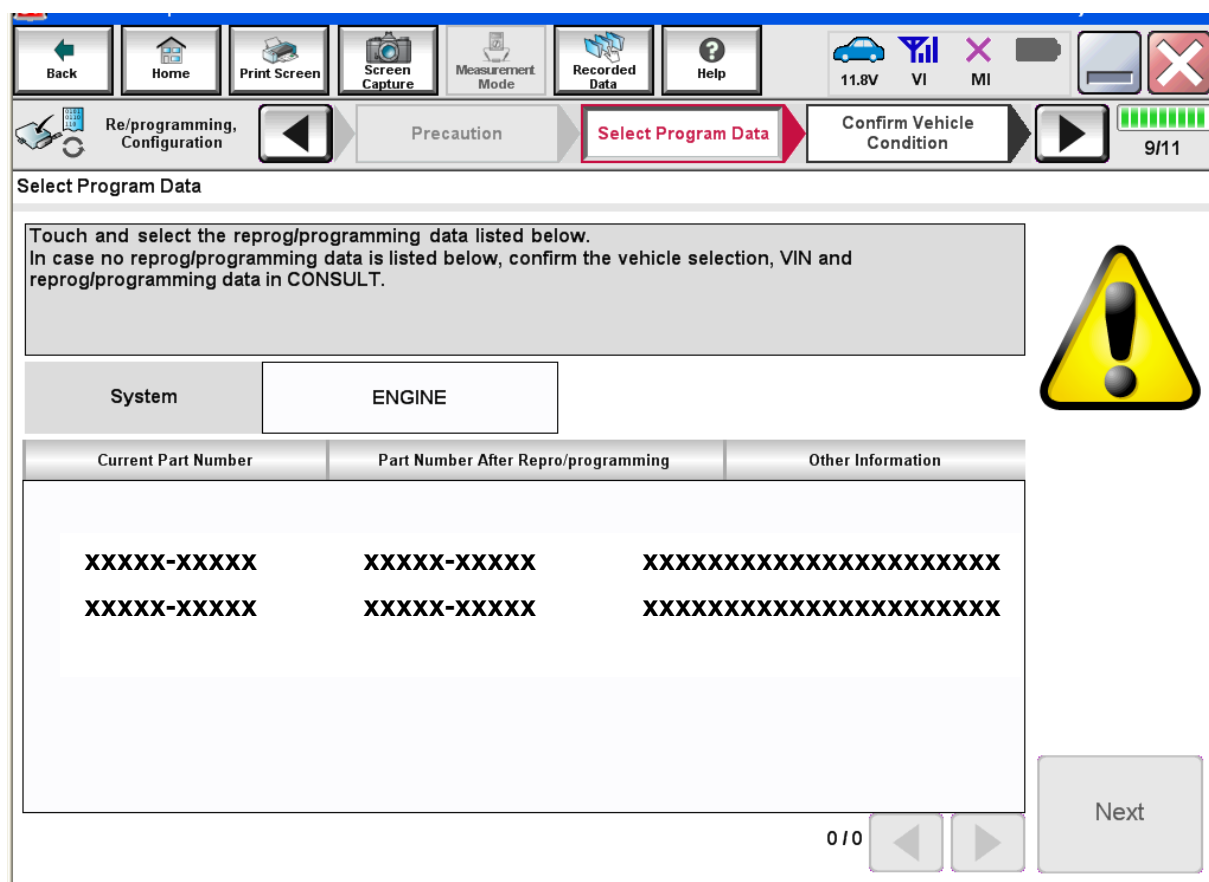
- In some cases, more than one new part number for reprogramming is available.
  - In this case, the screen in Figure 17 displays.
  - Select and use the reprogramming option that **does not** have the message “Caution! Use ONLY with NTBXX-XXX”.
- If you get this screen and it is blank (no reprogramming listed), it means there is no ECM reprogramming available for this vehicle.

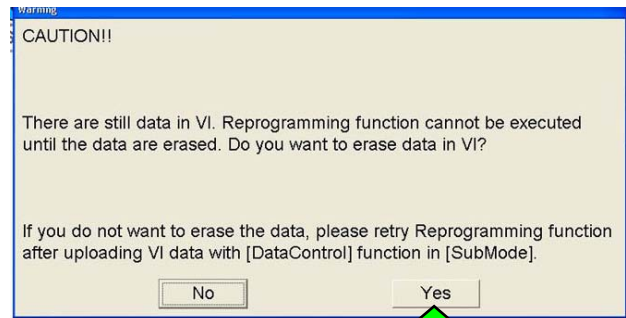
**NOTE:** If the message shown in Figure 18 appears, there is data stored in the plus VI. Select **Yes** to proceed with reprogramming.

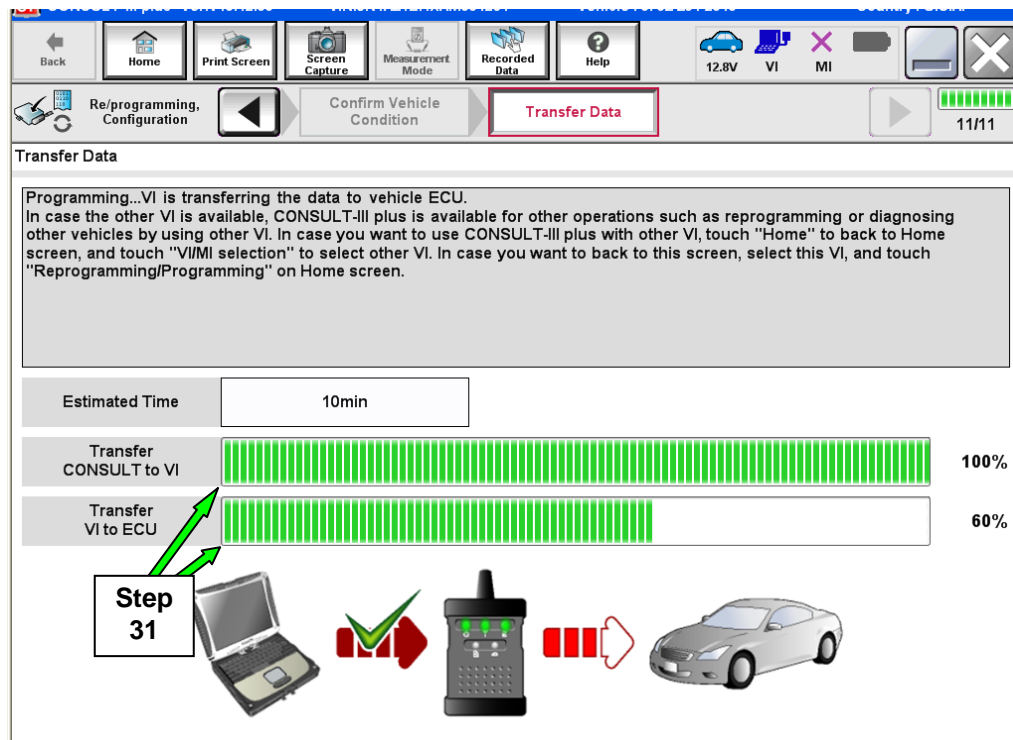
Figure 19

31. Wait for both progress bars to complete.

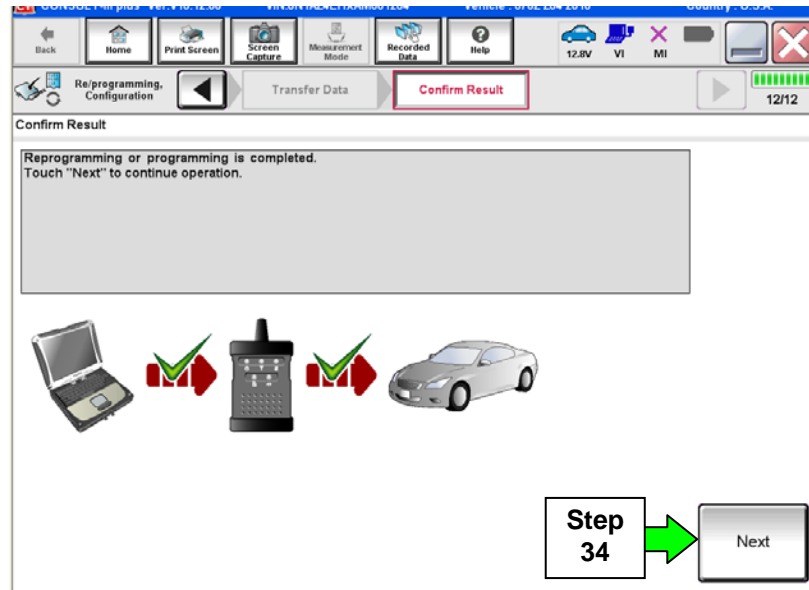
32. When the screen in Figure 20 displays, the reprogramming is complete.

**NOTE:** If the screen in Figure 20 does not display (reprogramming does not complete), refer to the information on page 17-19.

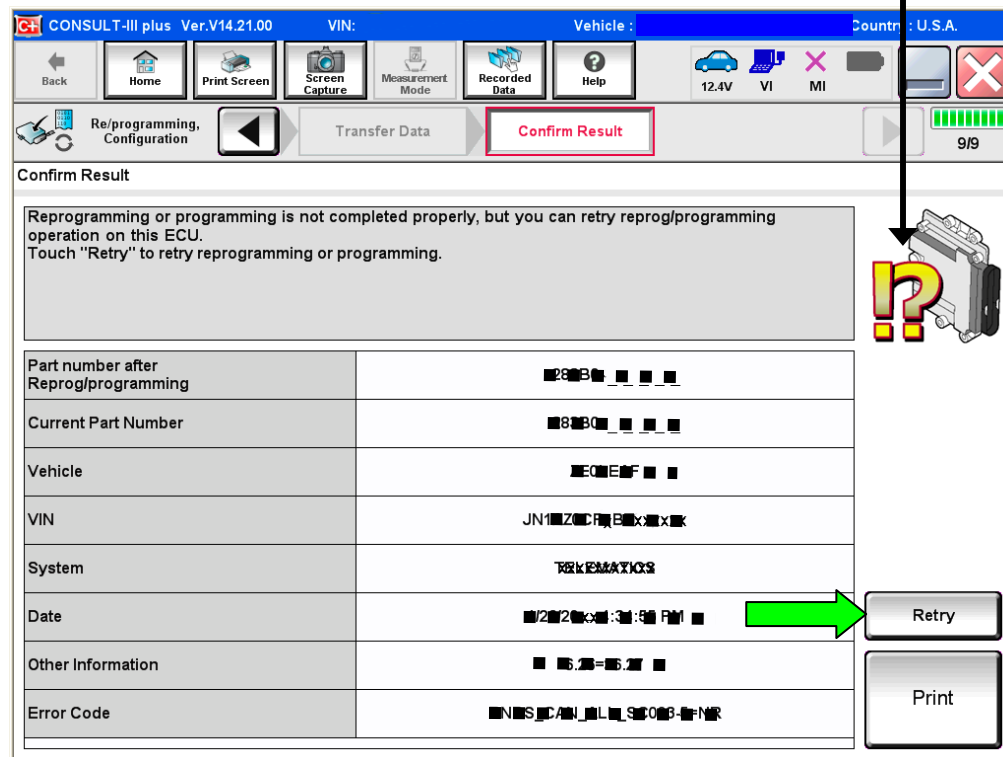
Figure 22

If reprogramming does not complete and the “!?” symbol displays as shown in Figure 22:

- Check battery voltage (12.0 - 15.5V).
- Ignition is ON.
- External Bluetooth® devices are OFF.
- All electrical loads are OFF.
- Select **Retry** and follow the on screen instructions.

**NOTE:** **Retry** may not go through on the first attempt and can be selected more than once.

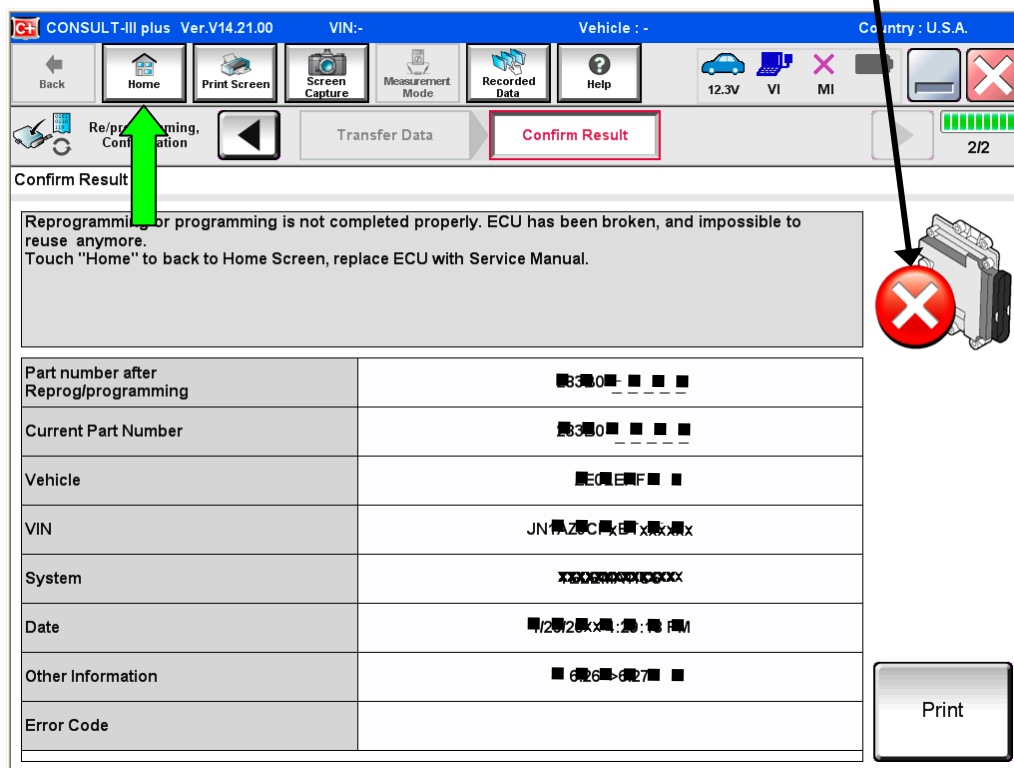
Figure 23

If reprogramming does not complete and the “X” symbol displays as shown in Figure 23:

- Check battery voltage (12.0 - 15.5V).
- CONSULT A/C adapter is plugged in.
- Ignition is ON.
- Transmission in Park.
- All C-III plus / plus VI cables are securely connected.
- All C-III plus updates are installed.
- Select **Home**.
- Shut down C-III plus. DO NOT shut down the CONSULT PC.
- Turn the ignition OFF.
- Disconnect the plus VI from the vehicle.
- Connect the plus VI to the vehicle.
- Restart ECM reprogramming (page 5, step 10).

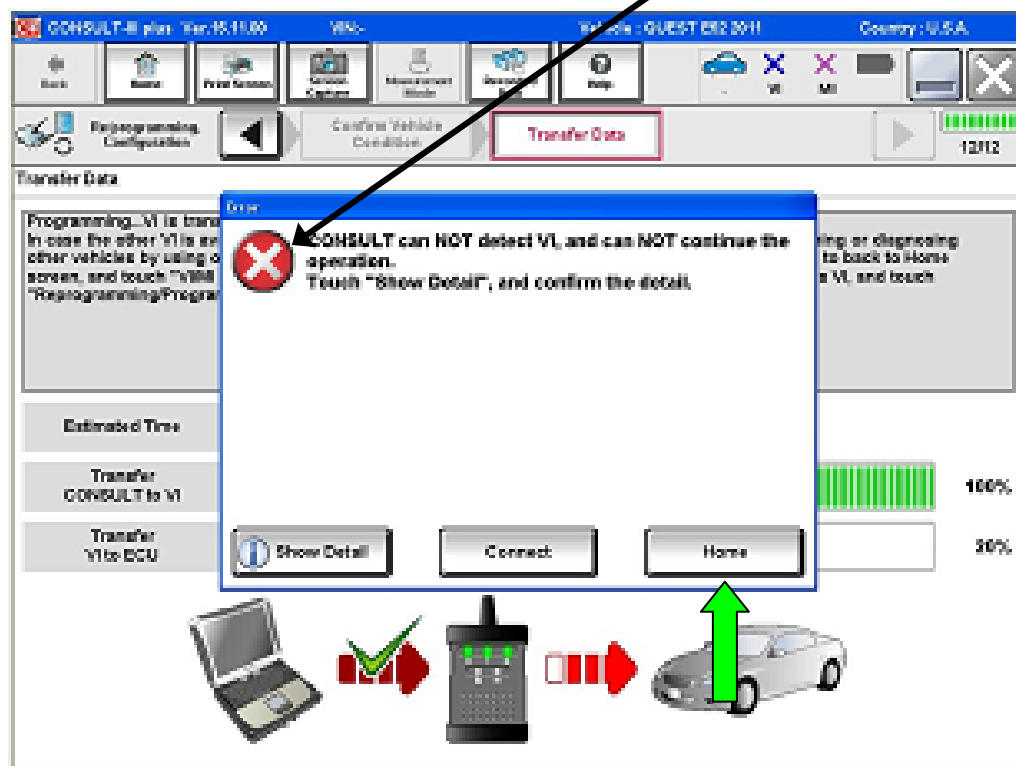
Figure 24

If reprogramming does not complete and the “X” symbol displays as shown in Figure 24:

- Check battery voltage (12.0 – 15.5V).
- CONSULT A/C adapter is plugged in.
- Ignition is ON.
- Transmission in Park.
- All C-III plus / plus VI cables are securely connected.
- All C-III plus updates are installed.
- Select **Home**.
- Shut down C-III plus. DO NOT shut down the CONSULT PC.
- Turn the ignition OFF.
- Disconnect the plus VI from the vehicle.
- Connect the plus VI to the vehicle.
- Restart ECM reprogramming (page 5, step 10).

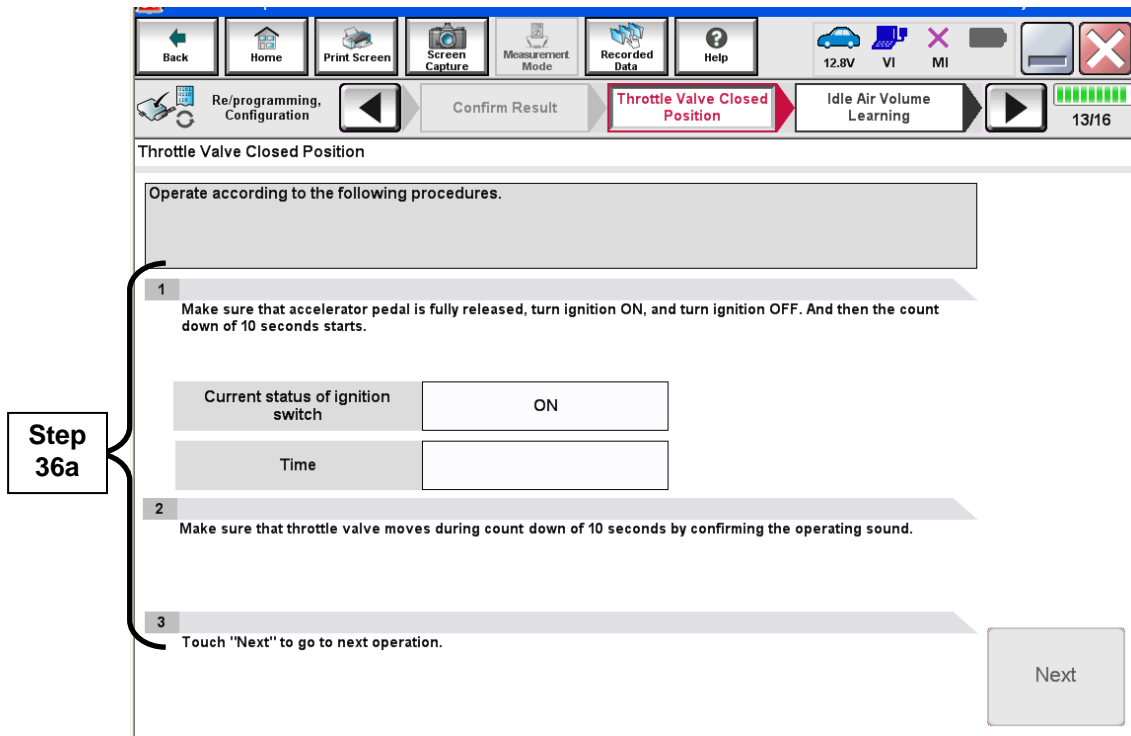
Figure 25

36. Perform **Throttle Valve Closed Position** procedure.

a. Follow the on-screen instructions.

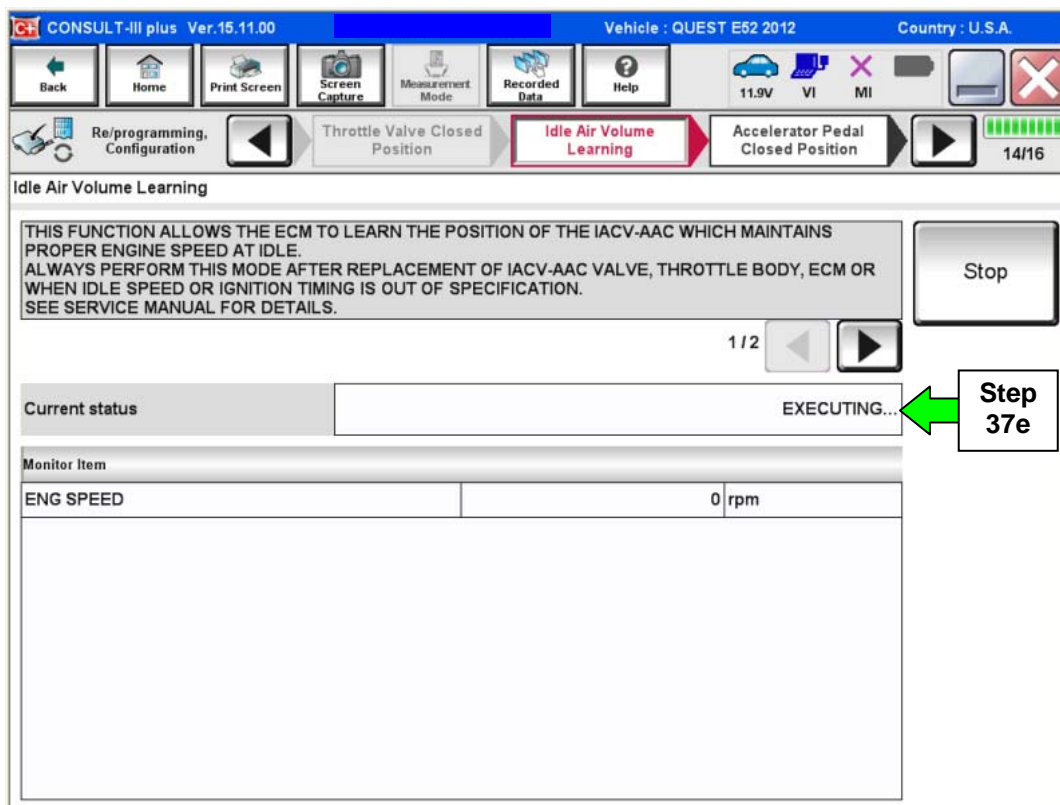
Figure 28a

e. Wait for IAVL to complete.

- If IAVL does not complete within two (2) minutes, one or more of the following common conditions may be out-of-range:
  - Engine coolant temperature: 70 - 100°C (158 - 212°F)
  - Battery voltage: More than 12.9V (At idle)
  - Selector lever: P or N
  - Electric load switch: OFF (Air conditioner, headlamp, rear window defogger)
  - Steering wheel: Neutral (Straight-ahead position)
  - Vehicle speed: Stopped
  - Transmission: Warmed up
- **For specific conditions required, refer to the ENGINE>EC section of the appropriate Quest Electronic Service Manual (ESM).**
- Select **Stop**.
- When the **Information** screen (similar to the one below) appears, select **Yes**, and then make sure all conditions are met.
- By selecting **Yes**, this will take you back to the screen in Figure 27, page 21. Restart the IAVL procedure (page 21, step 37c).

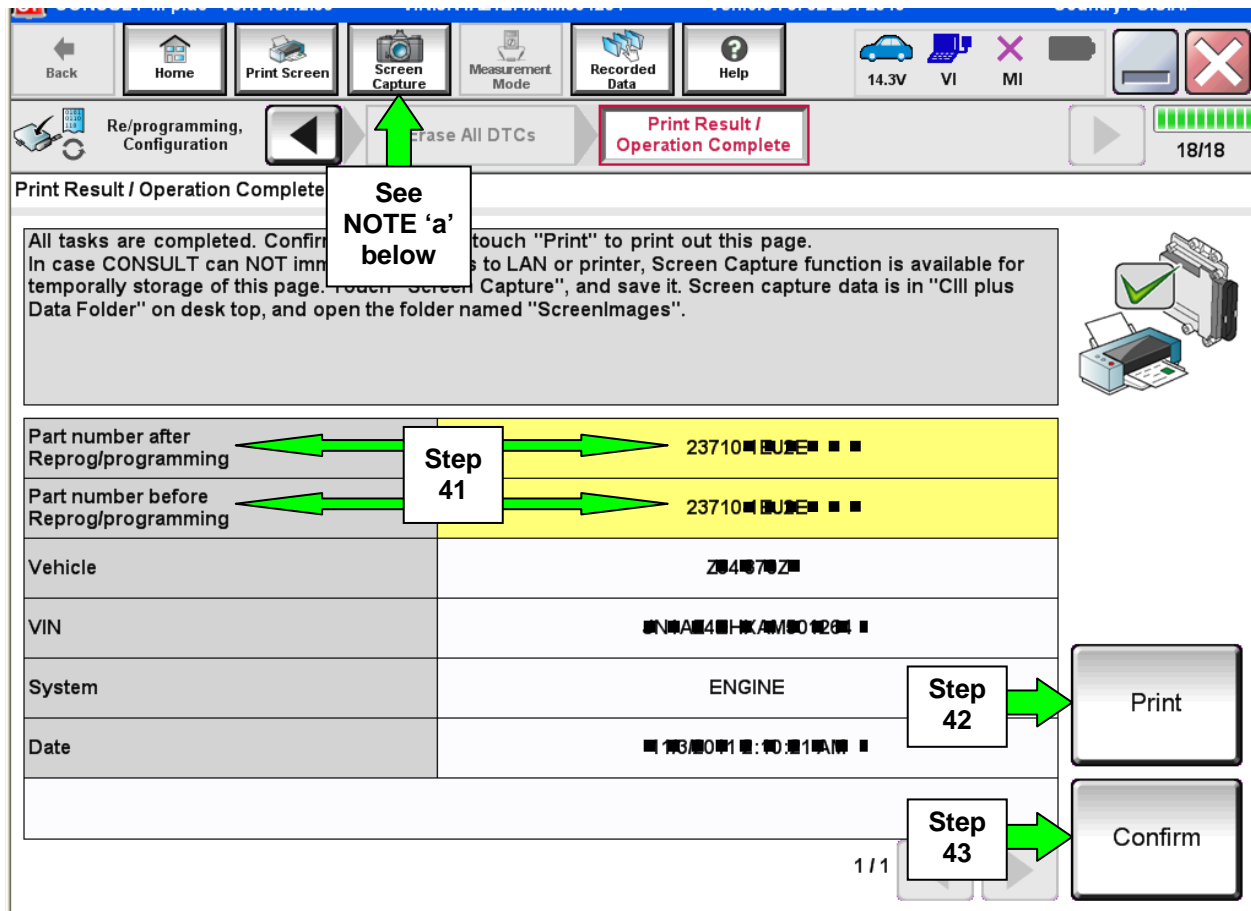
Figure 33

41. Verify the before and after part numbers are different.
42. Print a copy of this screen (Figure 33) and attach it to the repair order.
43. Select **Confirm**.
