Recall Campaign 12V-161: Replace the Auxiliary Coolant Pump for Turbocharger

F01 and F02 (7 Series) with N63 engine (including Alpina B7, B7L) or N74 engine

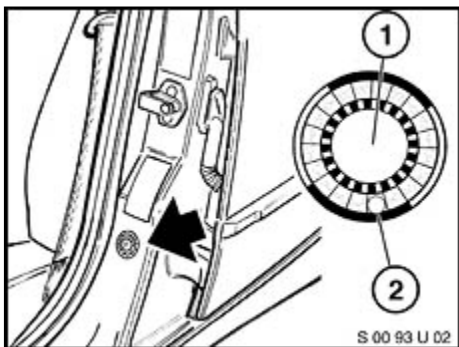
LABEL INSTRUCTIONS

This Recall Campaign has been assigned code number **618**. After the vehicle has been checked and/or corrected, obtain a label (SD 92-403) and:

- Emboss your BMW center warranty number in the middle of the label (1);
- Punch out code number **618** (2), printed on the label; and
- Affix the label to the B-pillar as shown.
