Explorer Van Company, Inc.

Recall Campaign #2013-1: Wire Assembly Attachment

Inspection / Repair of wiring on Explorer seats equipped with the Power Recline / Lumbar option

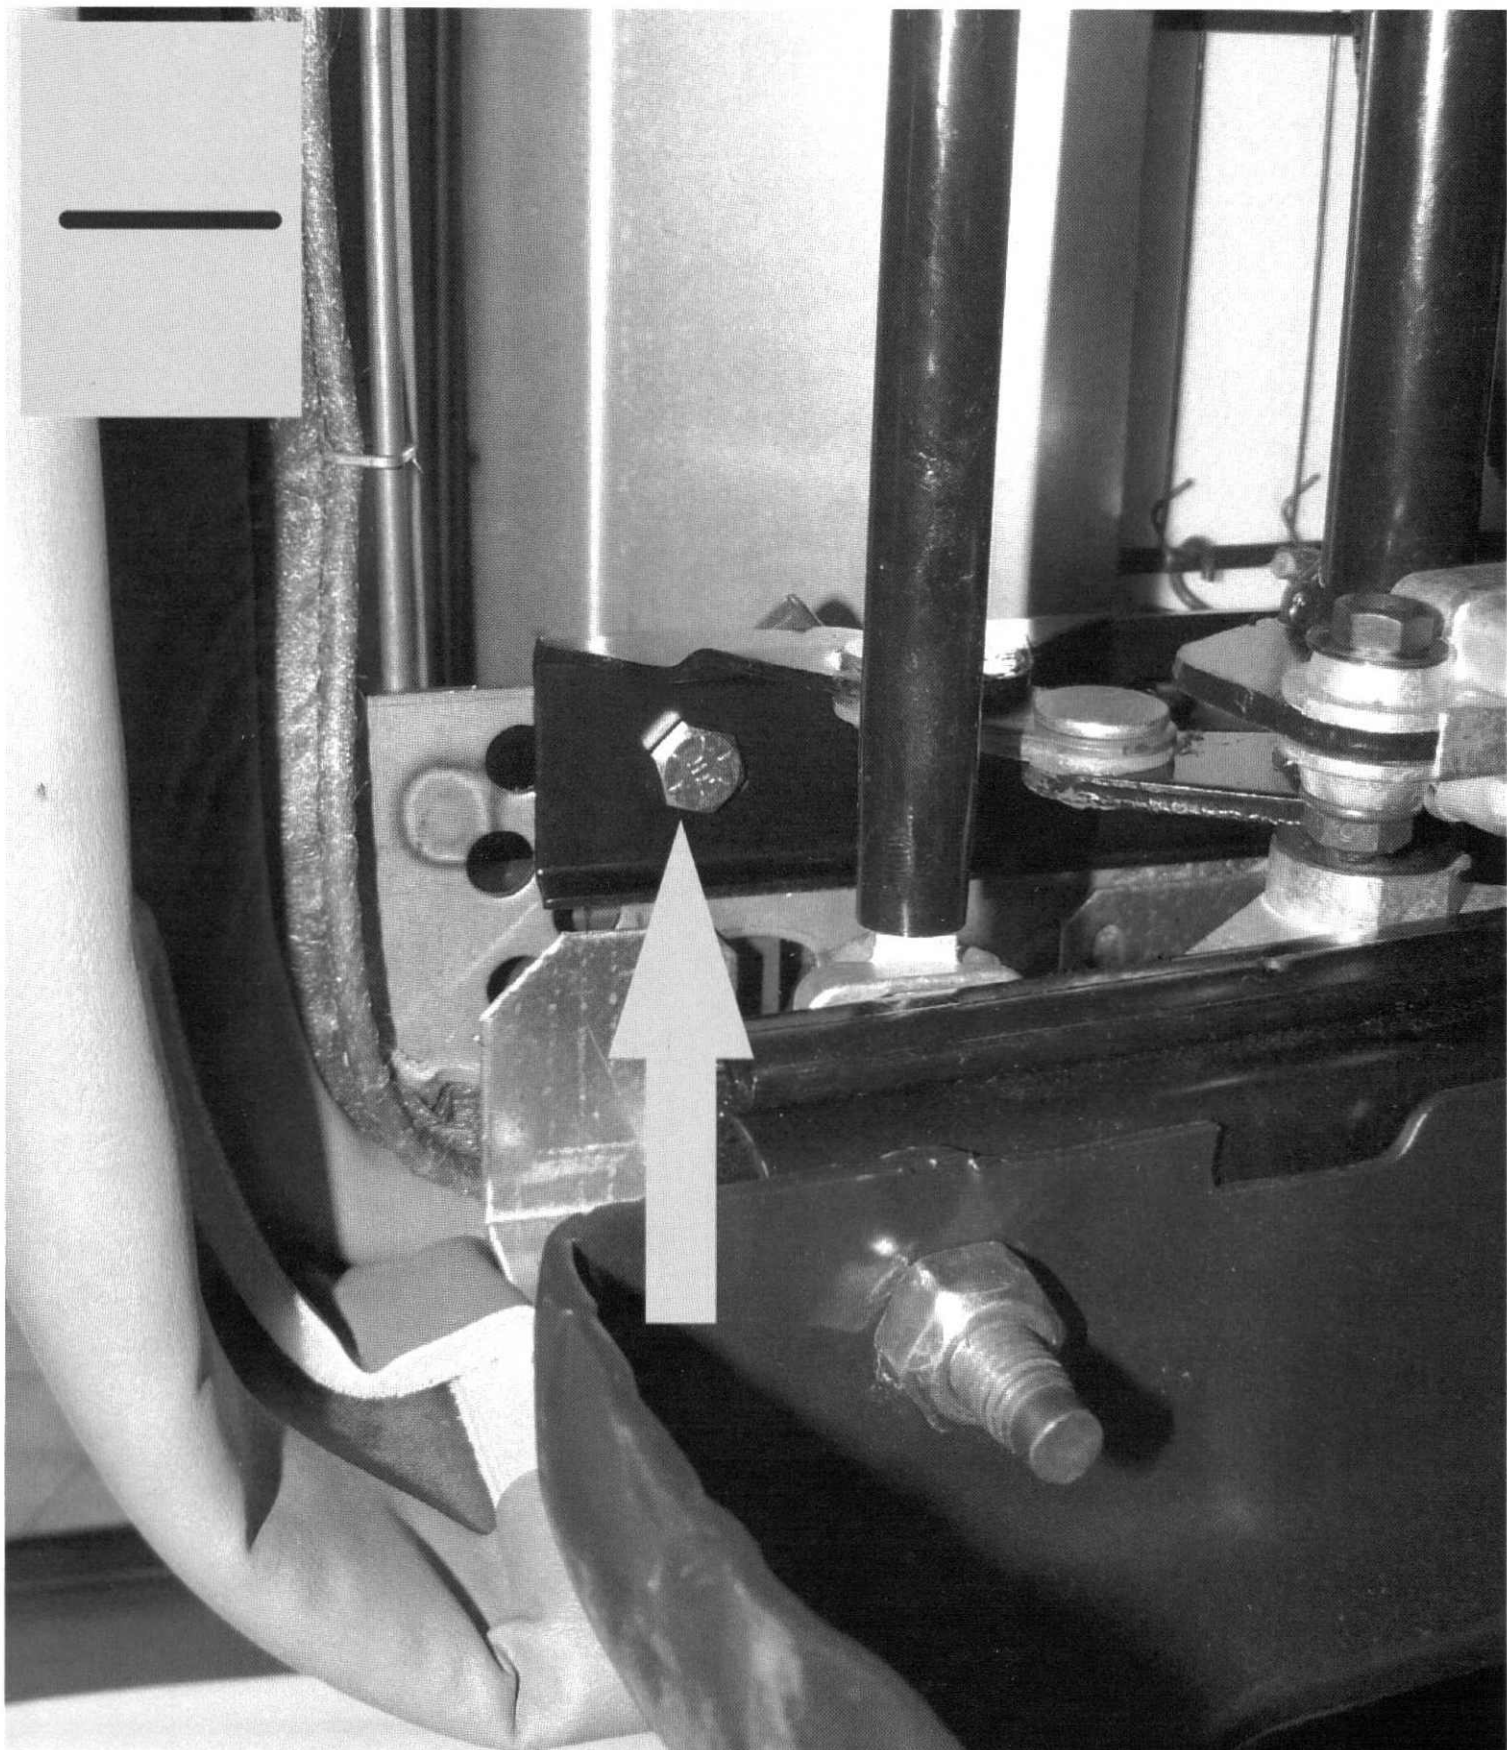
2

1. Using the driver / passenger 6-way power seat controls, raise the seat as high as possible.
2. Separate the chair from the seat motor frame by removing the four (4) ½ inch mounting bolts located under the chair, two under the front side and two accessed from under the back of the seat. We recommend a ratchet with a five (5) inch extension. See pictures 1,2 and 3
3. Unplug the 6-way power seat switch. See picture 4.
4. Slowly tip chair back to reveal the underside of the seat bottom and associated wiring.
5. **IMPORTANT!** Please inspect the complete wiring harness for any damage, breaks or broken connections. If any damage is found, contact the Explorer Van service department immediately for instructions to acquire a new wiring harness. (574) 267-7666 or (800) 926-7878.
