Reference:

ITB13-041

VOLUNTARY SAFETY RECALL CAMPAIGN 2013-2014 JX35/QX60 ABS SOFTWARE UPDATE

CAMPAIGN I.D. #: R1307**APPLIED VEHICLE:** 2013 JX35 (L50)
2014 QX60 (L50)
2014 QX60 Hybrid (L50)**Check Service Comm to confirm campaign eligibility.**

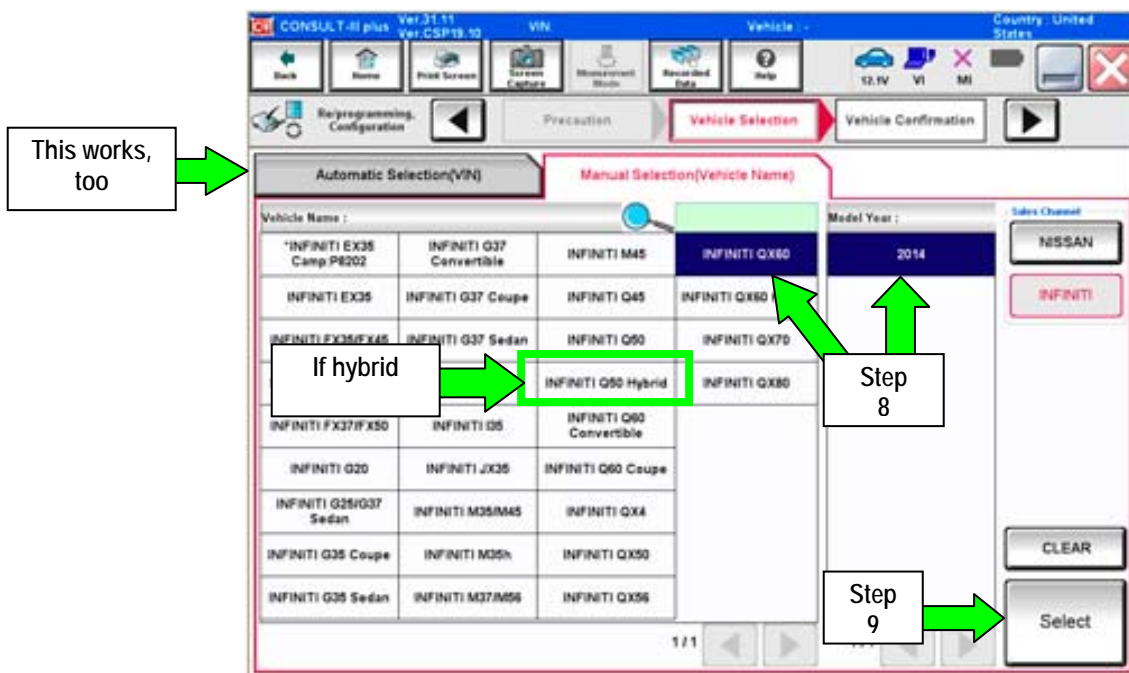
Figure 3

8. Select **INFINITI**, the model and the model year, or **Automatic Selection(VIN)**.

- Under **Manual Selection(Vehicle Name)** select **INFINITI**, JX35, QX60 or QX60 Hybrid, the model year and then click **Select**.
- If **Automatic Selection(VIN)** is selected, wait for the Reading VIN screen (not shown) to complete.

9. Select **Select**.

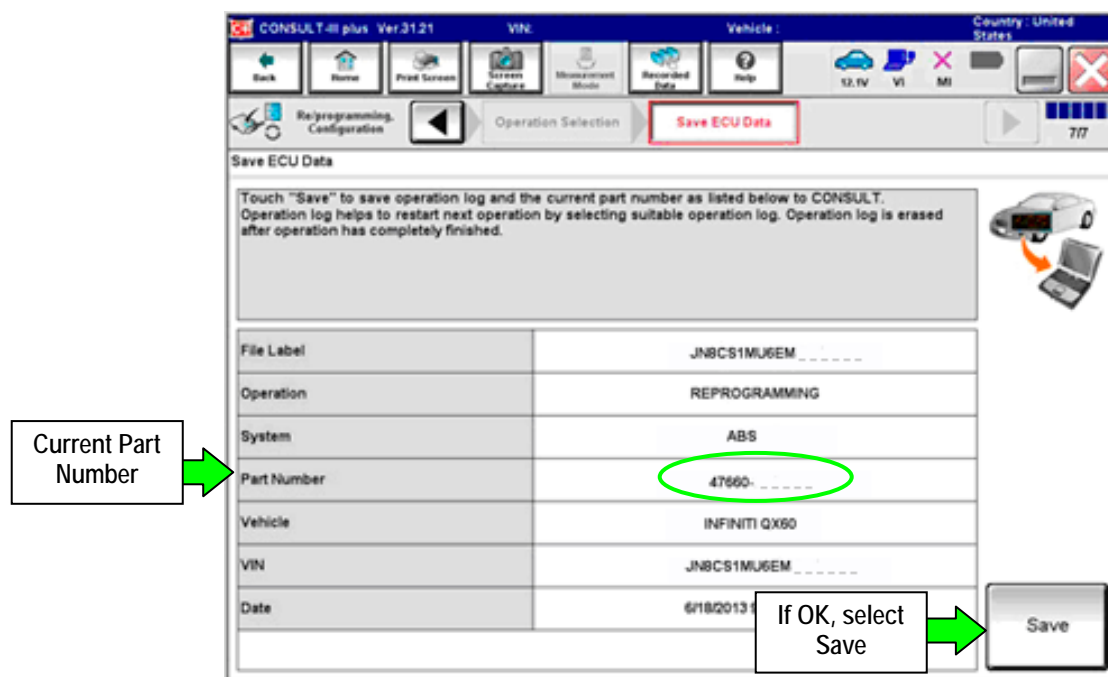
Figure 8

14. When you get to the screen shown in Figure 8, confirm reprogramming applies as follows:

- a. Find the ABS Part Number and write it on the repair order.

NOTE: This is the current ABS Part Number.

- b. Compare the P/N you wrote down to the numbers in the Current Part Number column of **Table A** below:

- If there is a match, the reprogramming applies. Continue with the reprogramming procedure.
- If there is not a match, reprogramming does not apply.
- **NOTE:** If the ABS part number is **not** in the table below, this campaign may not apply or it has already been done. Close C-III plus (select **Home**, and then the "X") and the CONSULT PC, disconnect from the vehicle, and then recheck Service Comm for campaign eligibility.

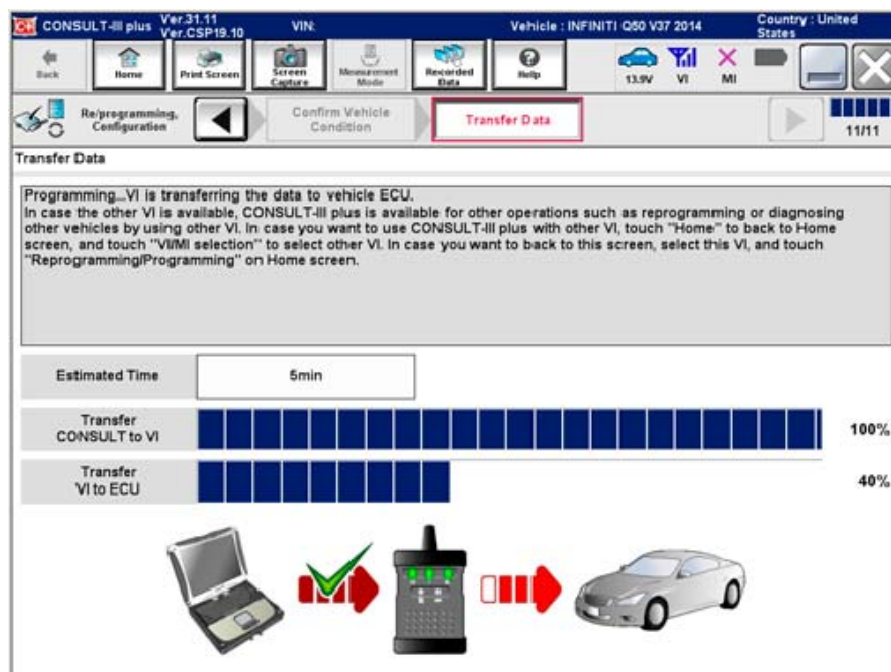
Figure 15

20. Wait for both bar graphs to complete.
