# RECALL CAMPAIGN BULLETIN

NTB13-091a

## VOLUNTARY SAFETY RECALL CAMPAIGN 2014 PATHFINDER PASSENGER FRONT AIR BAG COVER (ALMOND COLOR INTERIOR)

**APPLIED VEHICLE:** 2014 Pathfinder (R52) with Almond color interior ONLY

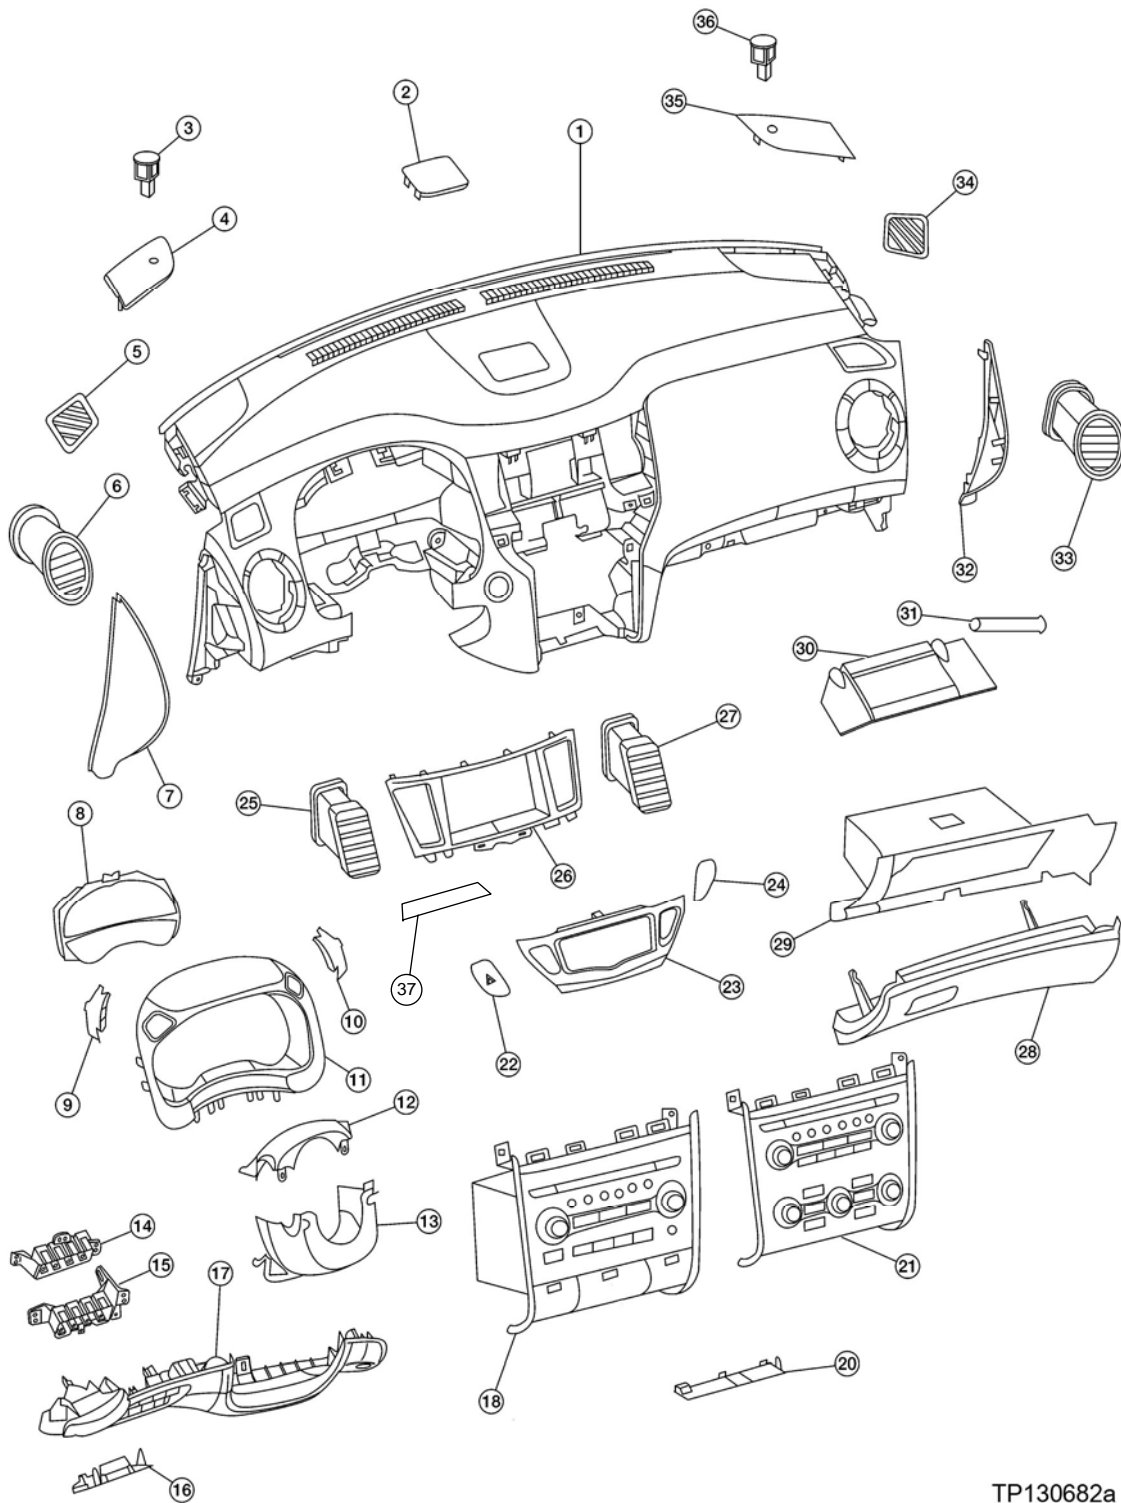
TP130682a

| 1. Instrument panel assembly | 2. Center speaker grille | 3. Sunload sensor |
| 4. Instrument panel tweeter grille (LH) | 5. Side defroster grille (LH) | 6. Side ventilator grille (LH) |
| 7. Instrument side finisher (LH) | 8. Combination meter | 9. Illumination control switch |
| 10. Trip computer switch | 11. Cluster lid A | 12. Steering column upper cover |
| 13. Steering column upper cover | 14. Upper switch carrier | 15. Lower switch carrier |
| 16. Fuse block cover | 17. Instrument lower panel LH | 18. Audio unit |
| 19. Not listed | 20. Cluster lid C lower | 21. A/C and audio control assembly |
| 22. Hazard switch | 23. A/C and AV (or navigation) switch assembly | 24. Front passenger air bag off indicator |
| 25. Center ventilator grille (LH) | 26. Cluster lid D | 27. Center ventilator grille (RH) |
| 28. Glove box lid | 29. Glove box | 30. Glove box tray |
| 31. Glove box dampener | 32. Instrument side finisher (RH) | 33. Side ventilator grille (RH) |
| 34. Side defroster grille (RH) | 35. Instrument panel tweeter grille (RH) | 36. Optical sensor |
| 37. Cluster lid D lower | | |

**NOTE:** Refer to the names of the parts above throughout this bulletin.

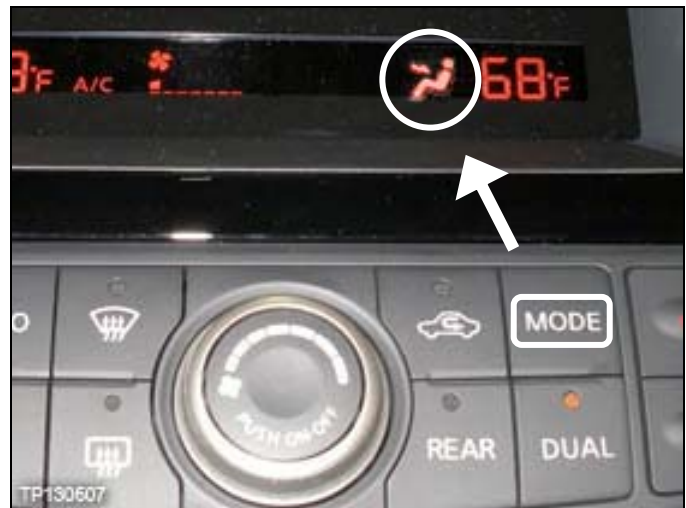
Figure 1

3. Set the HVAC in "FACE" Mode.

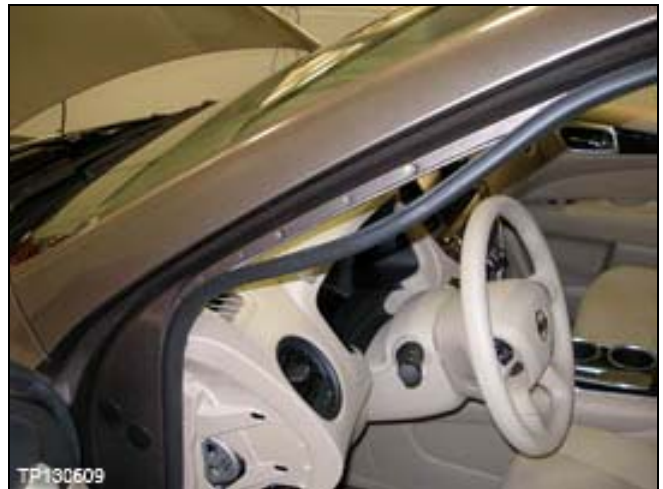
Figure 4

8. Pull down the front LH driver door welt as shown in Figure 4.
9. Remove the LH front pillar finisher:
  - a. Grab and then pull/unsnap the LH front pillar finisher.
  - b. Cut the LH front pillar finisher tether clip.
    - Replace this clip (see **PARTS INFORMATION**).

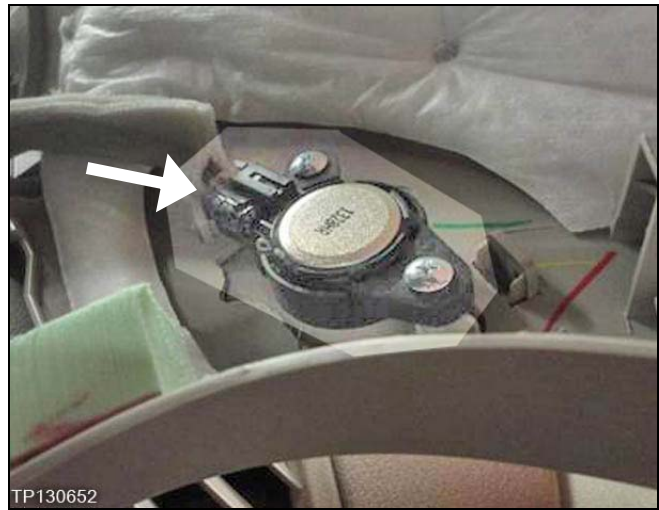
Figure 7

- c. If equipped, disconnect the LH front pillar finisher speaker's harness connector (see Figure 7).

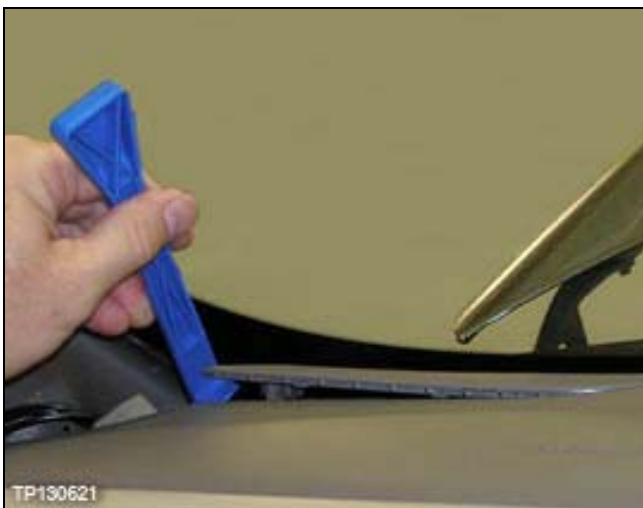
Figure 9

- 10. Pry up to unsnap the LH instrument panel tweeter grille (see Figure 9).

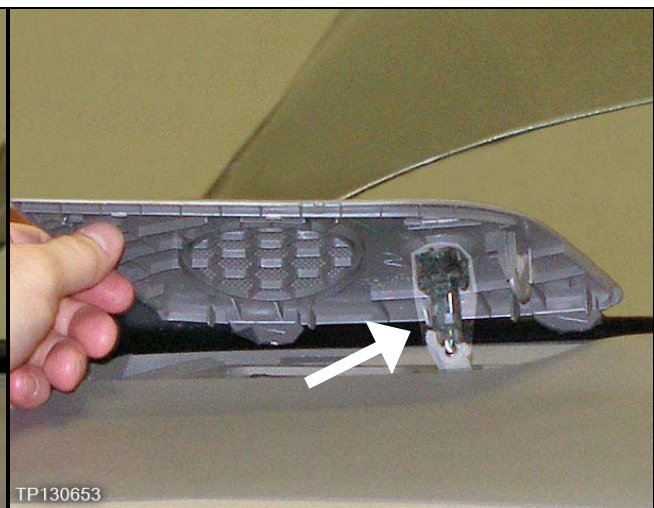
Figure 10

- 11. Disconnect the sunload sensor, and then remove the LH instrument panel tweeter grille (see Figure 10).

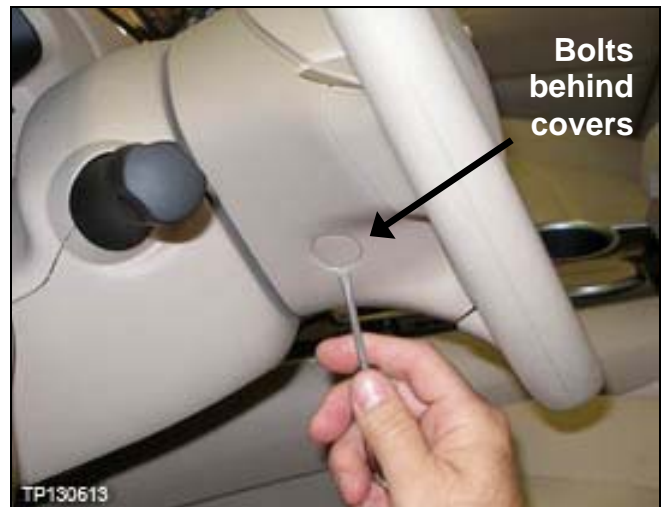
Figure 12

a. Remove both covers, and then remove the hidden bolts (see Figure 12).

- Do not reuse the bolts. They will be replaced with new ones (see **PARTS INFORMATION**).

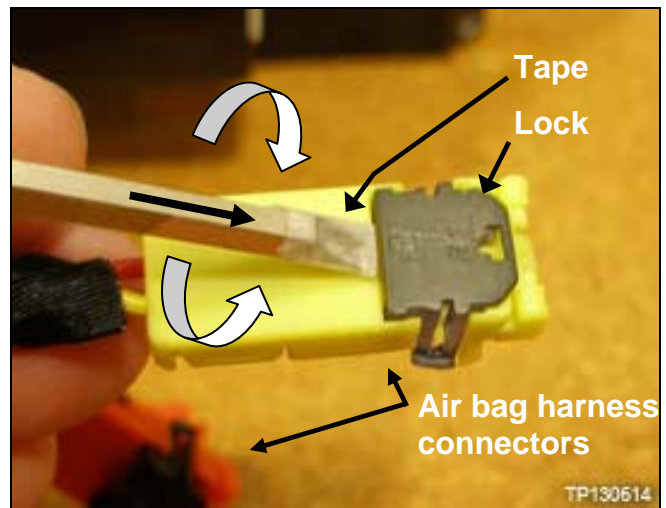
Figure 13

- b. Disconnect the two air bag module harness connectors, and then remove the driver air bag module.
- To unlock the lock, tape the end of a “pocket” screwdriver or suitable tool, insert it in the notch, and then twist (see Figure 13).

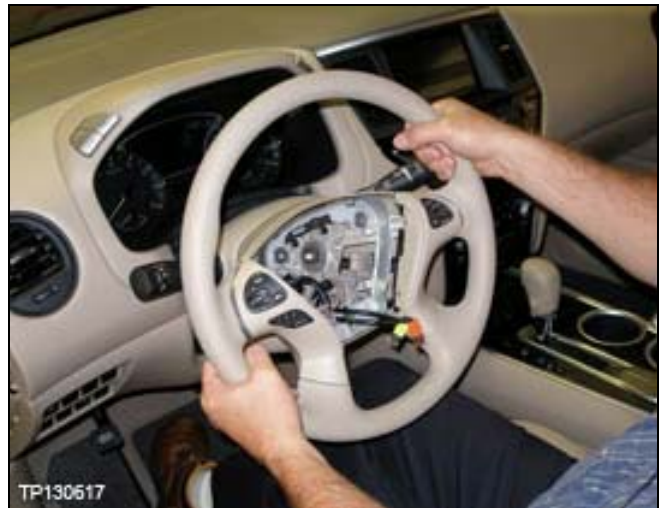
Figure 16

e. Firmly grab the steering wheel, rock it back and forth (not too hard) to loosen, and then remove it. See Figure 16.

- It is recommended to leave the nut on but backed away from the steering wheel while rocking it back and forth.
  - If the steering wheel does not come loose with this method, use a suitable puller.

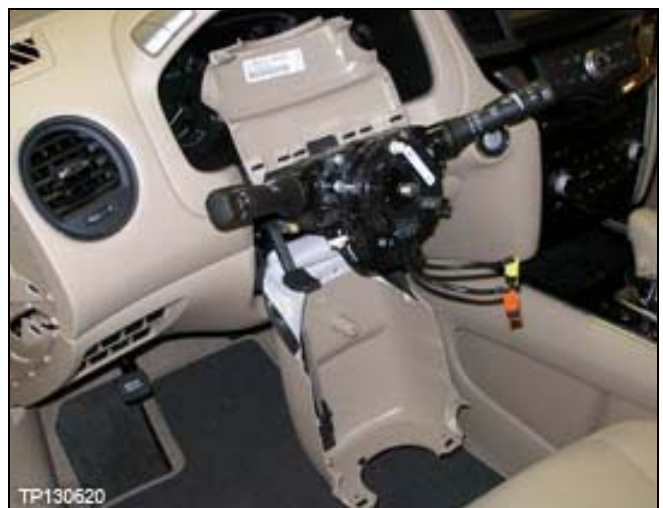
Figure 18

14. Open up the upper and lower steering column covers (see Figure 18).

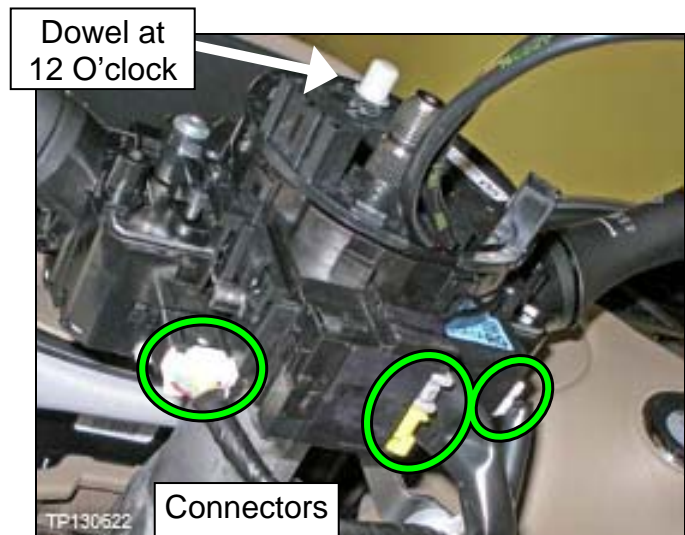
Figure 19

a. Disconnect all connectors where shown in Figure 19.

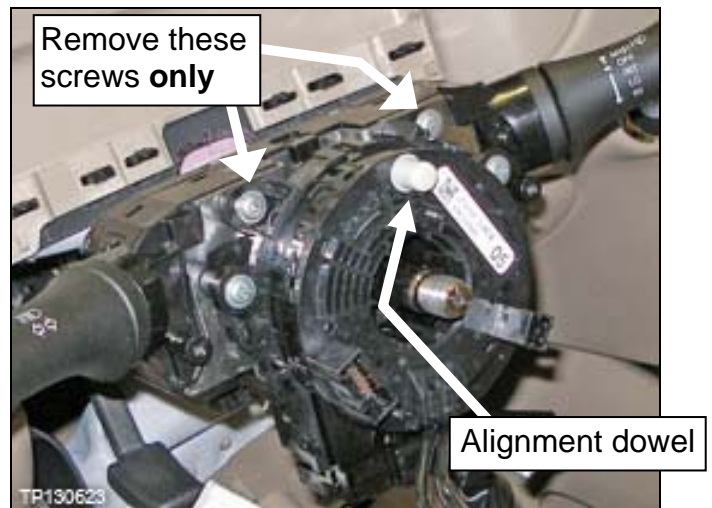
Figure 20

b. Remove the two (2) upper screws where shown in Figure 20.

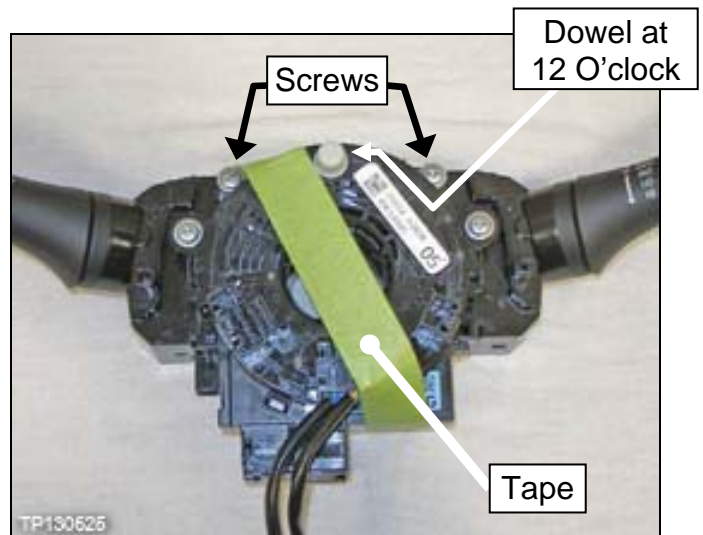
Figure 22

- Loosely fasten the spiral cable to the combination switch with the two (2) screws, and then tape them together (see Figure 22).

- Once both parts are removed, tape them together to keep the spiral cable from rotating (see next page, Figure 22).

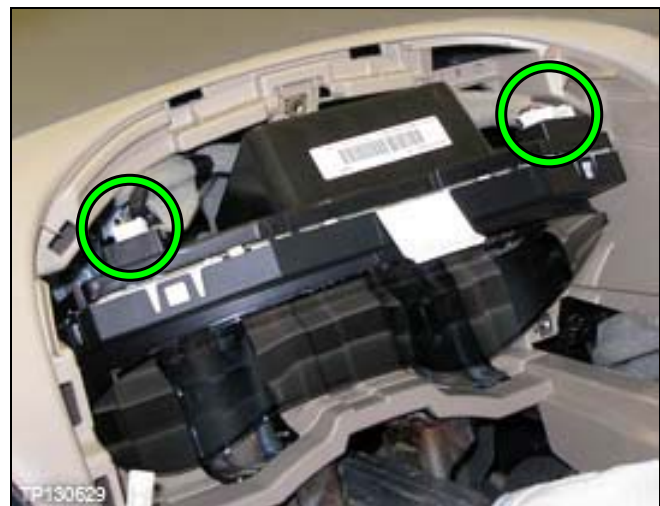
Figure 25a

19. Disconnect the two (2) connectors, and then remove the combination meter (see Figure 25a).

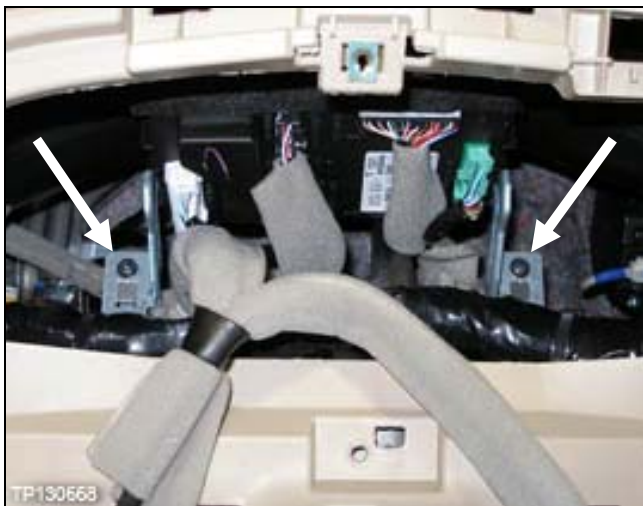
Figure 26

20. Have the BCM sitting loose by removing the two (2) screws shown in Figure 26.

- The BCM is located behind the combination meter.
- The BCM can now be moved around for easier IP removal/installation.

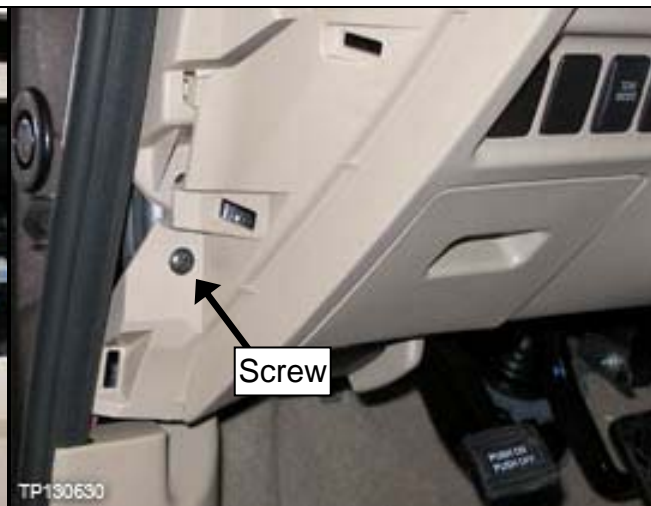
Figure 27

21. Remove the screw shown in Figure 27.

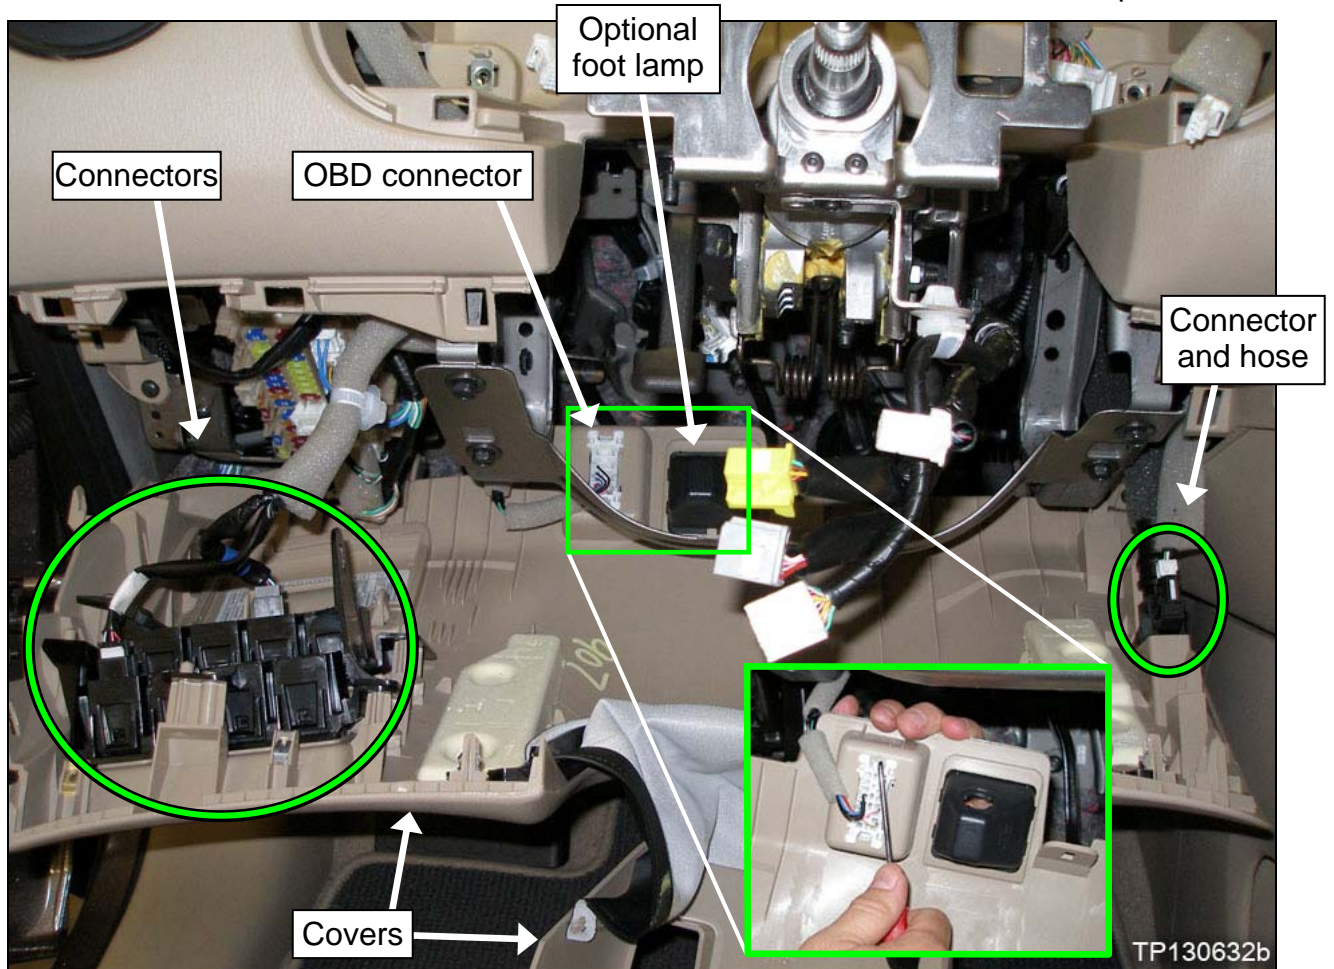
Figure 29

23. Disconnect all connectors and if equipped, the foot lamp and socket (see Figure 29).

24. Unsnap the data link (OBD) connector and hose from the lower cover, and then remove the LH instrument lower panel with steering column lower cover.

- The OBD connector comes out the back side of the LH instrument lower panel.

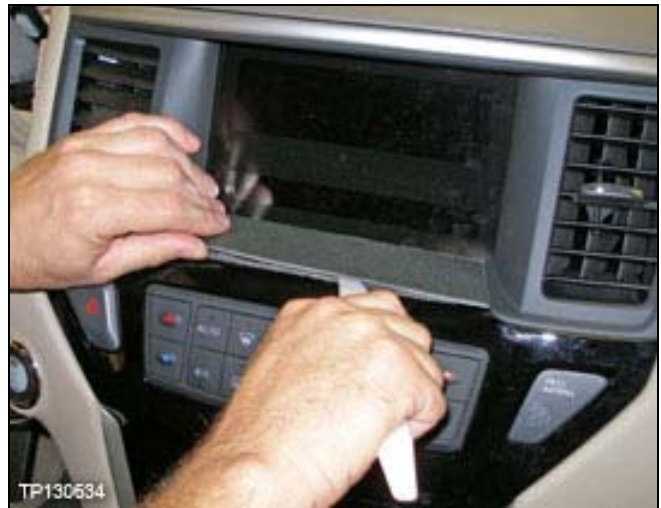
Figure 30

25. Using a suitable finesse tool, unsnap the front of “cluster lid **D** lower”, located at the bottom of the display unit (see Figure 30).

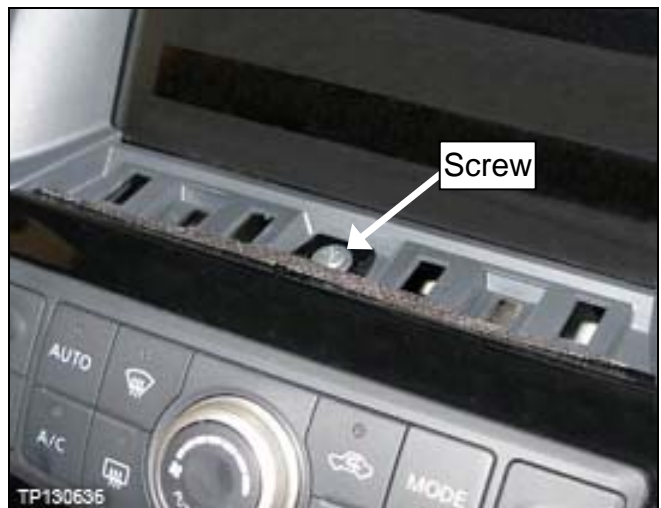
Figure 32

27. Remove the screw shown in Figure 32.

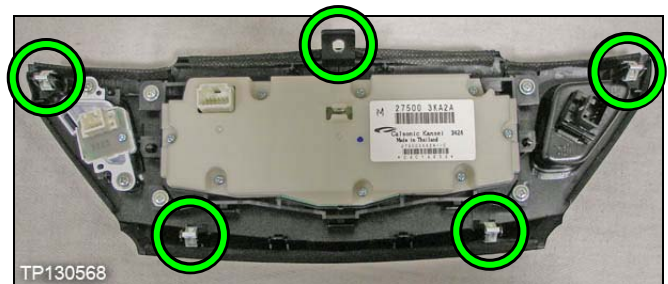
- Figure 34 shows the four (4) clips and screw hole on the A/C and AV (or navigation) switch assembly.

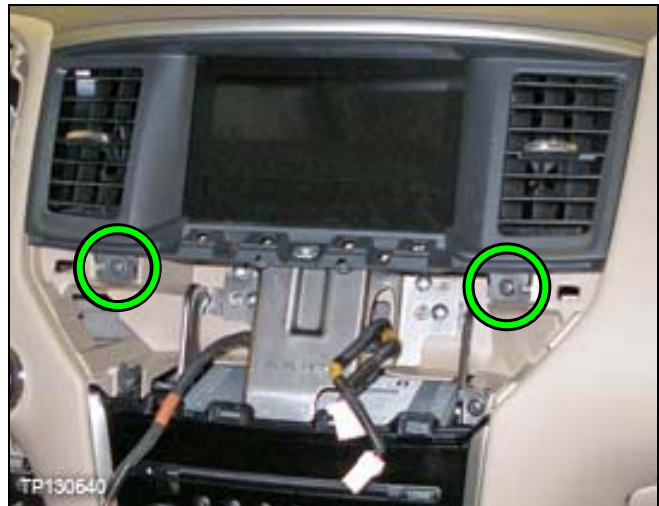
Figure 36

30. Remove the two (2) screws shown in Figure 36.

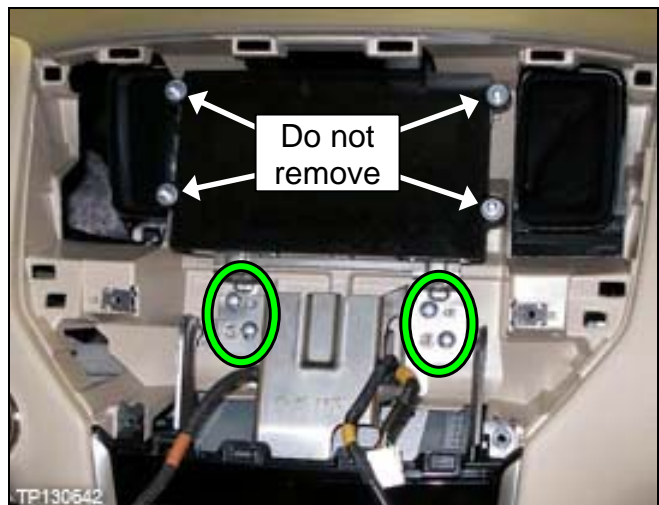
Figure 38

32. Remove the four (4) screws, and then remove the metal bracket (see Figure 38).

- Do not remove the screws on the display unit.

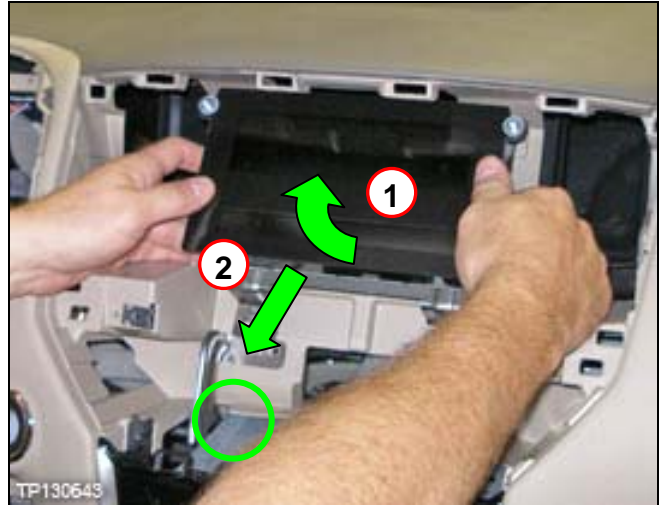
Figure 39

33. Swing up the display unit at the bottom, and then pull down (see Figure 39).

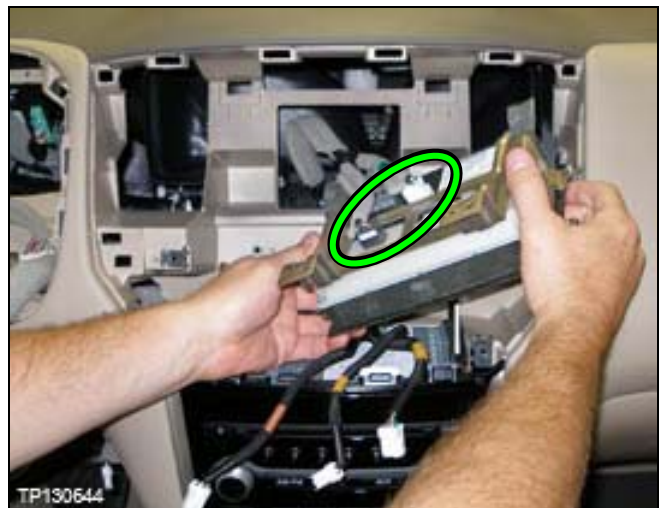
Figure 40

34. Disconnect the connectors, and then remove the display unit.

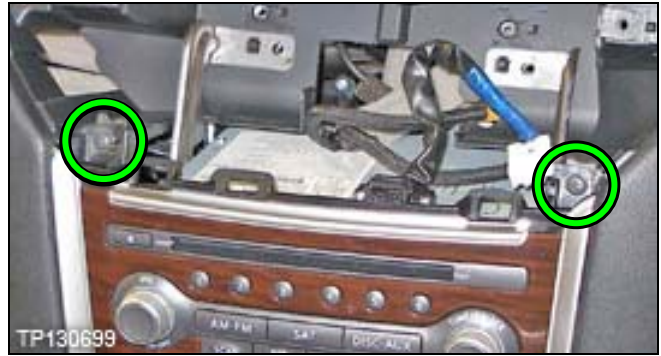
Figure 41

35. Remove the two (2) upper screws holding the audio unit (or A/C and audio control assembly).

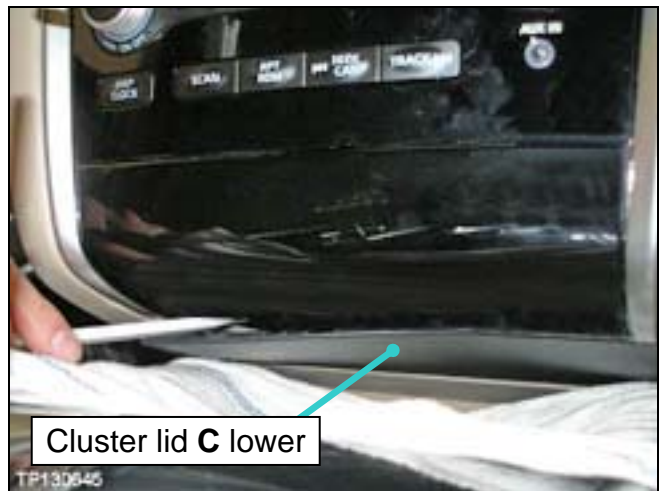
Figure 42

36. Using a suitable finesse tool, pry and unsnap to remove “cluster lid C lower”, located below the audio unit (or A/C and audio control assembly).

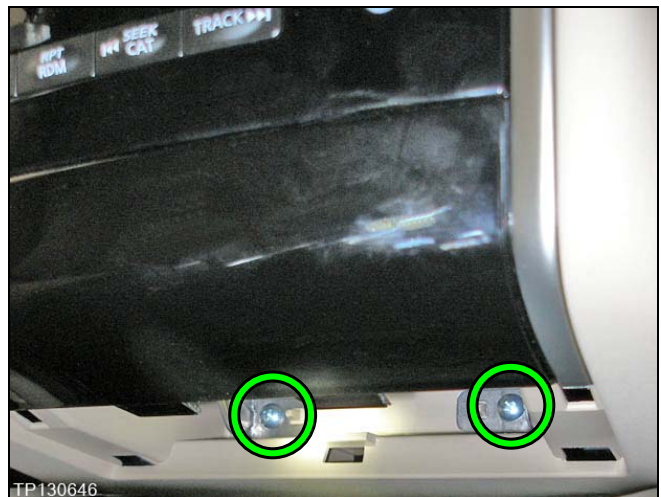
Figure 43

37. Remove the two (2) screws behind “cluster lid C lower” just removed.

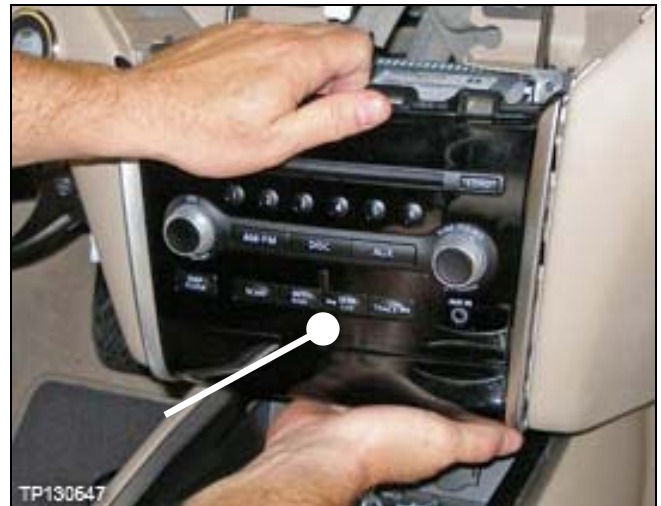
Figure 44

38. If equipped: Pull out the audio unit (see Figure 44).

- The audio unit may need to be “tugged on” to work it loose.

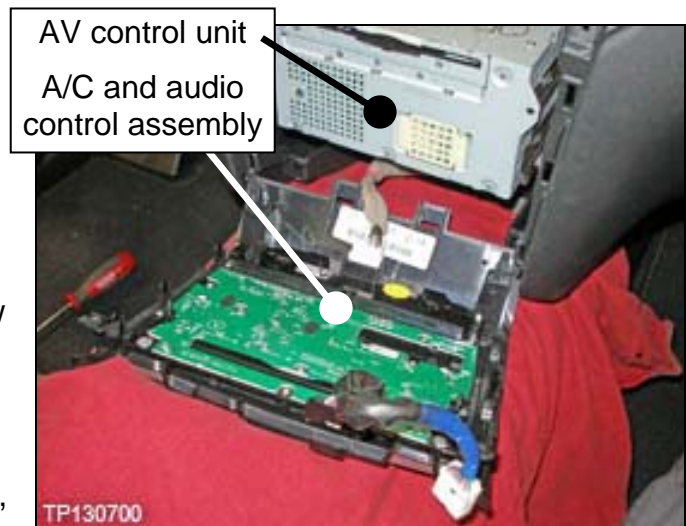
Figure 45

39. If equipped: Pull off the A/C and audio control assembly (Figure 45), and then pull out the AV control unit (Figure 45).

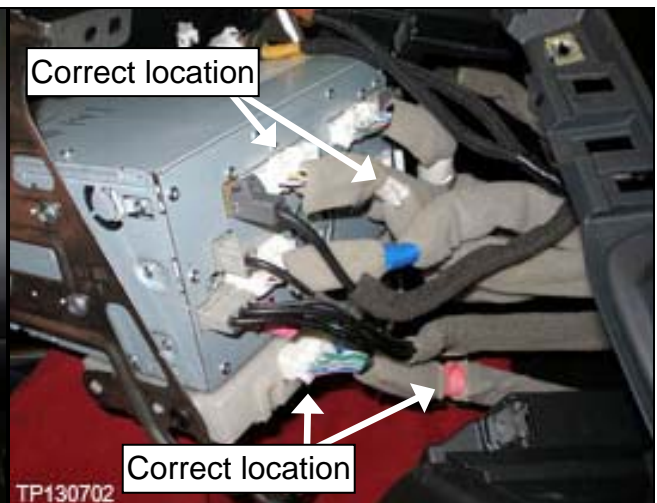
Figure 47

- For AV control unit equipped vehicles, remember: The white taped connector is located above, and the pink taped connector is located below (see Figure 47).

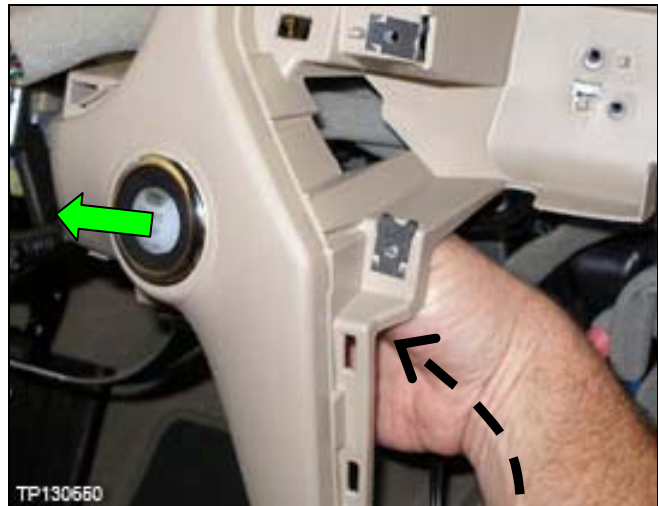
Figure 48

42. Remove the push-button ignition switch:

- a. Pinch in on the clips, and then push the push-button ignition switch through the front.
- b. Disconnect and remove the push-button ignition switch.

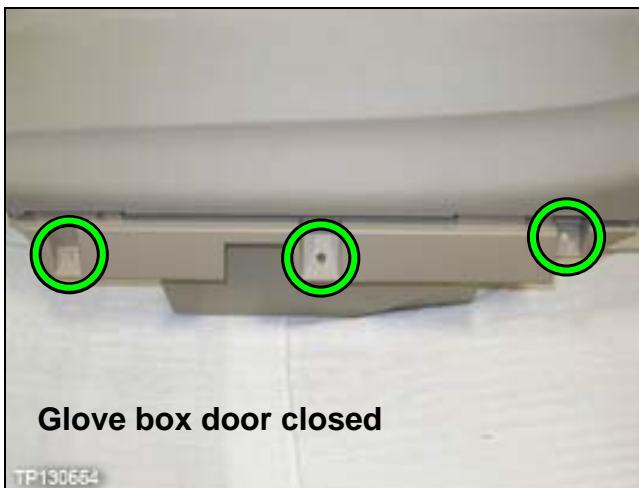
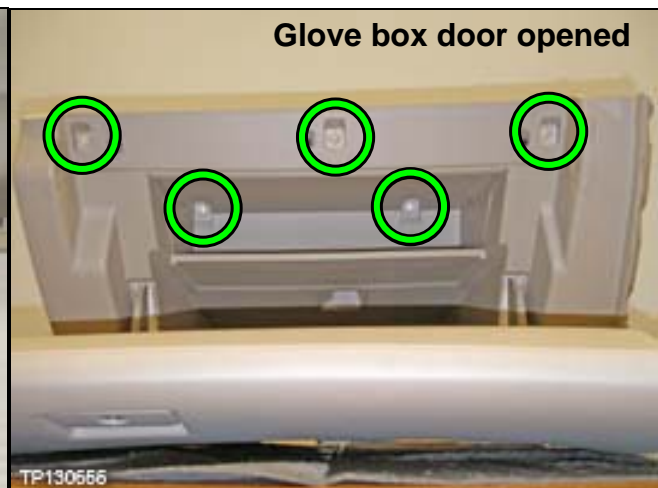
- a. Remove eight (8) screws. See Figure 50 and 51.

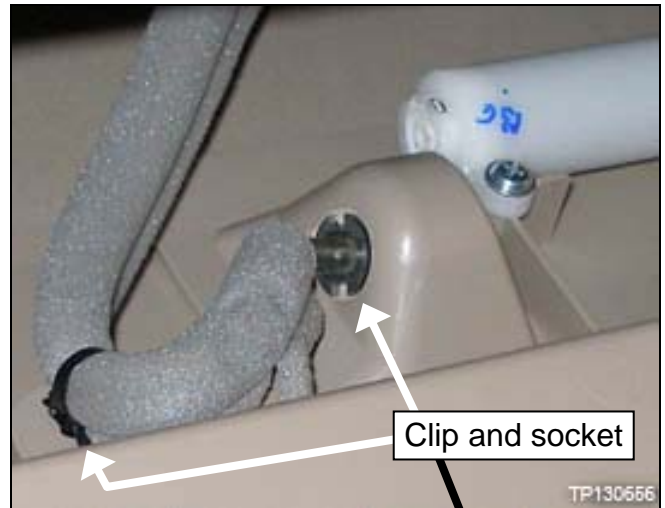
Figure 52

- b. Pull out the glove box assembly.
- c. Unplug the glove box light and socket, and then unfasten the clip from the glove box assembly.
  - Unfasten the clip by pinching the tip and pushing it through its hole.
- d. Remove the glove box.

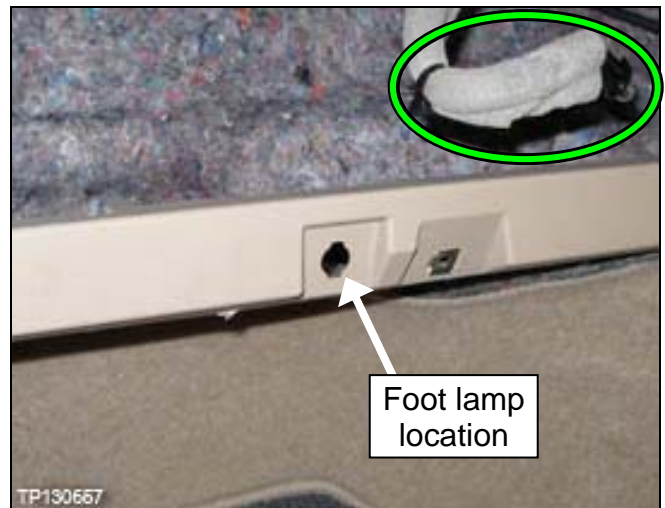
Figure 53

- e. If equipped: Unplug the passenger foot lamp and socket.

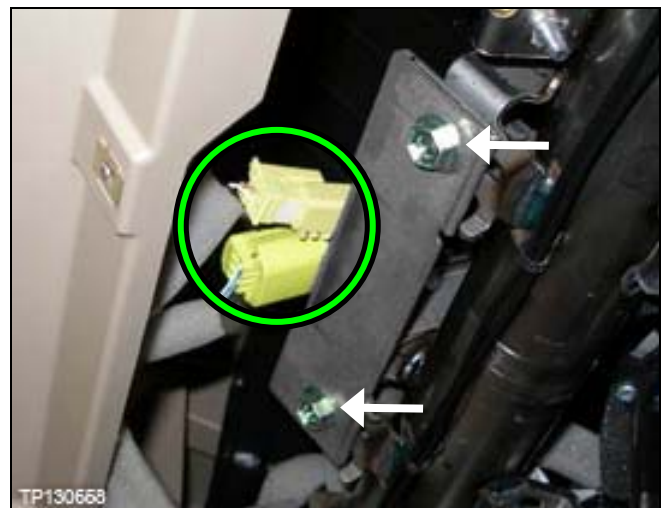
Figure 54

45. Remove the two (2) passenger side air bag module bolts, and then disconnect the connector(s) where shown in Figure 54.

- These items are located above the glove box area.
- The passenger air bag module will still be attached to the instrument panel.

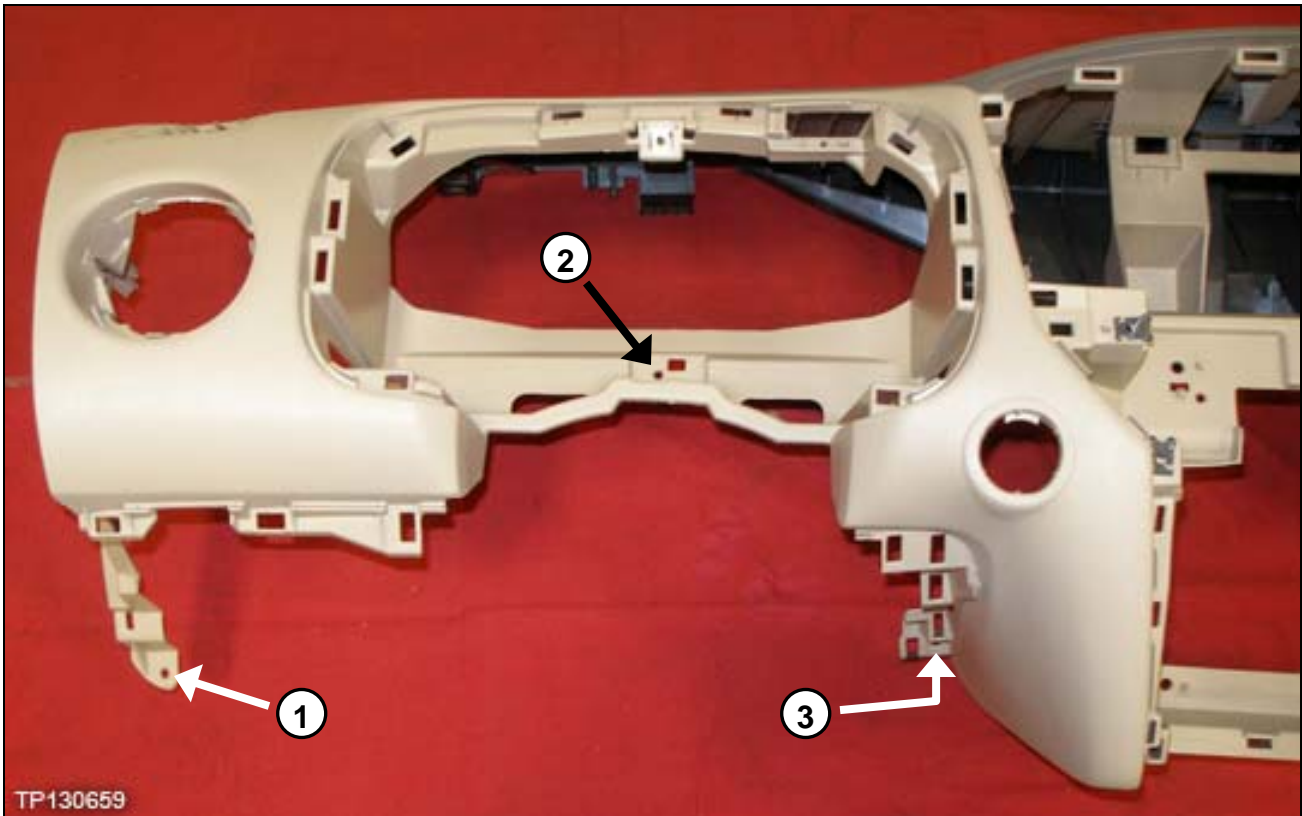
Figure 55; driver side, front

46. Remove the seven (7) IP screws, and one (1) 10 mm bolt.

- Refer to this and the next page for screws and bolt locations.

**IMPORTANT: The IP must be correctly seated on all hooks and tabs prior to securing the seven (7) screws and one (1) bolt.**

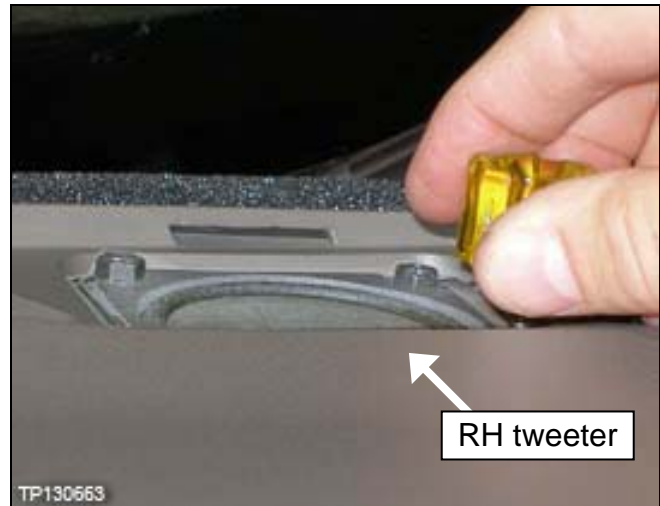
Figure 59

48. Using suitable tools, remove the three (3) small bolts, and then pull out the RH tweeter.

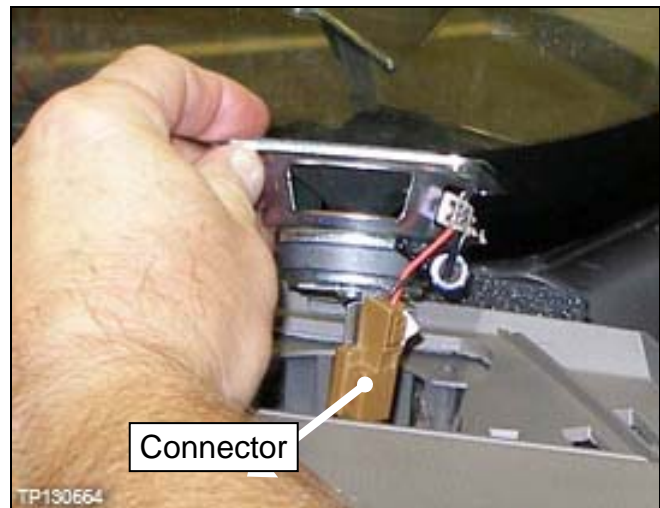
Figure 60

**NOTE:** The RH tweeter has one position for installation only, as shown in Figure 60.

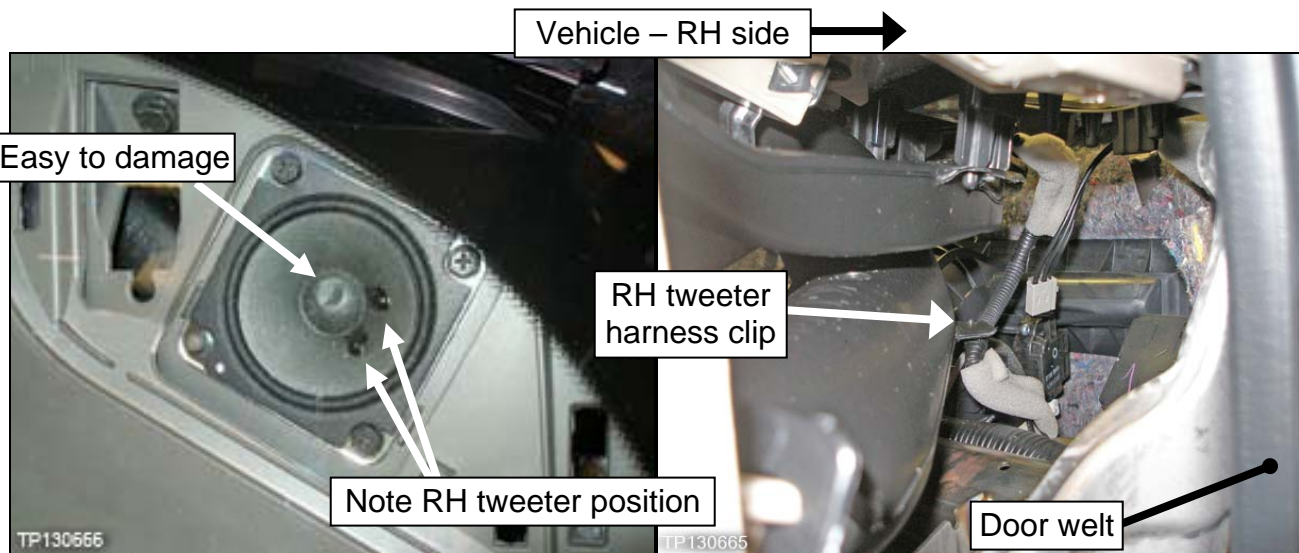
Figure 61

**CAUTION:** Be careful not to damage the tweeter (see Figure 61).

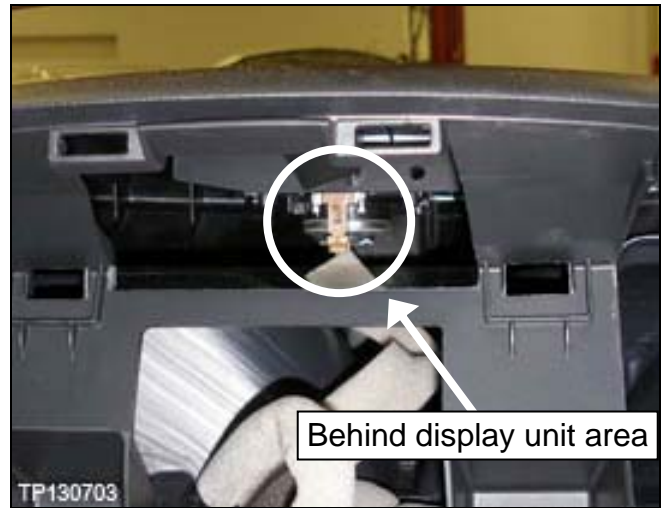
Figure 63

51. If equipped: Disconnect the center speaker's connector.

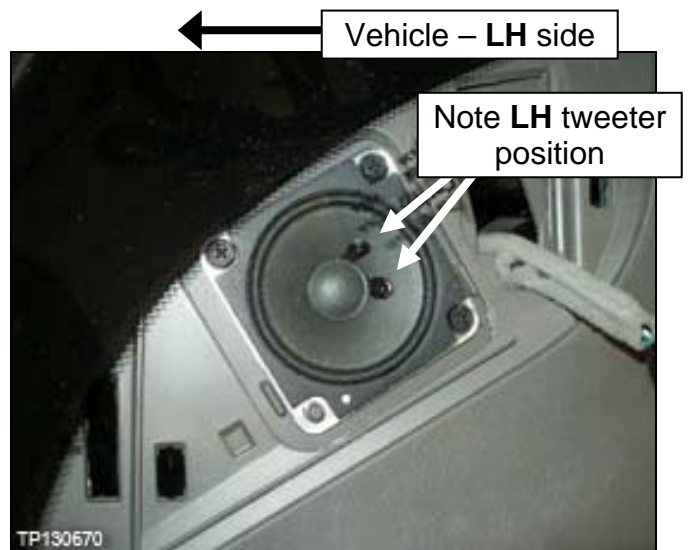
Figure 64

**NOTE:** The LH tweeter has one installed position only (see Figure 64).

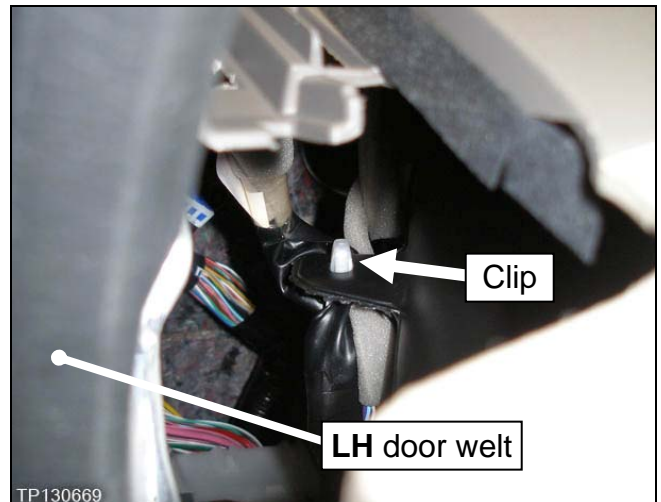
54. Unfasten the LH tweeter harness clip from the duct (see Figure 65).

- Figure 65 is looking in the end of the driver side IP partially pulled out.

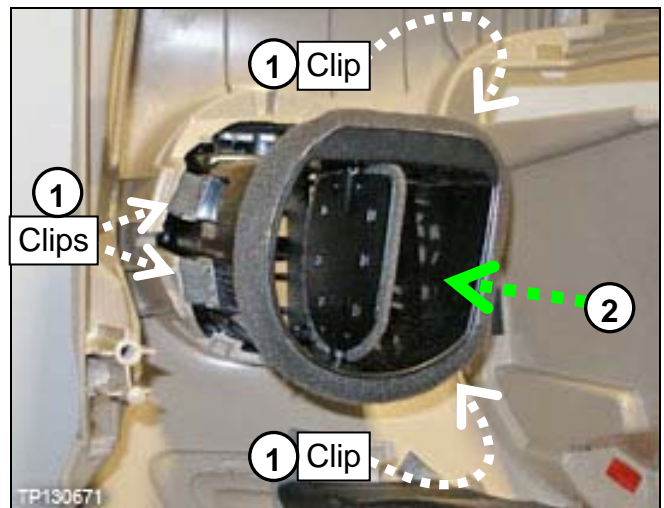
Figure 69

### Side ventilator grilles (see Figure 69)

- **1)** Press in on clips, **2)** push side ventilator grille through the front of the IP.
- Install the side ventilator grilles in the new IP in reverse direction of removal until the clips snap in place.

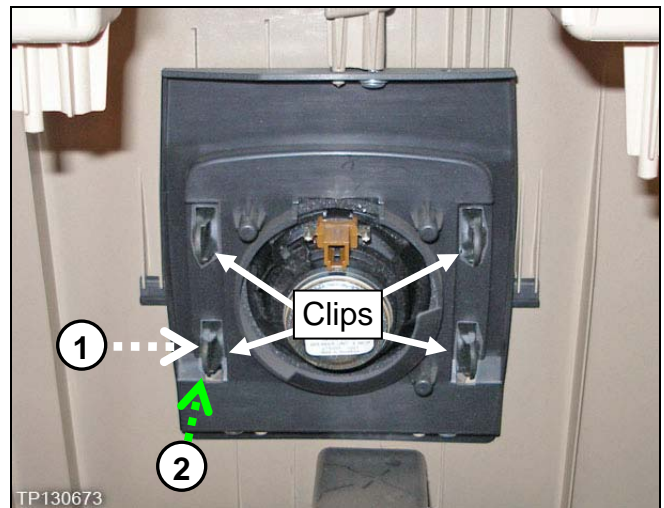
Figure 70

### Center grille/speaker grille (see Figure 70)

- **1)** Push clips inward, **2)** push clips through the holes, remove grille.

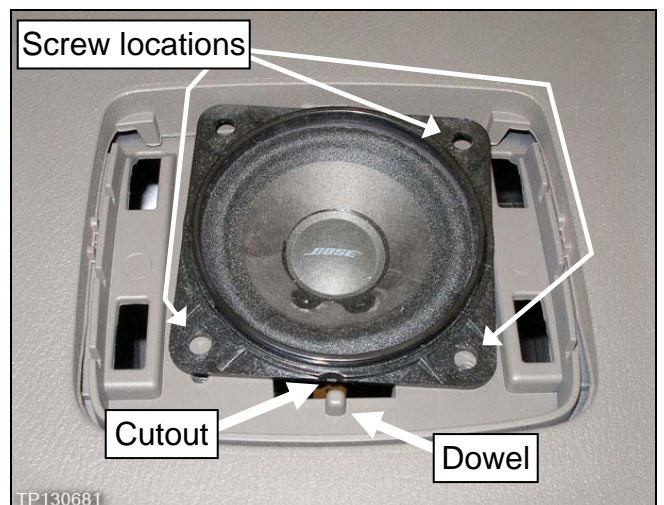
Figure 71

### If equipped: Center speaker (see Figure 71)

- Remove three (3) screws, lift out speaker.
- The center speaker has one installed position only. See cutout and dowel, Figure 71.

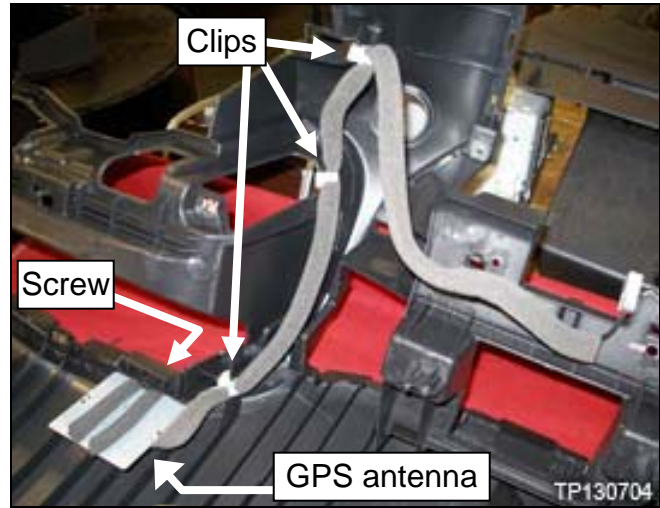
Figure 72

GPS antenna (see Figure 72)

- a. Remove one (1) screw.
- b. Unfasten three (3) clips.
- c. Install the GPS antenna in the new IP.

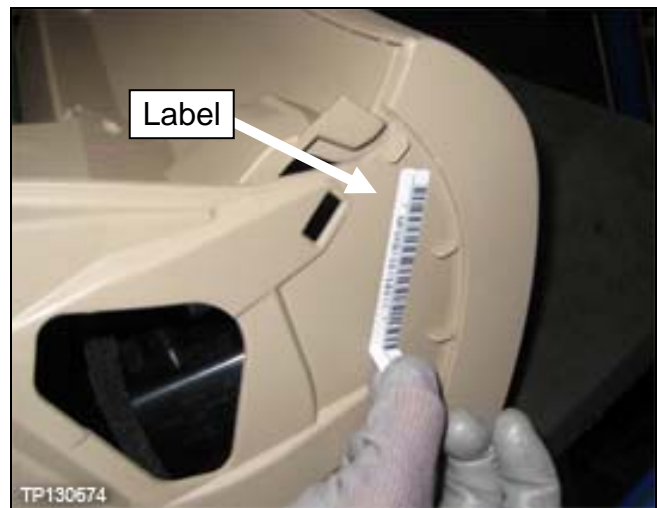
Figure 73

Transfer the passenger side air bag module traceability barcode label (see Figure 73) from the old to the new IP in the same location.

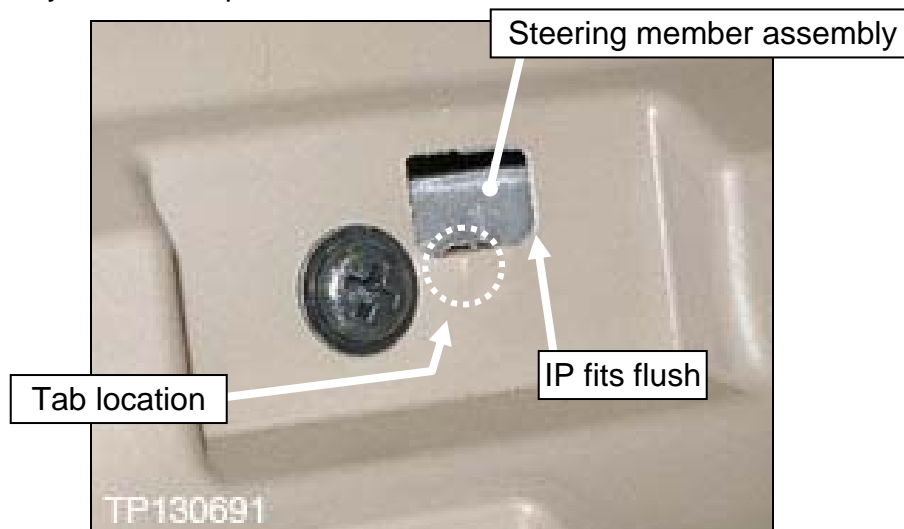
Figure 74

- There is a screw hole next to each tab where the IP is almond colored. When the tabs are properly seated, the IP will be flush against the steering member assembly. See example below.
