AD03 - Re-coding Instrument Cluster (Recall Campaign)

Vehicle Type: **Cayenne (92A)/Cayenne Diesel (92A)/Cayenne S Hybrid (92A)
Cayenne S (92A)/Cayenne GTS (92A)/Cayenne Turbo (92A)/Cayenne Turbo S (92A)**

Concerns: **Instrument cluster**

Action Required: **Re-code the instrument cluster** using the PIWIS Tester with software version **12.700** (or higher) installed.

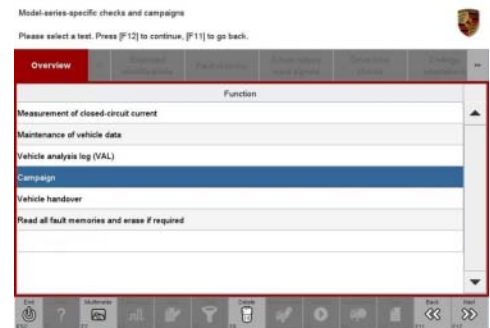
Additional menu – Campaign

You are then prompted to enter a start code.
