Safety Recall 13S12 – Supplement #1

All 2013 Model Year Escape Vehicles Equipped with a 1.6L Engine

Risk of Localized Overheating of the Engine Cylinder Head that May Lead to Oil Leak Fires

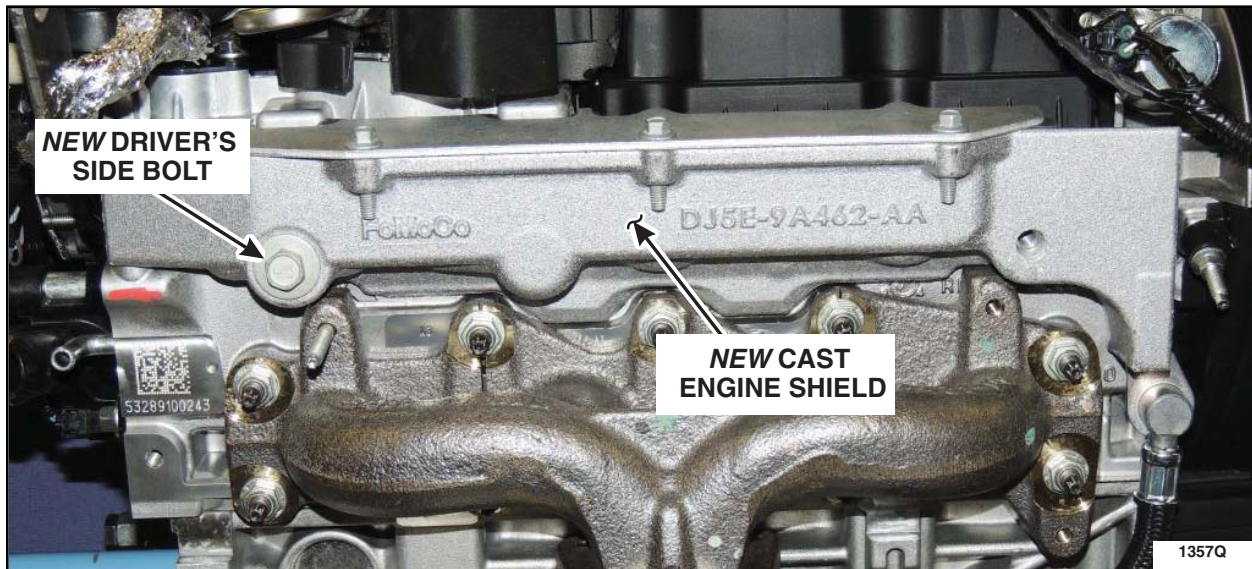
FIGURE C7

8. Carefully position the *new* cast engine shield to the rear of the cylinder head and install the *new* driver's side bolt finger tight. The LOCTITE® patch on the bolt will only allow you to install it a few threads. See Figure C7.

- Do not fully tighten the bolt at this time.

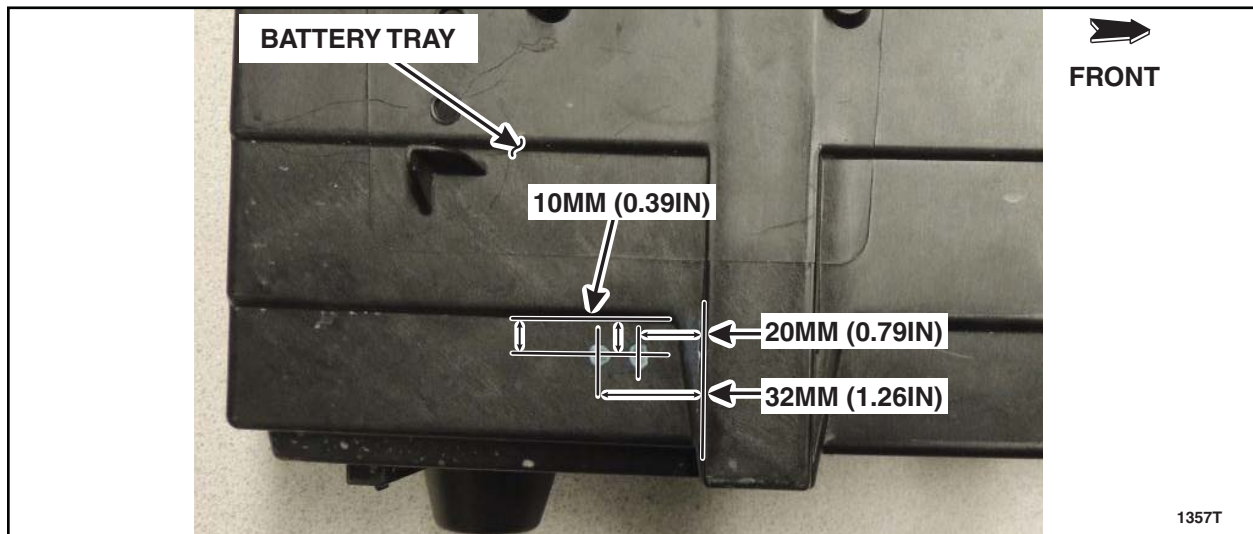
FIGURE D2

2. Measure and mark the two hole locations on the battery tray for the *new* wire harness clip. See Figure D2.

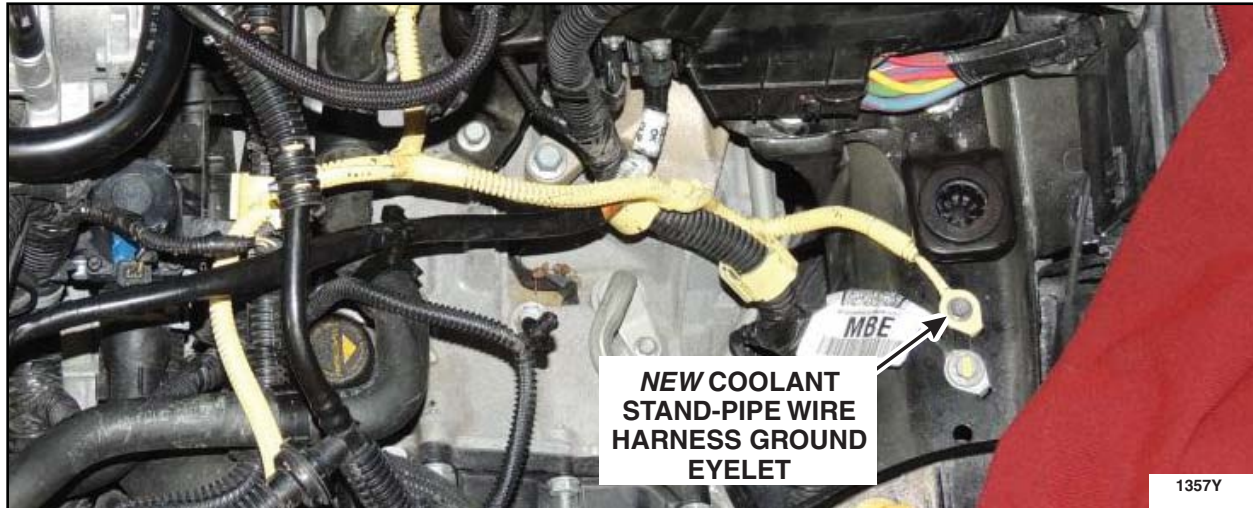
FIGURE E4

6. Install the *new* coolant stand-pipe wire harness ground eyelet to the vehicle using the *new* wire harness ground bolt. See Figure E4.

- Tighten to 12 Nm (106 lb-in).

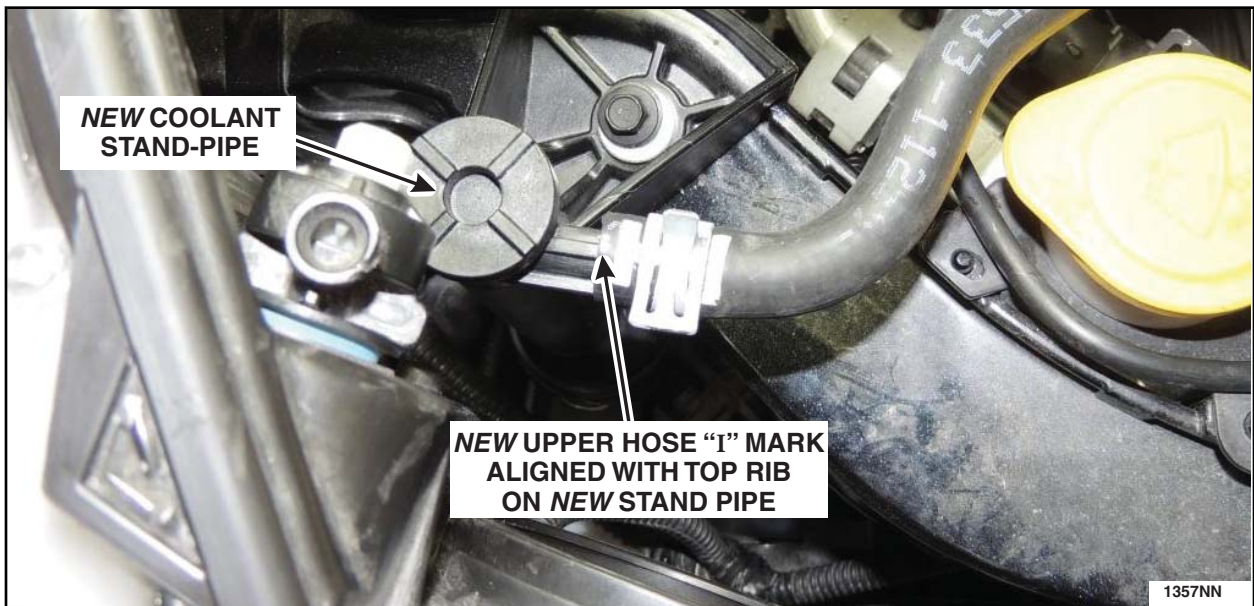
FIGURE J7

9. Install the *new* clamp. Align and connect the *new* upper hose to the top port on the *new* coolant stand-pipe and to the RH port on the degas bottle. See Figures J7 and J8.

- Ensure the "I" mark on the *new* upper hose is in the 12 o'clock position, aligned with top rib of stand-pipe top port. See Figure J7.
- The *new* clamp when installed should also be aligned with the "I" mark in the 12 o'clock position. See Figure J7.

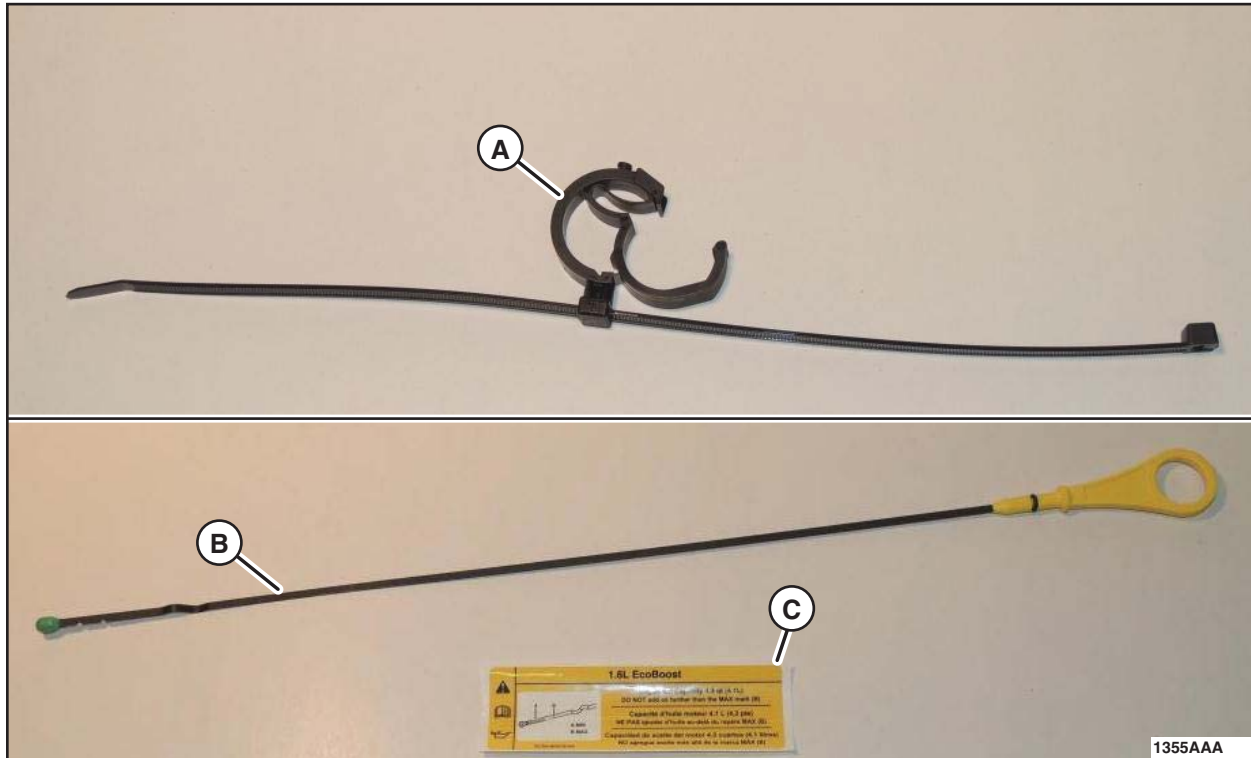
A	PCV Tube Retainer / Tie strap
B	Engine Oil Dipstick (Kit -6750-)
C	Engine Oil Fill Label (Kit -6750-)
D	Motorcraft® Metal Brake Parts Cleaner (PM-4-A or PM-4-B) (Dealer Procured) (Not Shown)
E	Motorcraft® Orange Antifreeze / Coolant Prediluted (VC-3DIL-B (U.S.) CVC-3DIL-B (Canada) / WSS-M97B44-D2) (Dealer Procured) (Not Shown)

OVERVIEW: The vehicle is reassembled, the cooling system is filled, pressure tested and bled; and a PCV tube retainer is installed. The PCM is reprogrammed and coolant level sensor operation is validated. The dipstick is replaced and an oil identification label is attached to the engine cover to complete the repair.

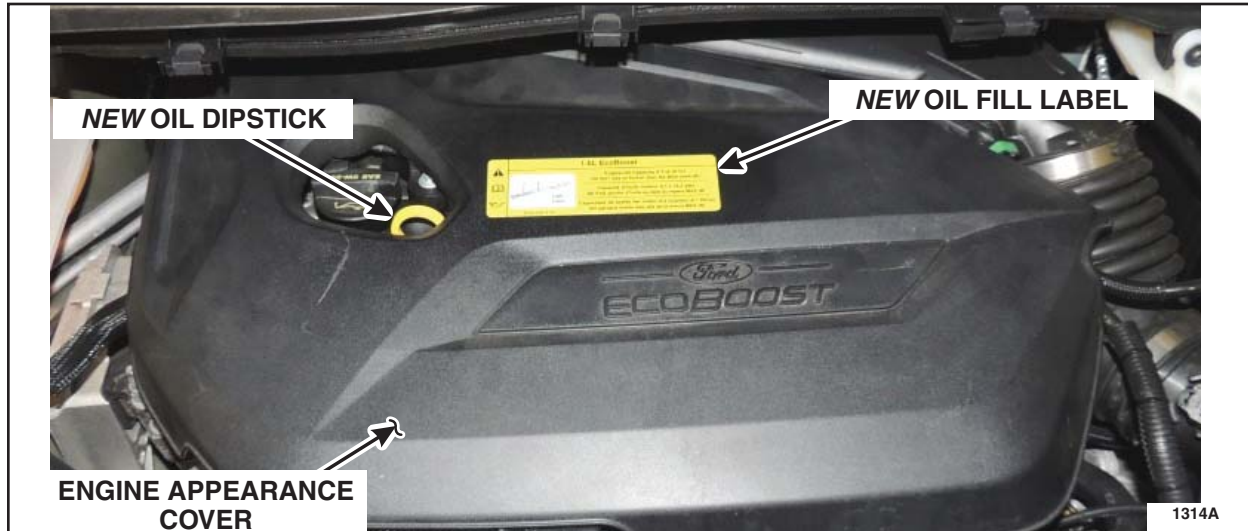
FIGURE N3

16. Clean the area on the engine appearance cover that the *new* engine oil fill label will be installed. Use Motorcraft® Metal Brake Parts Cleaner (PM-4-A or PM-4-B), and allow to dry. See Figure N3.

17. Install the *new* engine oil fill label onto the engine appearance cover as shown. See Figure N3.

18. Replace the vehicle's engine oil dipstick with the *new* engine oil dipstick. See Figure N3.

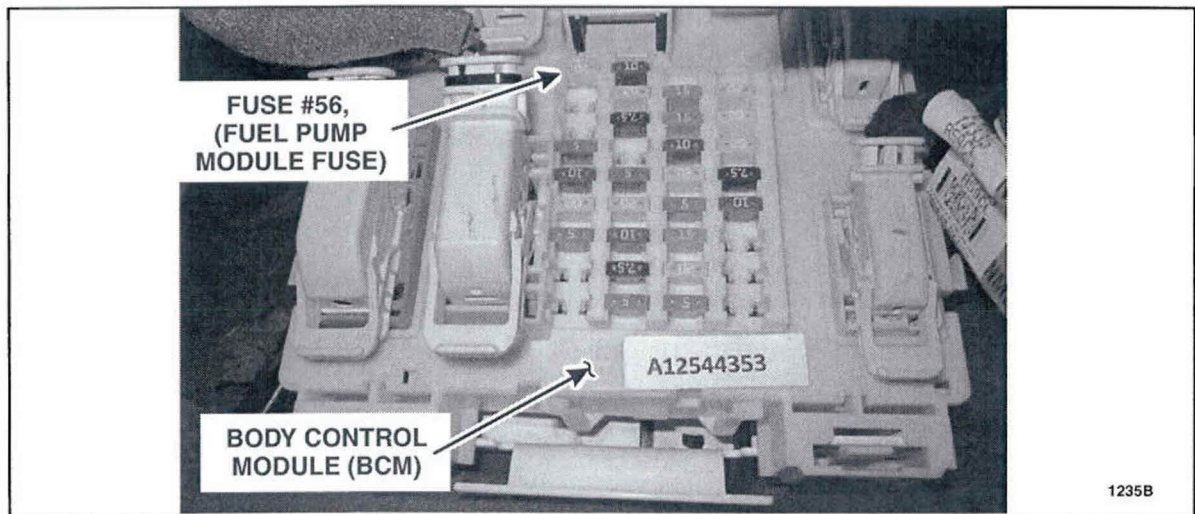
FIGURE 6

2. Remove Fuse #56 (Fuel Pump Module fuse), from the BCM. See Figure 6.
