Service Information

B65 06 14

Recall Campaign 13V-564: E90, E91 Front Passenger Airbag Seat Occupancy Sensor Mat

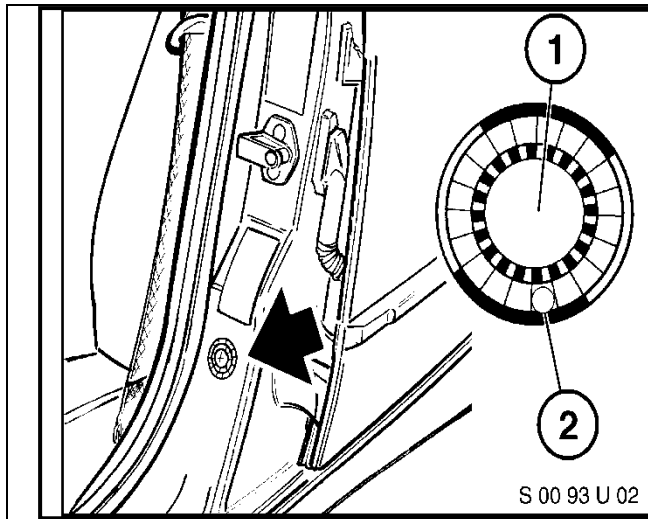
LABEL INSTRUCTIONS

This Recall has been assigned code number **678**. After the vehicle has been checked and/or corrected, obtain a label (SD 92-431) and:

- A. Emboss your BMW center warranty number in the middle of the label (1);
- B. Punch out code number **678** (2), printed on the label; and
- C. Affix the label to the B-pillar as shown.
