SUBJECT: 2014-2015 Mazda6 and 2014 Mazda3 equipped with 2.5L Engine and i-ELOOP – Charging System Issue Safety and Emission Recall 7314D

ATTACHMENT I - DEALER SERVICE INFORMATION
Safety & Emission Recall 7314D

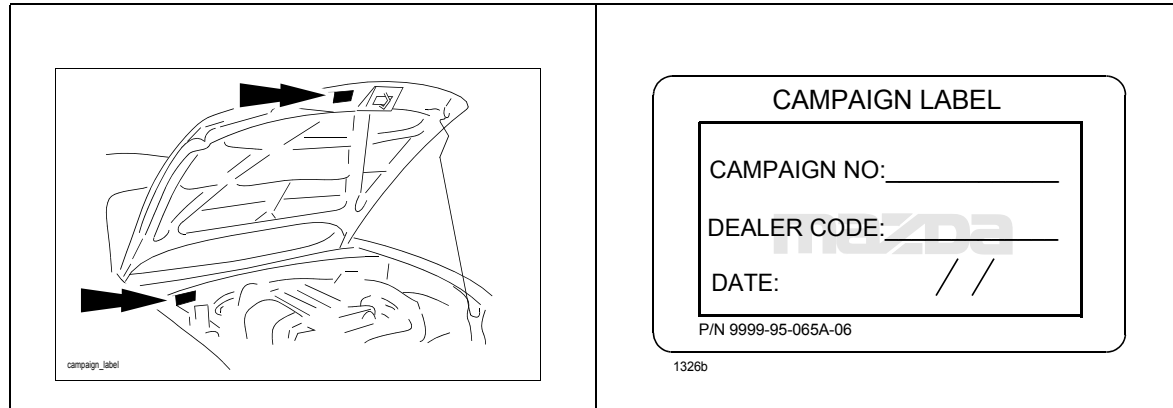
- If the vehicle is within one of the above VIN ranges, proceed to step 2.
 - If the vehicle is not within one of the above VIN ranges, return the vehicle to the customer or inventory.
2. Perform a Warranty Vehicle Inquiry using your eMDCS System and inspect vehicle for a Campaign Label **7314D** attached to the vehicle's hood or bulkhead. Refer to eMDCS System - Warranty Vehicle Inquiry Results table below.

NOTE: Verify Recall number as the vehicle may have multiple Recalls.

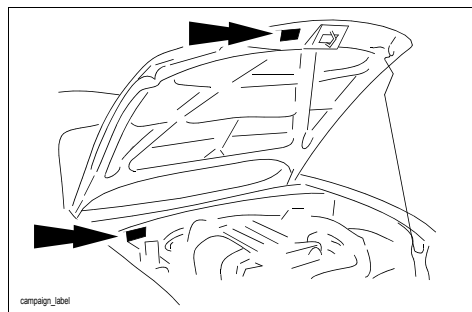
2. Affix it to the hood or bulkhead as shown:
