**SUBJECT: Safety Recall 14S05**

Certain 2008-2011 Model Year Escape and Mariner Vehicles  
Electric Power Steering

## Torque Sensor Replacement

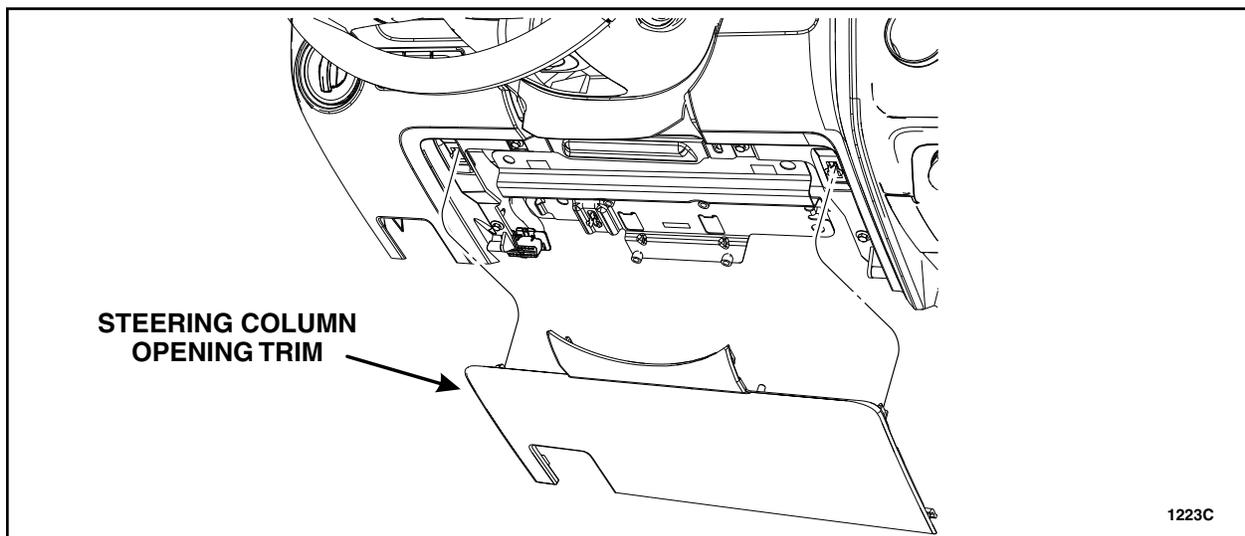
**FIGURE 1**

1. With the vehicle in NEUTRAL, position it on a hoist. For additional information, refer to WSM Section 100-02.
2. For ease of assembly, turn the steering wheel to the 11:00 o'clock position.
3. Hybrid vehicles: Depower the high-voltage traction battery. For additional information, refer to WSM Section 414-03.
4. Disconnect the 12V battery. For additional information, refer to WSM Section 414-01.
5. Remove the steering column opening trim. See Figure 1.

40. Install the steering column opening trim. See Figure 1.
41. Connect the 12V battery. For additional information, refer to WSM Section 414-01.
42. Hybrid vehicles: Repower the high-voltage traction battery. For additional information, refer to WSM Section 414-03.

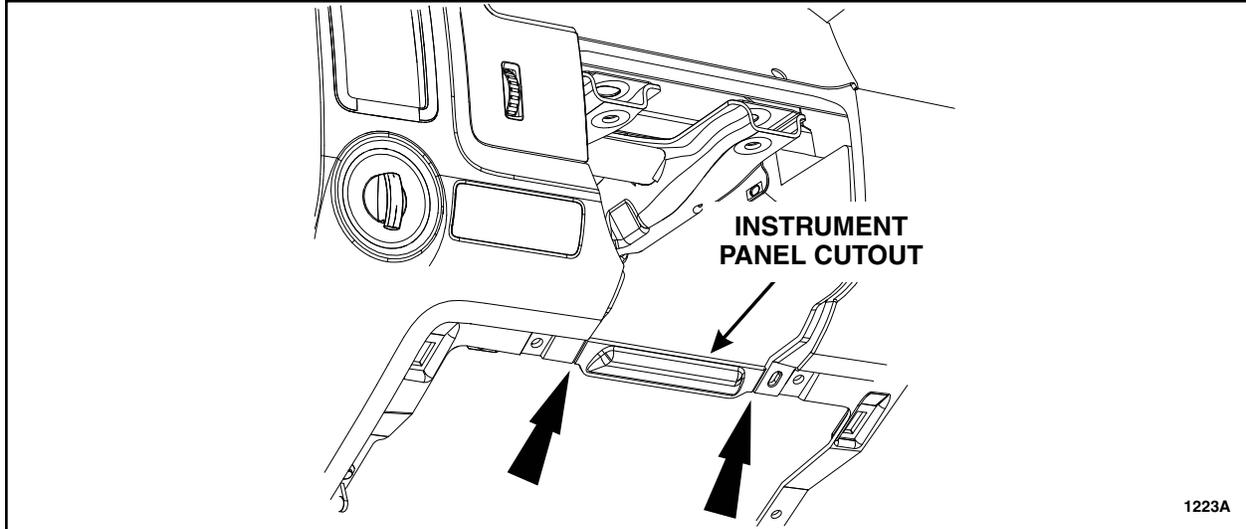
**FIGURE 2**

6. If present, use a suitable cutting tool to carefully cut through the two cutoff lines and discard the instrument panel cutout. See Figure 2.

**NOTE:** Steering column removed for clarity.

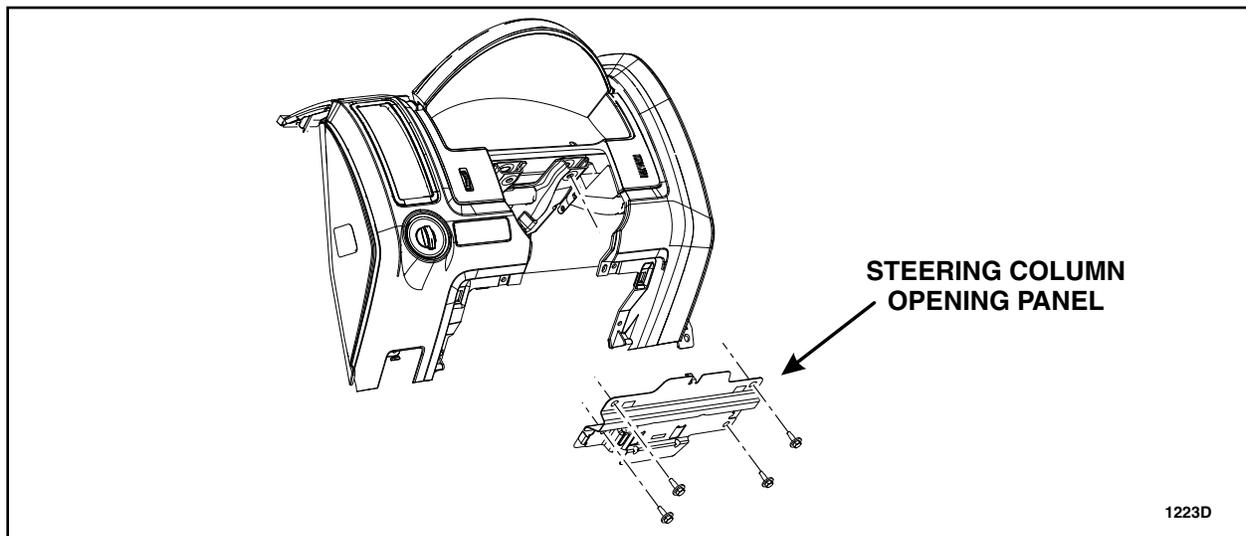
**FIGURE 3**

7. Remove the four bolts and the steering column opening panel. See Figure 3.

**NOTE:** Steering column removed for clarity.

38. Install the upper column shroud. See Figure 4.
39. Install the four bolts and the steering column opening panel. See Figure 3.
  - Tighten to 8 Nm (71 lb-in).

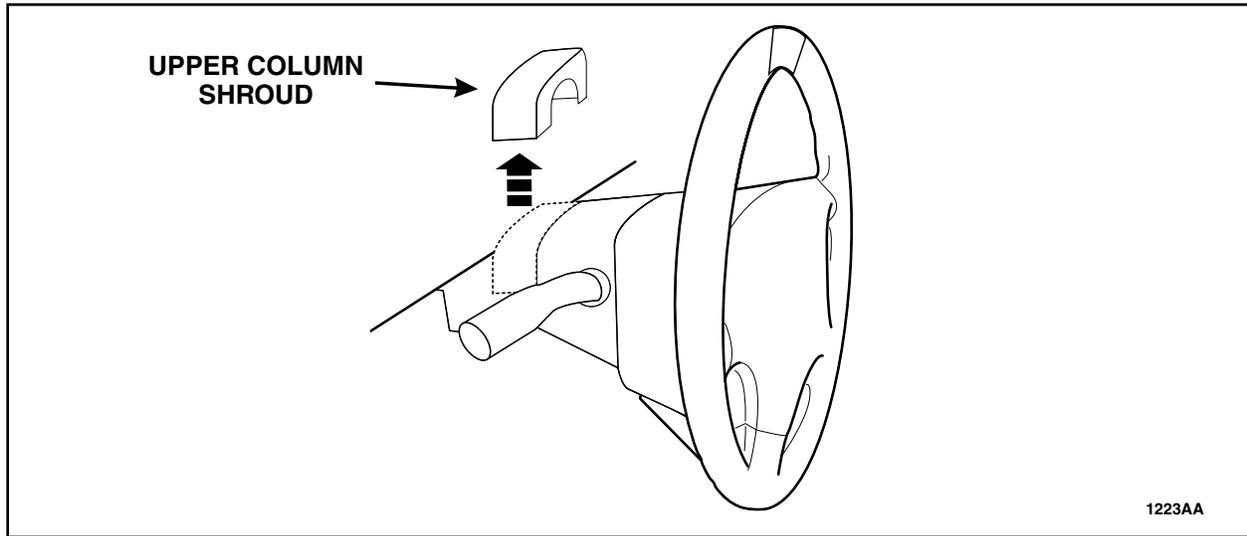
FIGURE 4

8. Pull up and remove the upper column shroud. See Figure 4.

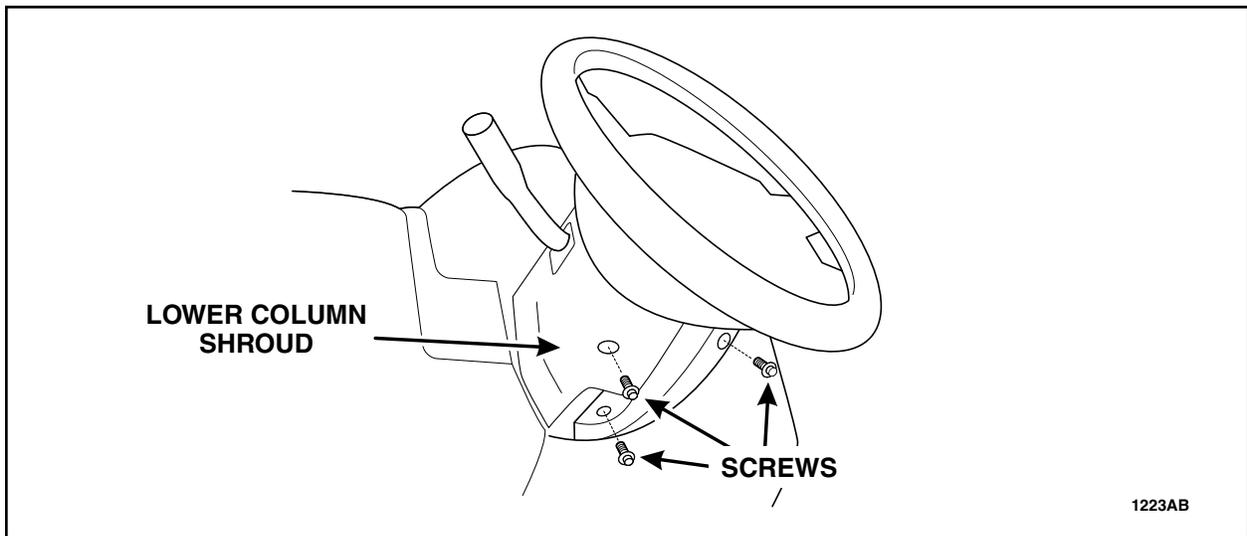
FIGURE 5

9. Remove the three machine screws and the lower column shroud. See Figure 5.

36. Connect the three connectors on the left side of the column. Install the two harness pin-type retainers. See Figure 6.
37. Install the lower column shroud and tighten the three machine screws. See Figure 5.

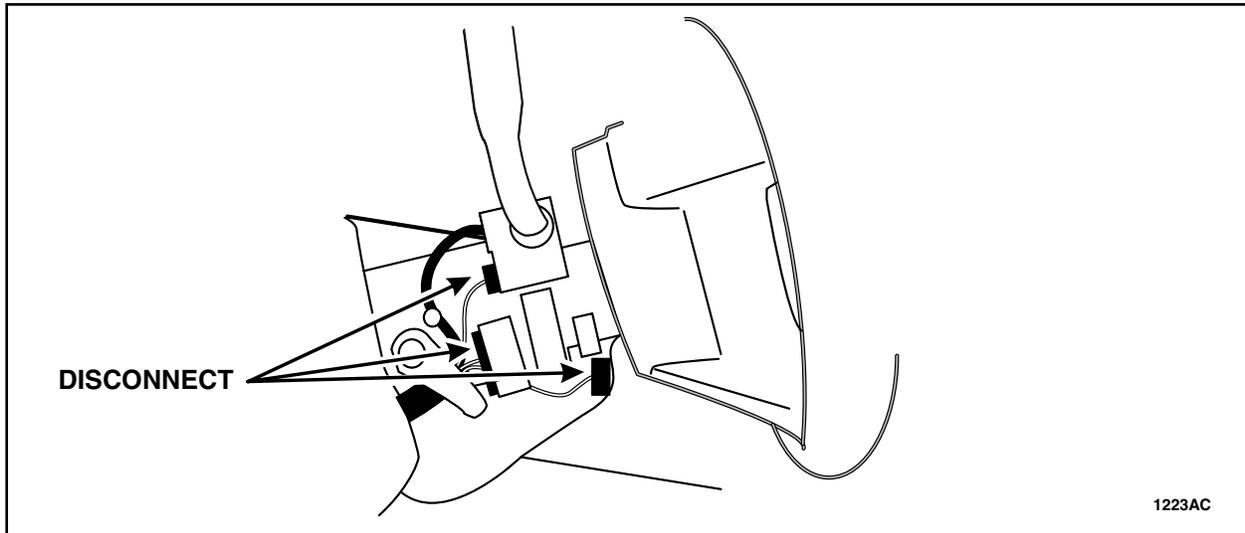
FIGURE 6

10. Disconnect the three connectors on the left side of the column. Remove the two harness pin-type retainers. See Figure 6.

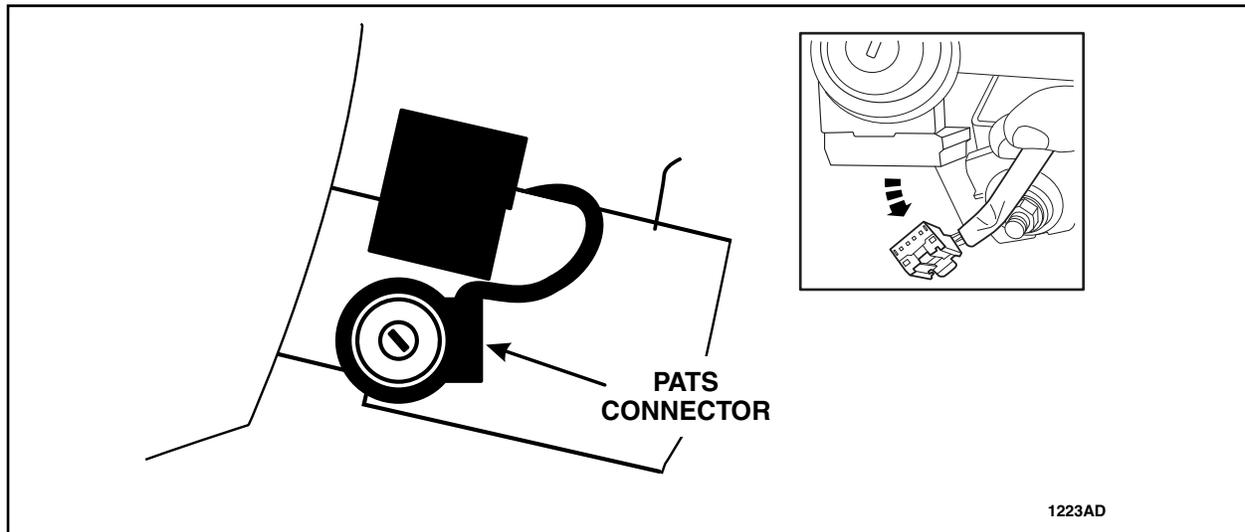
FIGURE 7

11. If equipped, disconnect the Passive Anti-Theft System (PATS) transceiver electrical connector. Remove the harness pin-type retainer and position the harness aside. See Figure 7.

34. Install two (2) new upper column bolts. See Figure 8.
  - Tighten bolts to 28 Nm (21 lb-ft).
35. If equipped, connect the PATS transceiver electrical connector. Reposition the harness and install the pin-type retainer. See Figure 7.

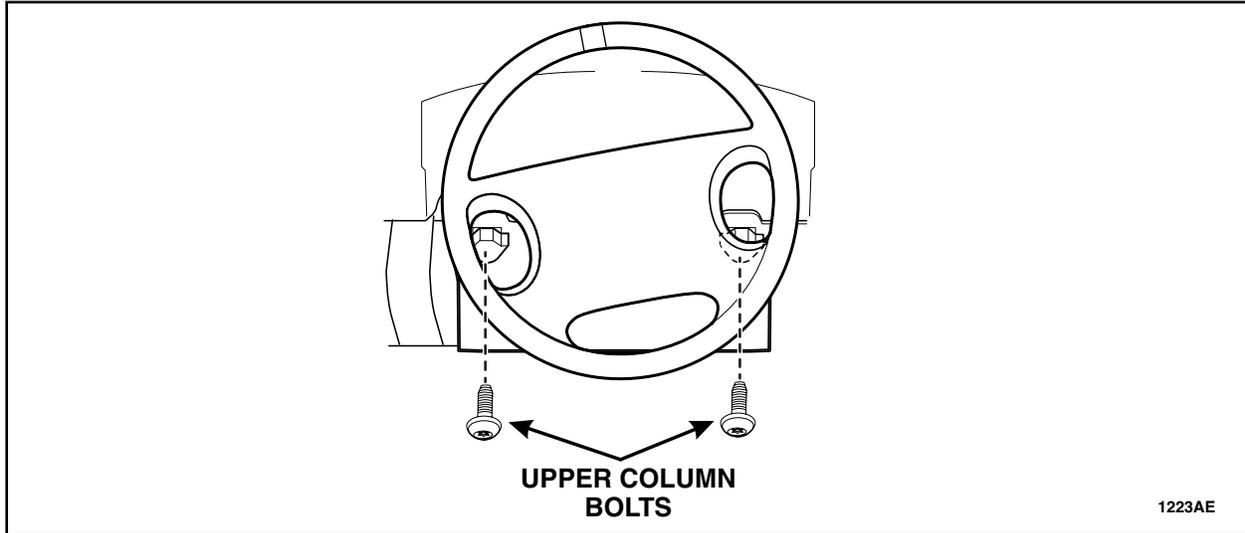
FIGURE 8

12. Remove and discard the two upper column bolts. See Figure 8.

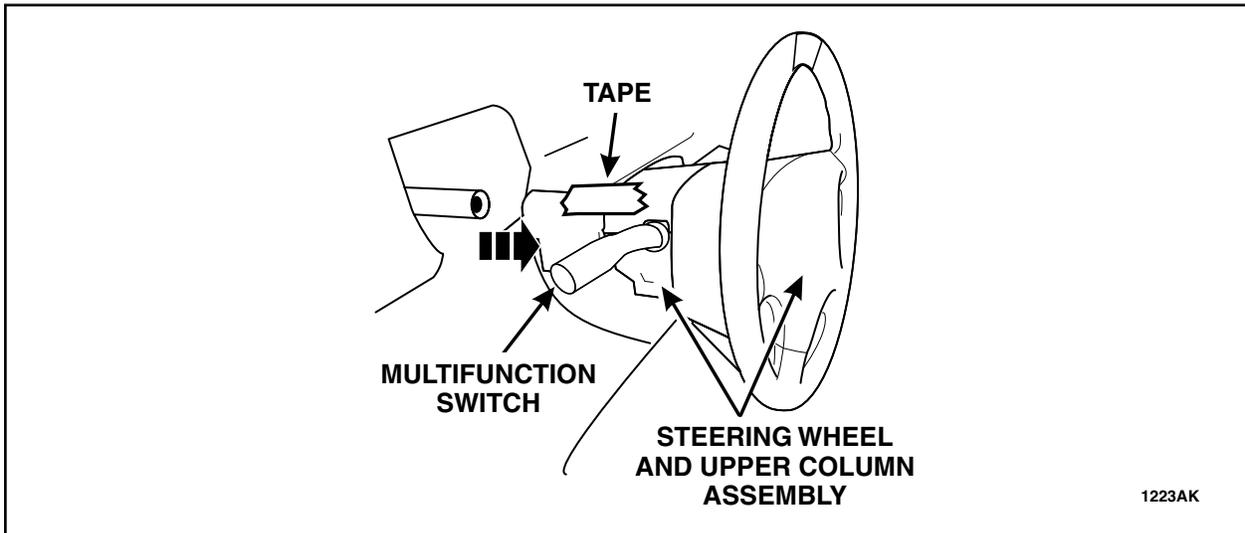
FIGURE 9

13. Tape the wheel to the Multifunction Switch (MFS) to prevent rotation of the wheel. Pull out and remove the steering wheel and upper column assembly as a single unit. See Figure 9.

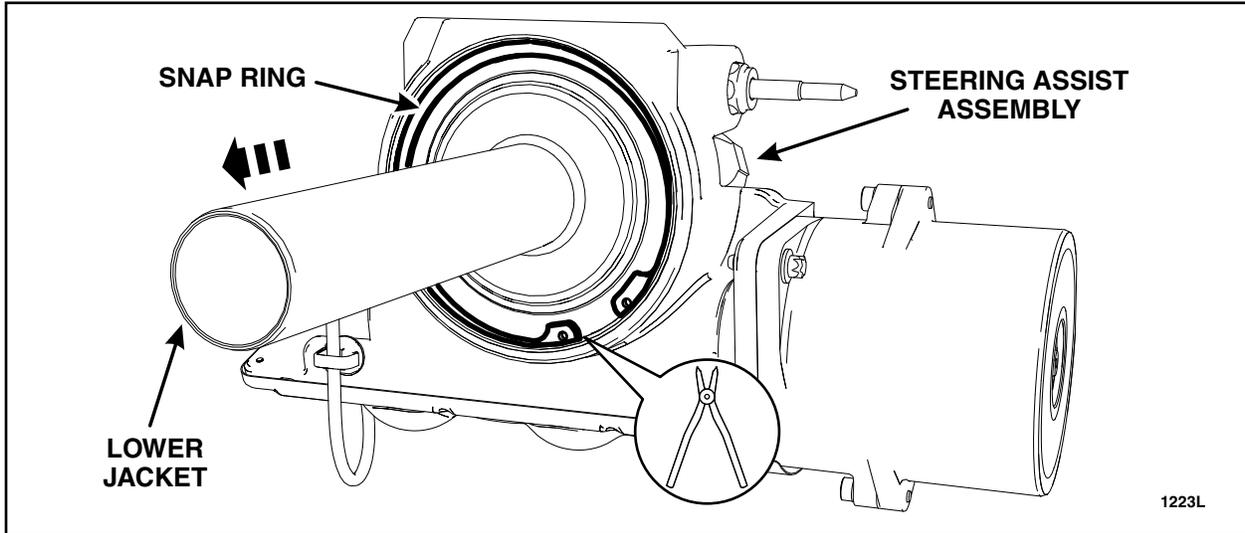
FIGURE 10

14. Remove the snap ring using Rotor Clip® RP-900 ratchet and grip ring pliers or equivalent. Remove the lower jacket. See Figure 10.

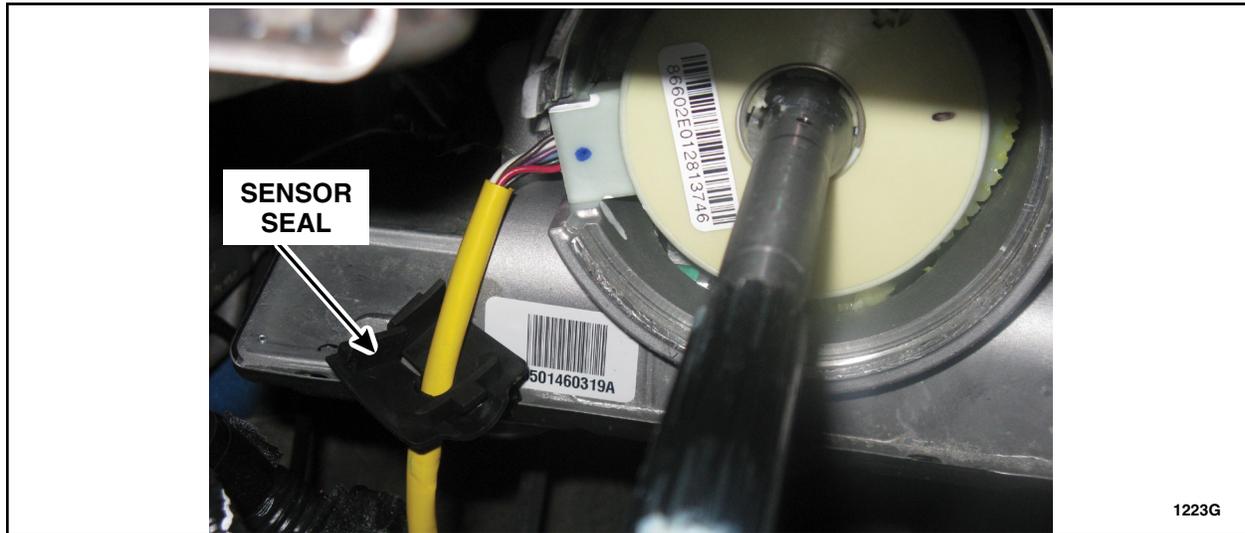
FIGURE 11

15. Remove the sensor seal from the steering assist assembly. See Figure 11.

29. Connect the torque sensor electrical connector and install the harness pin-type retainer.  
See Figure 12.
30. Reinstall the sensor seal onto the steering assist assembly. See Figure 11.
31. Install the lower jacket and the original snap ring bevel side up. See Figure 23.

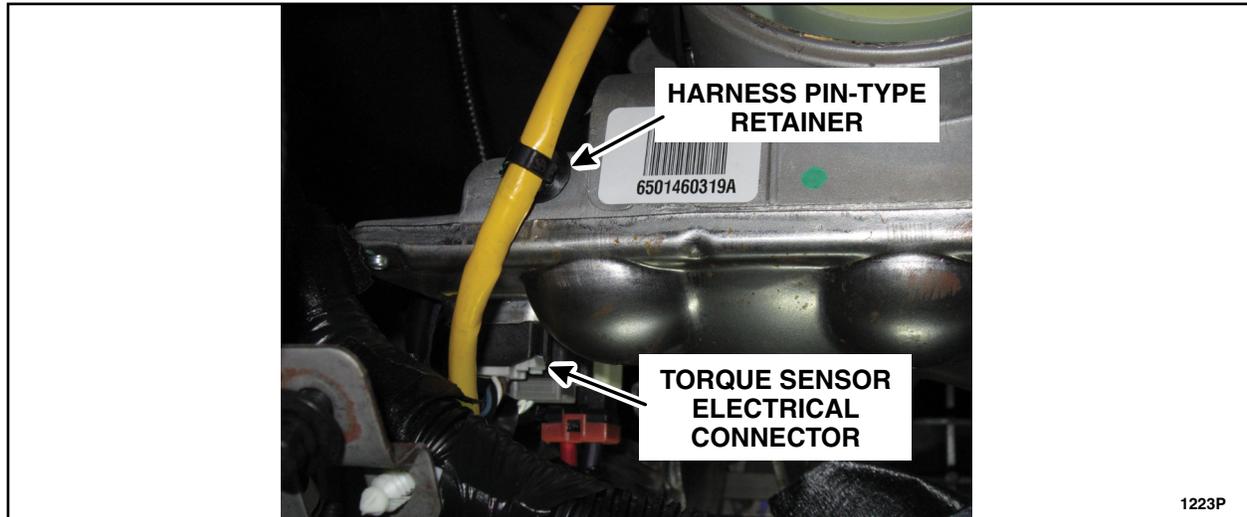
FIGURE 12

16. Disconnect the torque sensor electrical connector and remove the harness pin-type retainer.  
See Figure 12.

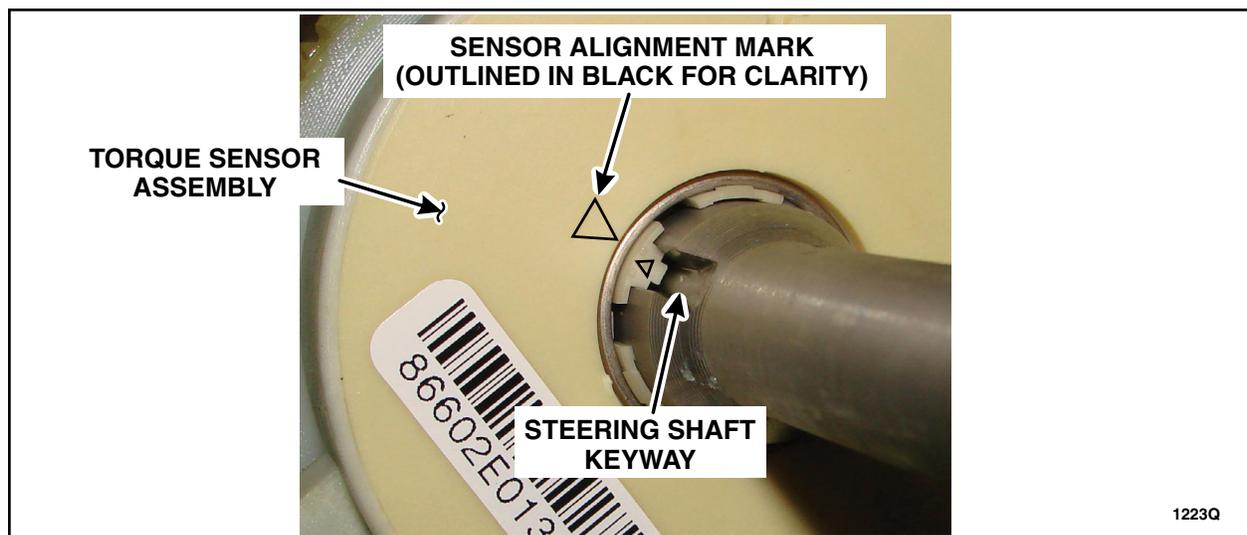
FIGURE 13

18. Before removing the old torque sensor assembly, verify the steering shaft keyway is aligned with the sensor alignment mark. This will ensure that the steering input shaft is in the correct position for installation of the sensor alignment tool. (If necessary, have an assistant bump the front tires left or right until the sensor is perfectly aligned.) See Figure 13.

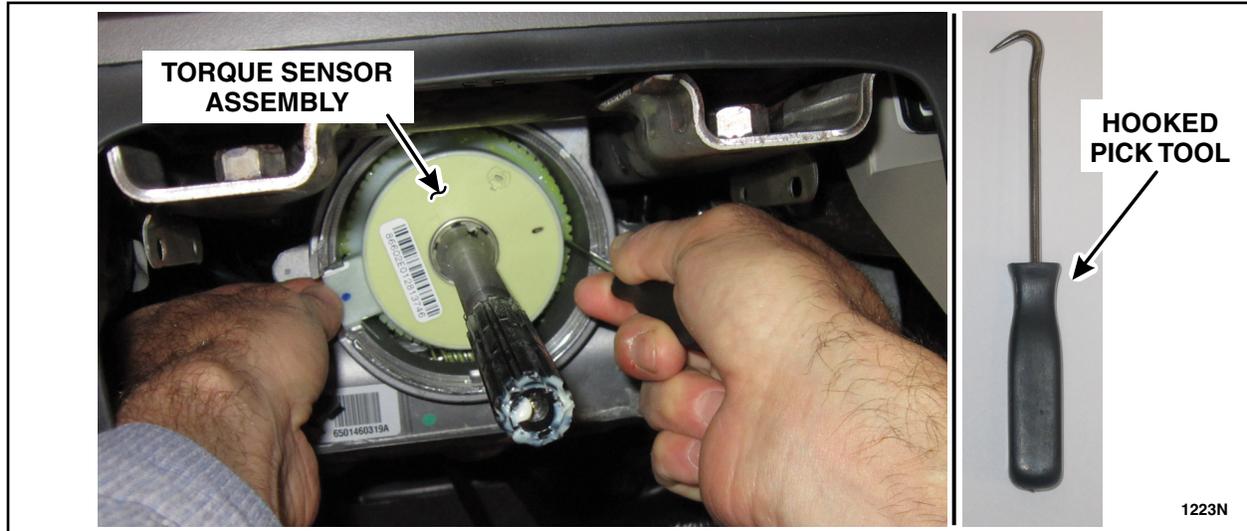
FIGURE 14

19. Prying gently from the back, remove the torque sensor assembly. Remove the sensor by gently pulling up on the sensor wires while using a hooked pick tool to lift the opposite side of the sensor. See Figure 14.

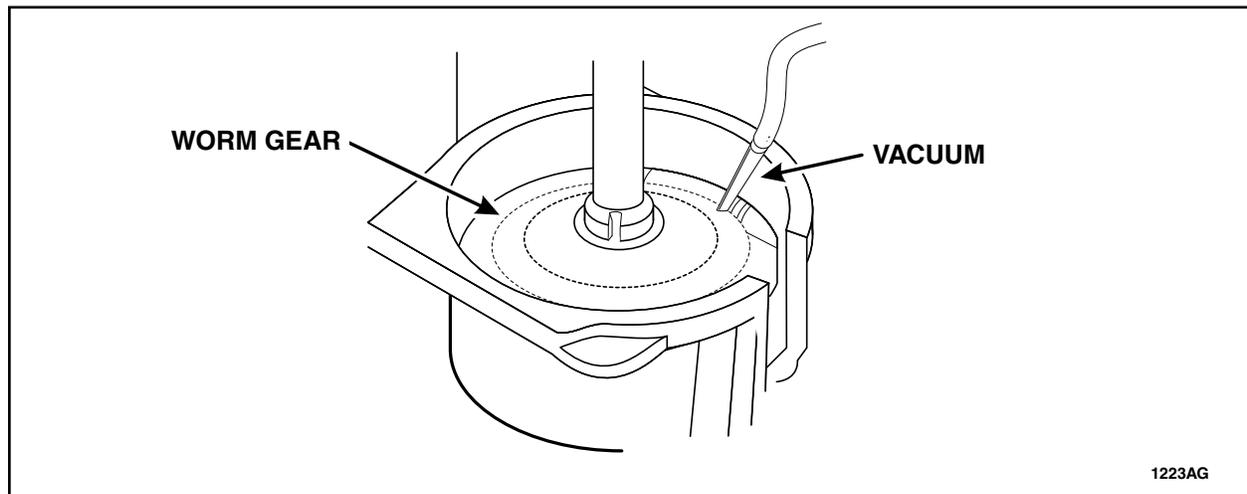
FIGURE 15

20. Inspect the underside of the sensor for damage. In case of breakage or damage, replace the steering column. For additional information, refer to WSM Section 211-04.
21. Vacuum the surface of the gear face to remove any contamination. Thoroughly vacuum the worm gear. See Figure 15.

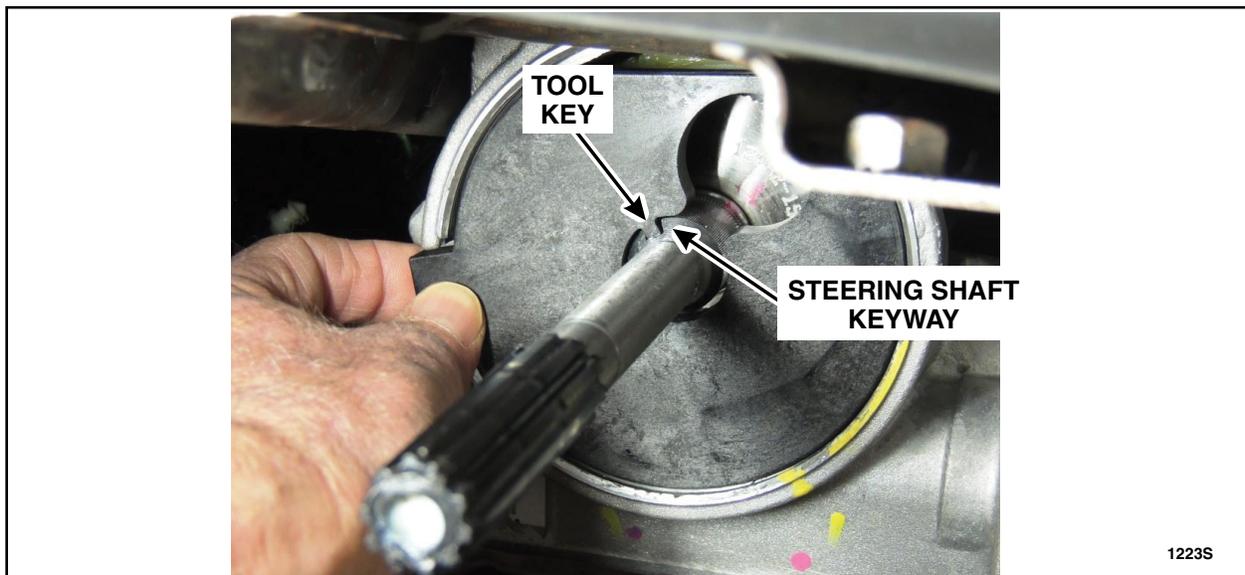
**FIGURE 16**

**NOTE:** Do not force tool into place, the tool must feel loose when in proper position.

22. Install the alignment tool. During installation of the tool, the tool key on the alignment tool should slide easily into the steering shaft key way. If there is any binding, have an assistant bump the tires slightly to the right or left again until the alignment tool falls into place. See Figure 16.

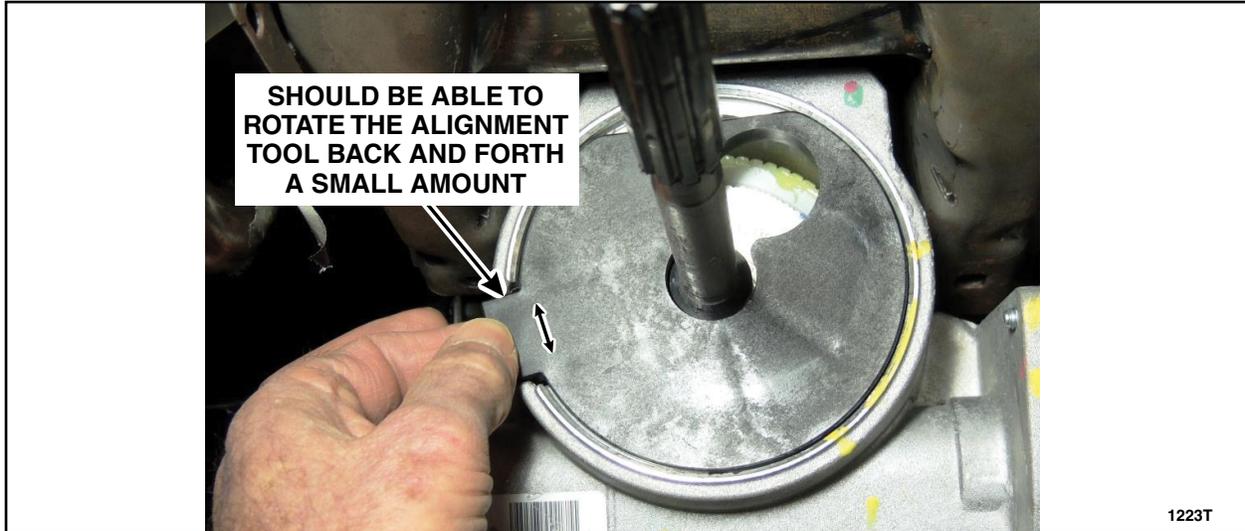
FIGURE 17

- If the alignment tool can freely rotate slightly in the clockwise and counter-clockwise direction, the tool is properly aligned. Proceed to Step 24. See Figure 17.
- If the alignment tool cannot freely rotate, the steering shaft is **is not** aligned. Have an assistant bump the tires slightly until the alignment tool can be rotated slightly.

**NOTE:** The alignment tool should not feel stiff while rotating. If it does, the steering shaft is not aligned.

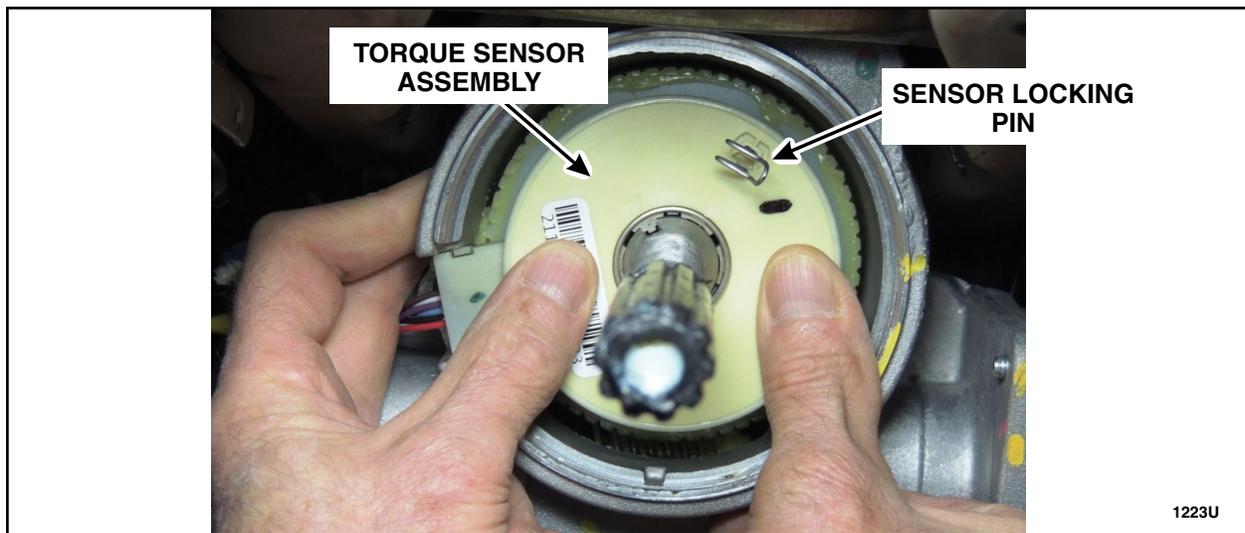
FIGURE 18

24. After the steering shaft is **perfectly** aligned with the spline on the alignment tool, remove the alignment tool and carefully install the torque sensor assembly with the locking pin still in place. When seating the torque sensor assembly, apply gentle but even force on both sides of the sensor (DO NOT REMOVE THE LOCKING PIN YET). See Figure 18.

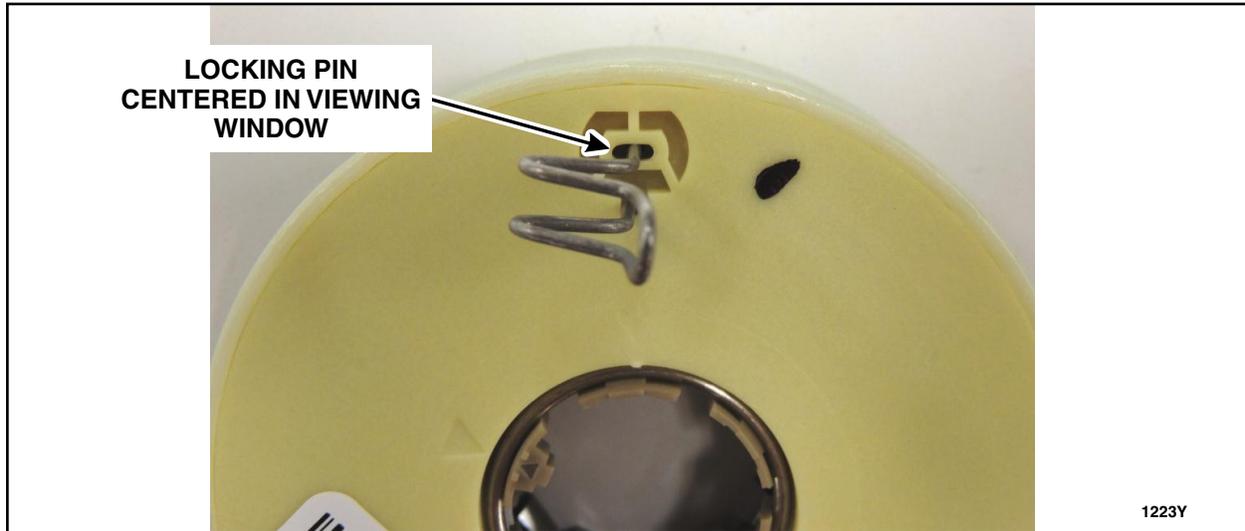
FIGURE 19

25. Ensure the locking pin is not shifted to one side of the sensor viewing window. The optimal position for the locking pin is centered in the viewing window. See Figure 19.

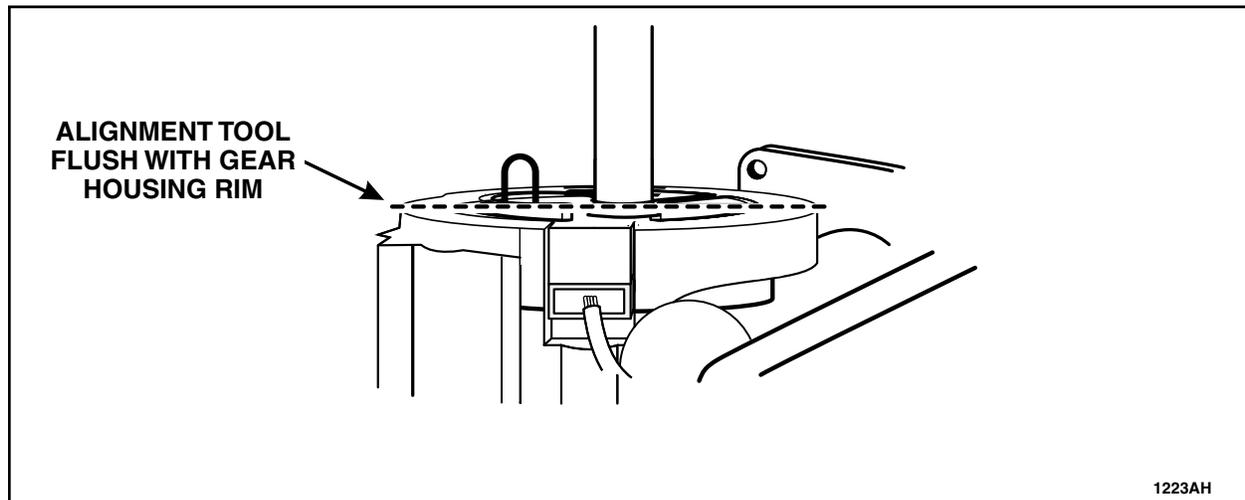
FIGURE 20

**NOTICE: DO NOT** push the torque sensor assembly past flush with the gear housing rim or damage to the sensor will occur.

Use the alignment tool to verify the torque sensor assembly is seated properly. The top of the alignment tool should be flush with gear housing rim. See Figure 20.

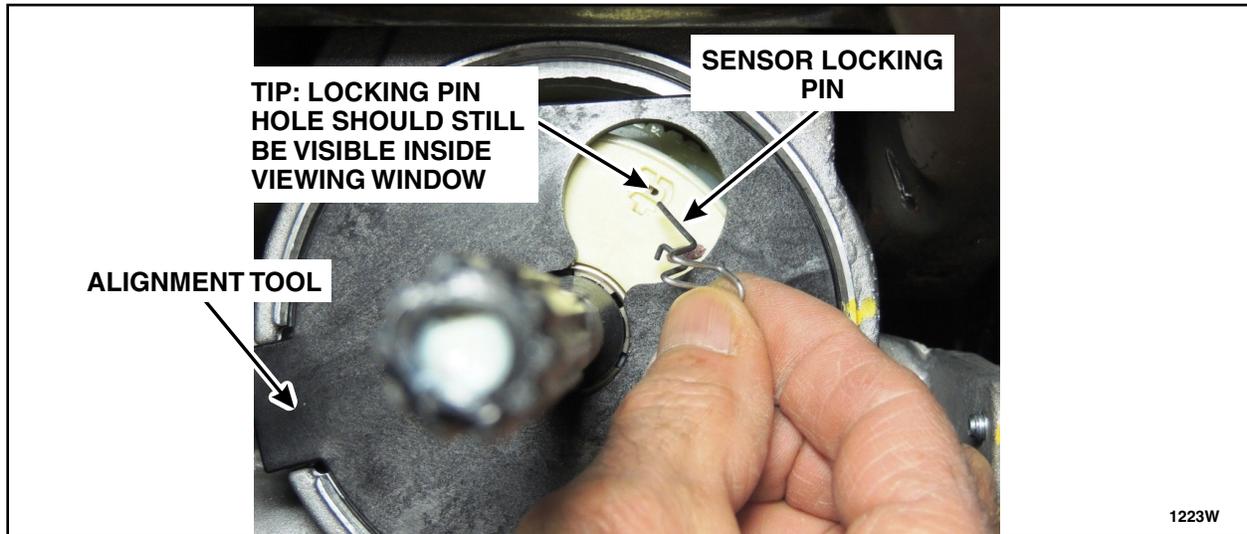
**FIGURE 21**

**NOTICE:** Do not drop the locking pin into the steering gear housing or damage may occur.

27. While the alignment tool is still in place, remove the locking pin, then remove the alignment tool.  
See Figure 21.

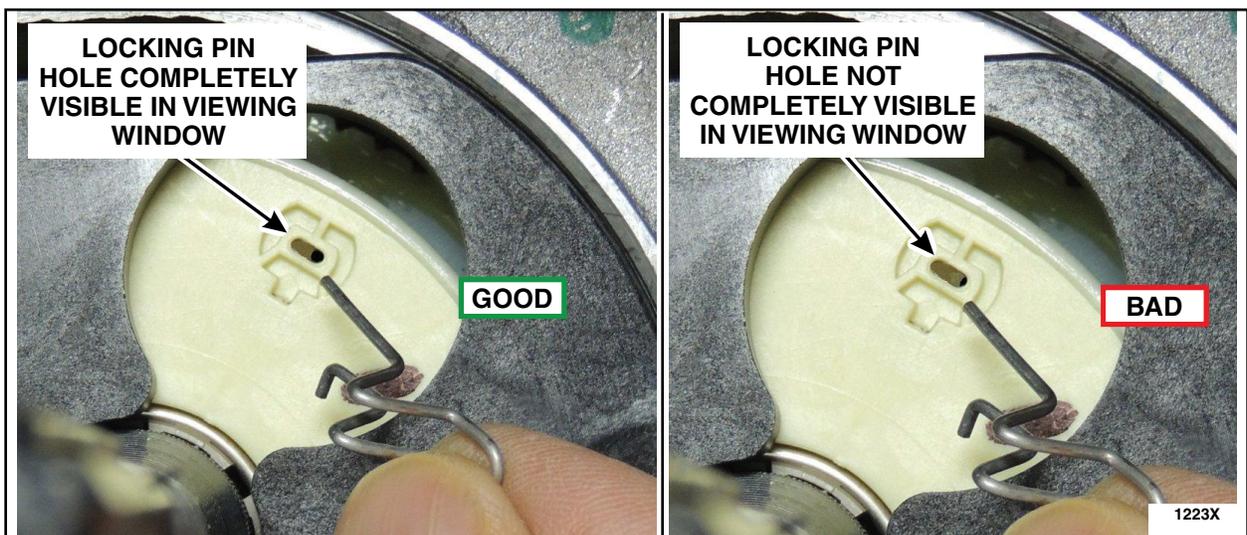
**FIGURE 22a**

**TIP:** When the locking pin is removed, the locking pin hole should still be visible inside the sensor viewing window. If the sensor was not properly aligned during installation, the locking pin hole will move out of view when the locking pin is removed.

- If the locking pin hole is completely visible (Figure 22a), the sensor is installed correctly. Proceed to Step 29.
- If the locking pin is not completely visible (Figure 22b), remove and discard the torque sensor. Obtain a new torque sensor and repeat Steps 22 through 28. See Figure 22a and 22b.

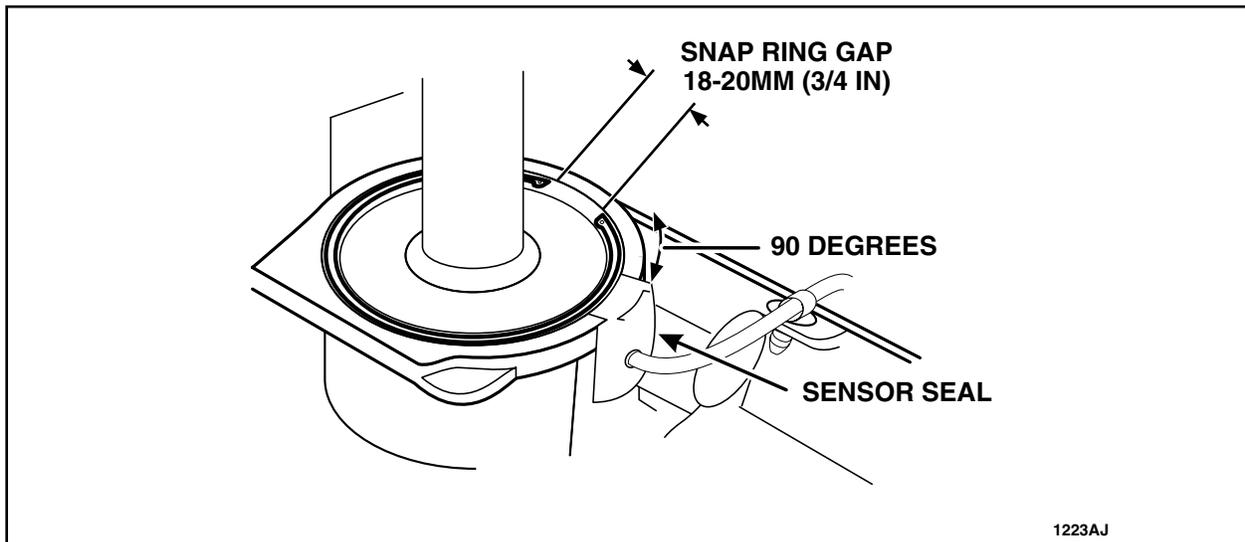
**FIGURE 24**

32. Ensure snap ring gap is positioned 90 degrees from sensor seal. Measure the gap between snap ring ears. Gap must be 18 - 20mm (3/4 in) to ensure snap ring is seated correctly.  
See Figure 24.
