TO: All Mazda Dealership General Managers, Service Managers, and Parts Managers
DATE: August 2014
SUBJECT: 2003-2004 Mazda6 and 2004 RX-8 Passenger Air Bag Safety Recall 7714F

Passenger-Side Air Bag Inflator Replacement Procedure:

**2003-2004 Mazda6 and 2004 RX-8
Front Passenger Air Bag - Safety Recall 7714F
NHTSA Campaign No. 14V-362**

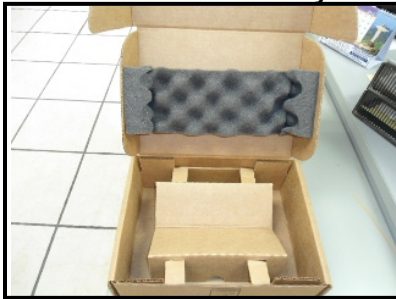
1. Use the carton the new inflator was shipped in. Place the undeployed air bag inflator in the “cradle” of the box insert. **Do not include any other hardware that may rattle, causing rejection of your shipment.**

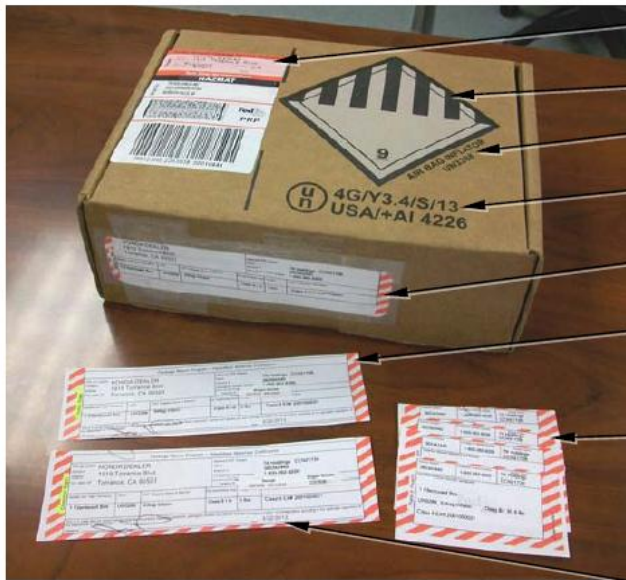
Top of Inflator Shipping Box and Form

FEDEX GROUND PRP SHIPPING LABEL

CLASS 9 HAZARD LABEL

PROPER SHIPPING NAME AND ID NUMBER

UN SPECIFICATION MARKING

CUSTOMER COPY OF OP-900PRP FORM

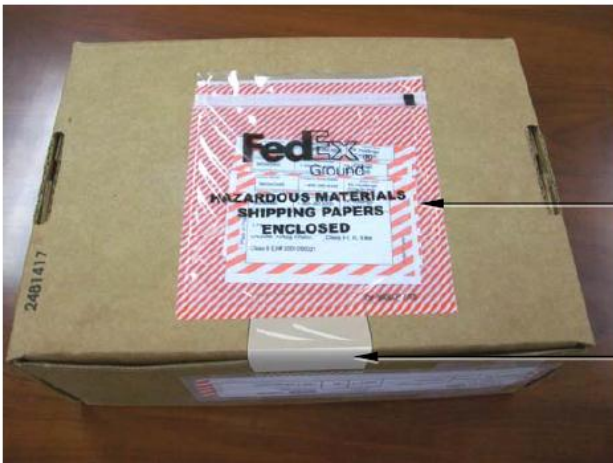
Bottom of Inflator Shipping Box

ADHESIVE POUCH CONTAINING ALL FOUR (4) BOTTOM LABELS FROM OP-900PRP FORM

STRIP OF CLEAR PACKING TAPE (enhanced in this photo)
