**Recall Campaign 14V-650: Replace Left Rear Seat Frame**

F15 (X5)

Replace the left rear seat frame. Refer to the B520114 attachment for ISTA Repair Instruction 52 26...

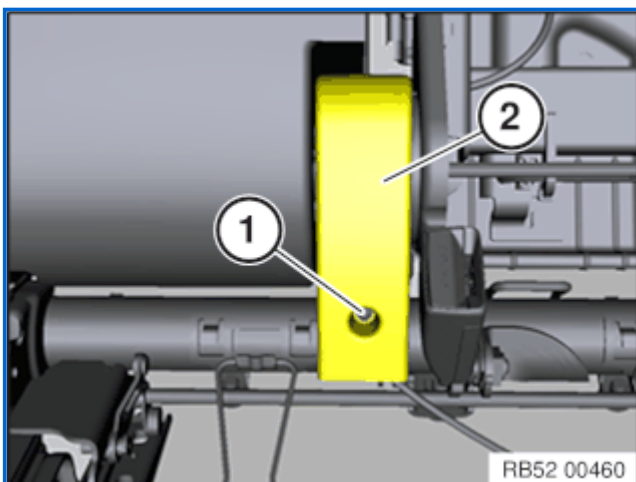
Release screw (1).

Unclip cover (2) towards front.

Release screws (1).

Tightening torque [52 26 27AZ](#).

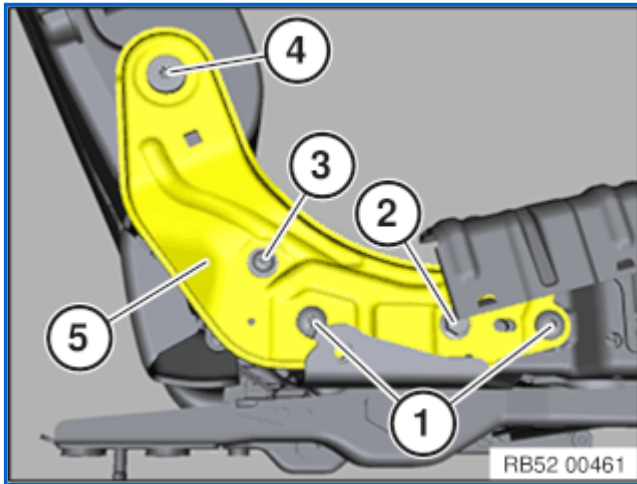
Release screw (2).

Tightening torque [52 26 28AZ](#).

Release screw (3).

Tightening torque [52 26 29AZ](#).

Release screw (4).

Tightening torque [52 26 31AZ](#).

Remove rail (5) to the side.

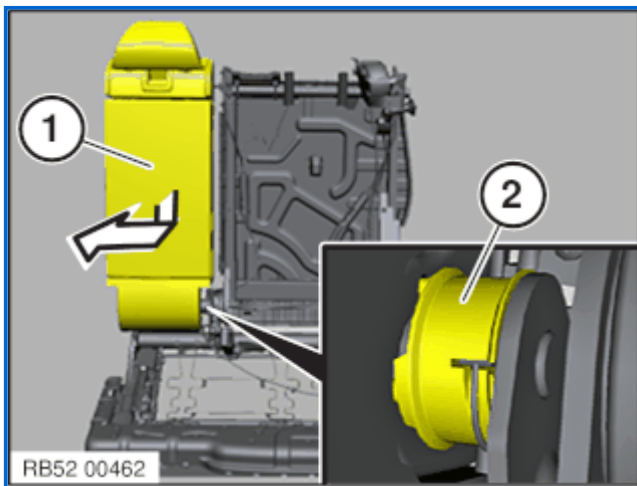
Fold centre backrest (1) forwards and feed out of the seat mechanism to the left.

*Note:*

Mounting for Bowden cable (2) is pre-tensioned.

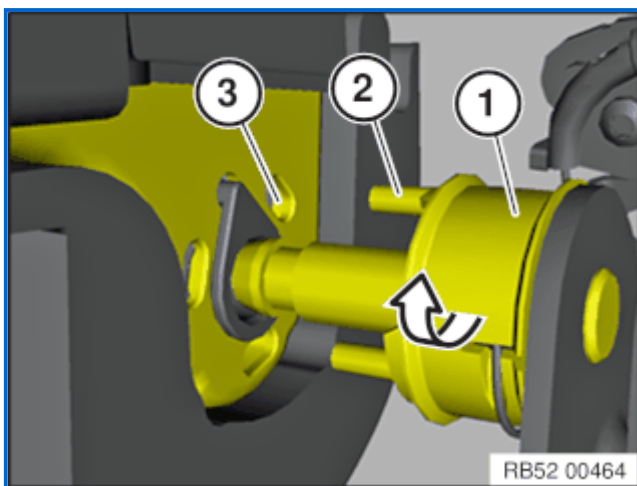
*Installation note:*

Mounting (1) is coded against incorrect assembly.

Twist mounting (1) in direction of arrow until guides (2) are fed into the corresponding openings (3).

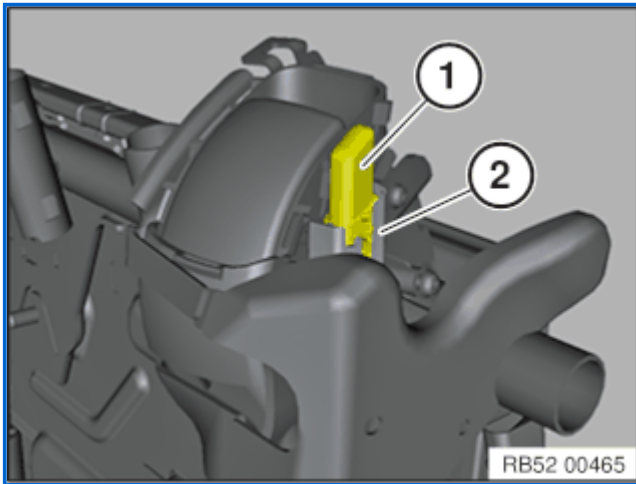
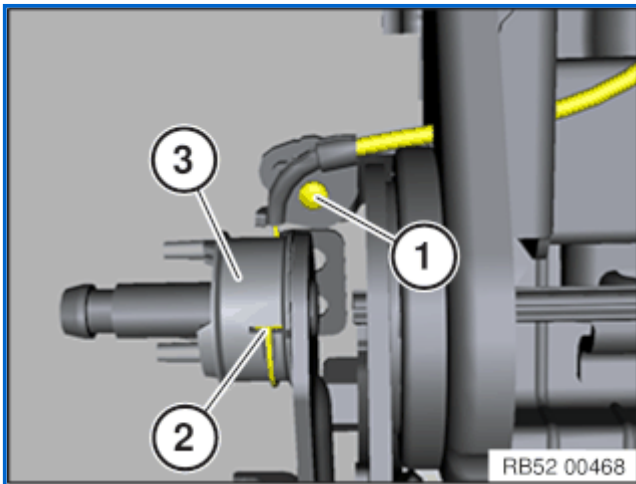
*Installation note:*

Pin (1) correctly attached in guide (2).

Release screw (1) and detach Bowden cable guide.

Feed Bowden cable (2) out of mounting (3).

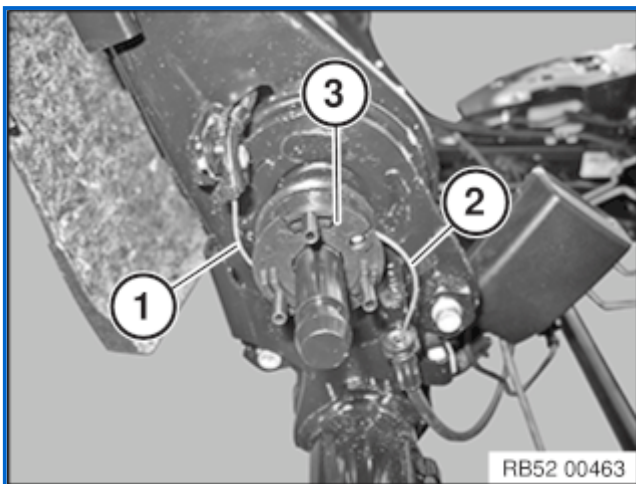
*Installation note:*

Attach Bowden cables (1 and 2) correctly in mounting (3).

Release screws (1).

Tightening torque [52 26 30AZ](#).

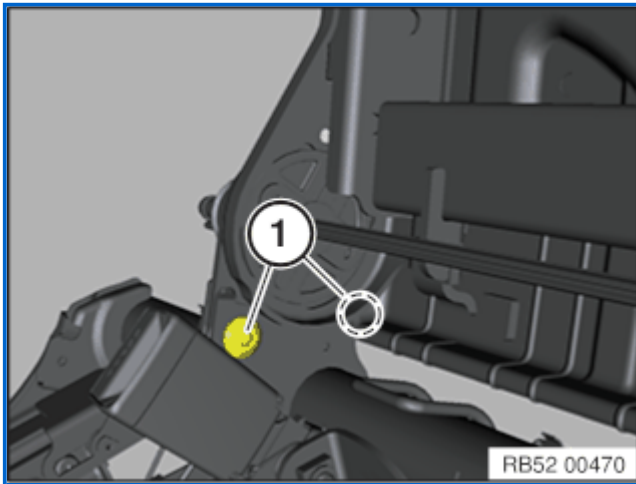
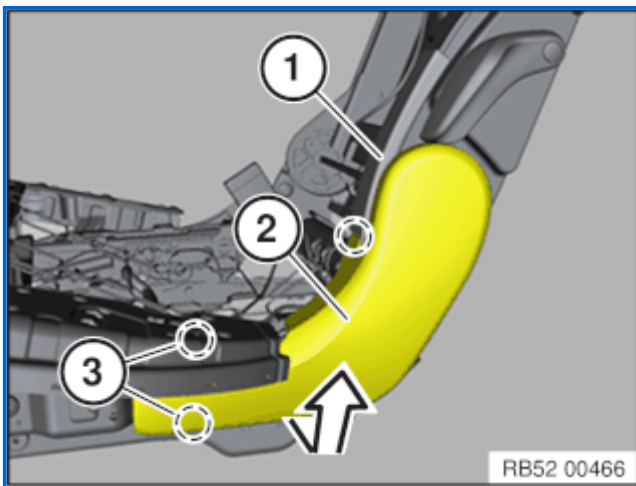
Detach slide (1) from cover (2) in the marked area.

Release screws (3) and feed out the cover (2) upwards and to the rear.

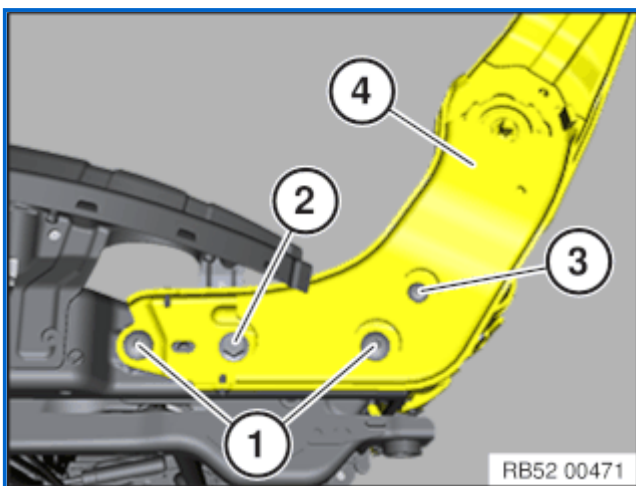
Release screws (1).

Tightening torque [52 26 27AZ](#).

Release screw (2).

Tightening torque [52 26 28AZ](#).

Release screw (3).

Tightening torque [52 26 29AZ](#).

Remove backrest frame (4) from seat mechanism.

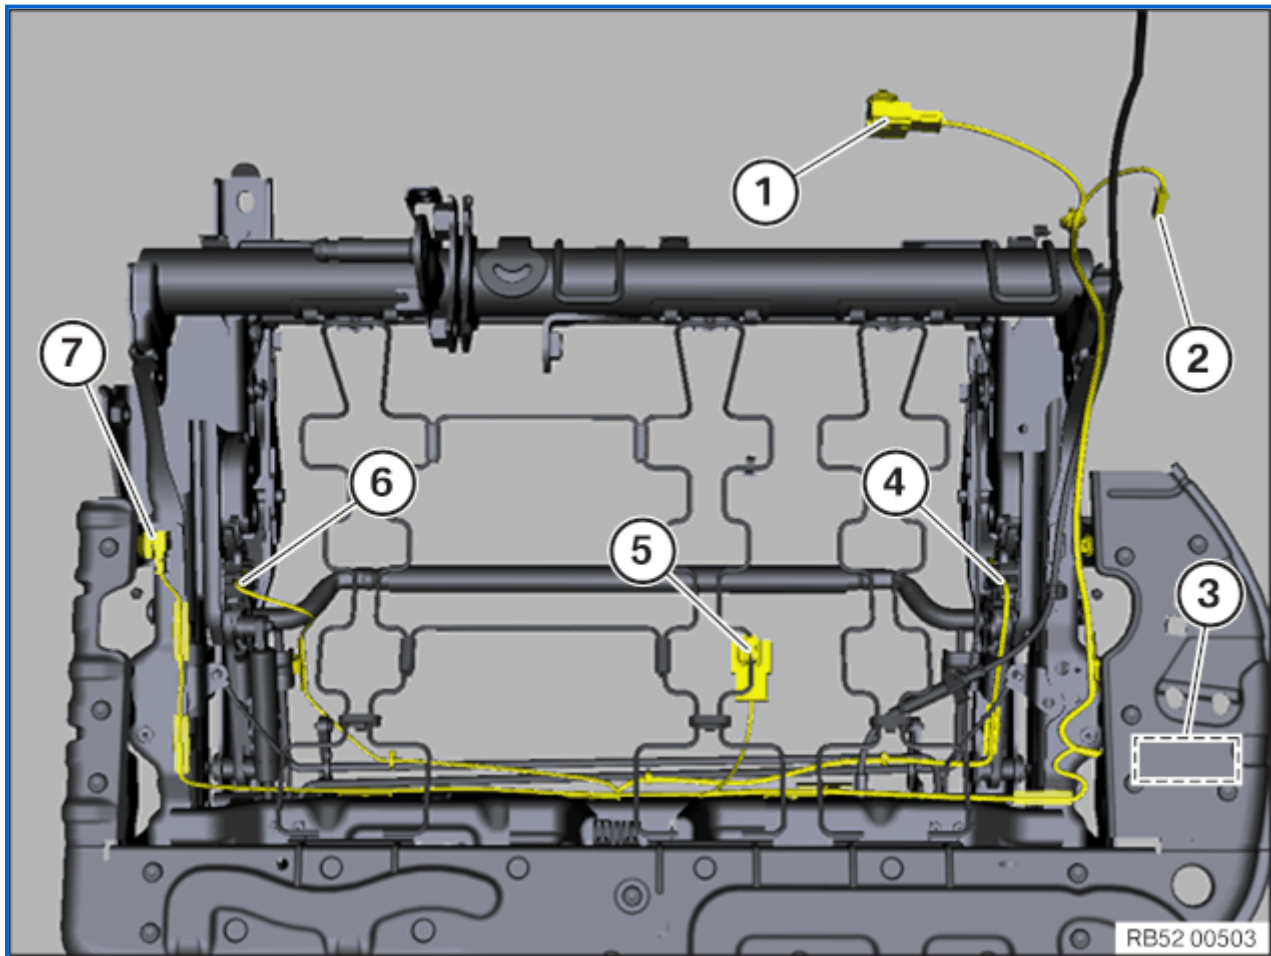
**Overview, plug connections:**

- 1 Seat heating, backrest
- 2 Microswitch, backrest angle adjustment
- 3 Module for seat heating
- 4 Microswitch for comfort entry on outer rear seat
- 5 Seat heating
- 6 Microswitch for comfort entry on inner rear seat
- 7 Seat belt buckle contact
