**Recall Campaign 14V-789: Program Body Domain Controller**

F56 (Cooper, Cooper S)

With automatic transmission

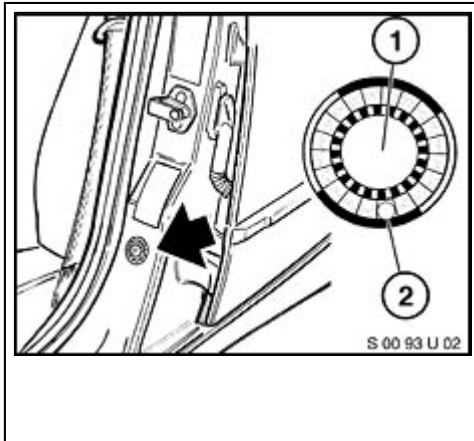
**LABEL INSTRUCTIONS**

<p>This Recall Campaign has been assigned code number <b>76</b>. After the vehicle has been checked and/or corrected, obtain a label (MD20-064) and:</p> <ol style="list-style-type: none"> <li>Emboss your MINI dealer warranty number in the middle of the label (1);</li> <li>Punch out code number <b>76</b> (2), printed on the label; and</li> <li>Affix the label to the <b>B</b>-pillar as shown.</li> </ol>
---	--

If the vehicle already has a label from a previous Service Action/Recall Campaign, affix the new label next to the old one. Do not affix one label on top of another one, because a number from an underlying label could appear in the punched-out hole of the new label.
