REF #: ICI21-023

**SUBJECT: Takata Airbag Inflator Returns Revision (FL684 & FL714)**

## Driver Air Bag Inflator Replacement

January 2021  
FL684A-D  
NHTSA #15V-361  
Transport Canada #15-257  
SIXTH REVISED NOTICE

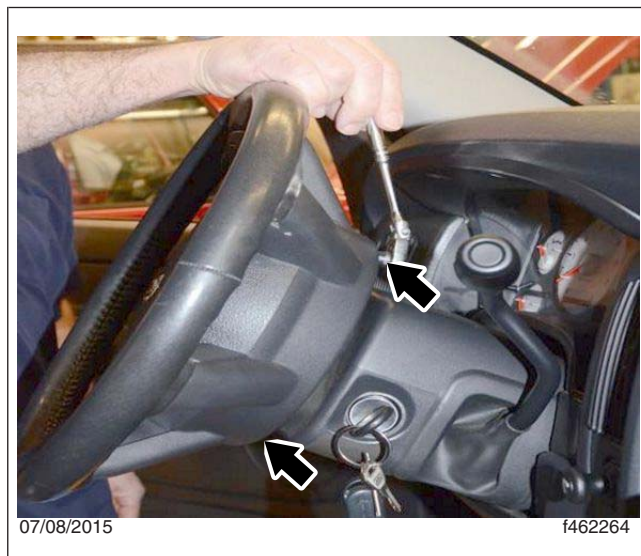
**Fig. 1, Driver Air Bag Screw Locations**

3. Disable the SRS, as follows:
  - 3.1 Disconnect and isolate the negative battery cable.
  - 3.2 Wait two minutes for the system capacitor to discharge before further service.
4. From the underside of the steering wheel, remove and save the two driver air bag screws that secure the driver air bag to the steering wheel armature. See [Fig. 1](#).

20. Carefully position the driver air bag in the steering wheel. Make sure that the clockspring pigtail wires and the steering wheel wire harness in the steering wheel hub area are not pinched between the driver air bag and the steering wheel armature.
21. Install the two screws that secure the driver air bag to the steering wheel armature. Tighten the screws 90 lbf-in (1000 N·cm) (Figure 1).
22. Perform the "Supplemental Restraint System (SRS) Verification Test," using the procedure below.

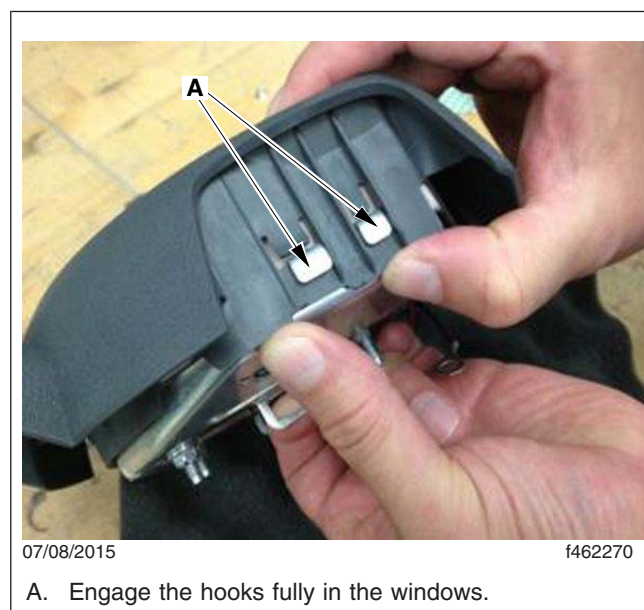
**Fig. 7, Inflator Assembly Hooks**

- 14.2 Pull on the inflator assembly to fully engage the windows and hooks on all sides. Make sure the hooks are fully engaged with the windows on all sides. See [Fig. 7](#).
