## Subject: Takata Driver Side Airbags

**Models Affected:** Specific model year 2008-2009 Sterling Bullet vehicles manufactured October 15, 2007, through November 10, 2008, with Takata Corporation driver side air bags.

December 2015  
FL684A  
NHTSA #15V-361  
Transport Canada #15-257  
SECOND REVISED NOTICE

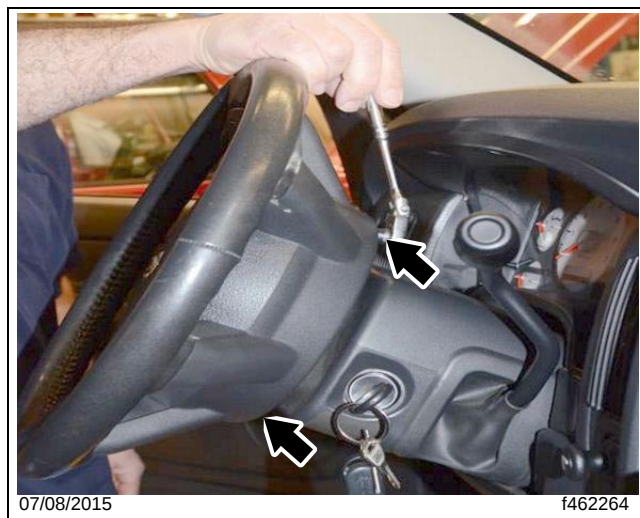
3. Disable the SRS, as follows:
  - 3.1 Disconnect and isolate the negative battery cable.
  - 3.2 Wait two minutes for the system capacitor to discharge before further service.
4. From the underside of the steering wheel, remove and save the two driver air bag screws that secure the driver air bag to the steering wheel armature. See **Fig. 1**.

**Fig. 1, Driver Air Bag Screw Locations**

21. Install the two screws that secure the driver air bag to the steering wheel armature. Tighten the screws 90 lbf-in (1000 N·cm) (Figure 1).
22. Perform the "Supplemental Restraint System (SRS) Verification Test," using the procedure below.

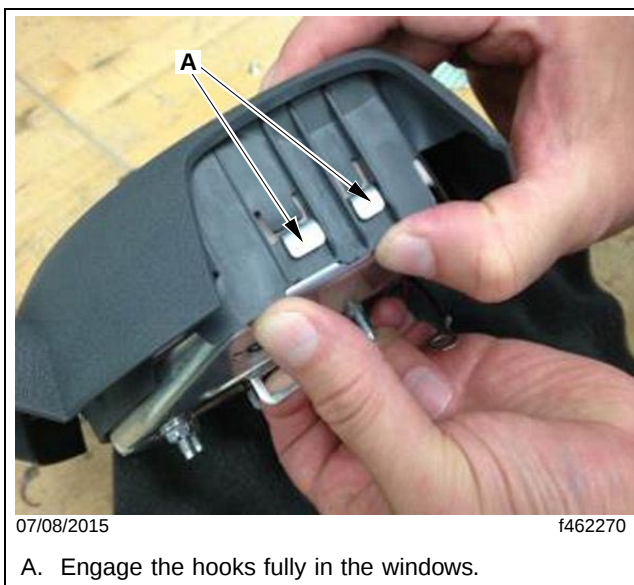
- 14.1 Insert the bottom hooks into the windows, then snap the remaining hooks on all sides into place.
    - 14.2 Pull on the inflator assembly to fully engage the windows and hooks on all sides. Make sure the hooks are fully engaged with the windows on all sides. See **Fig. 7**.

**Fig. 7, Inflator Assembly Hooks**

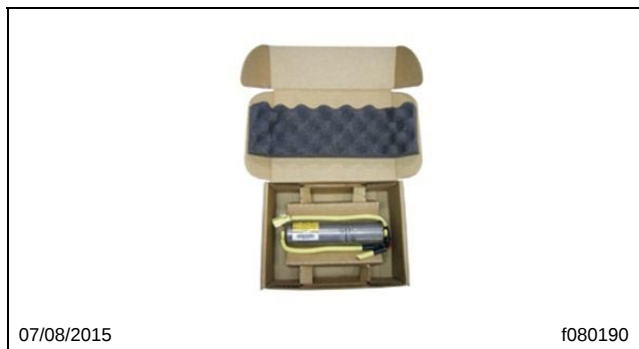
1. Package the un-deployed air bag inflator for return, using the replacement kit box.
  - 1.1 Confirm that the box is in acceptable condition. If a new box is needed, follow the procedure in "Requesting a New Box / Shipping Labels" at the end of these work instructions.
  - 1.2 Place the air bag inflator in the "cradle" of the box insert. See **Fig. 10**.
2. Close the box top flap, per box closure instructions located on front panel of the box. See **Fig. 11**.
3. Label each box as follows:

**Fig. 10, Packing the Inflator**

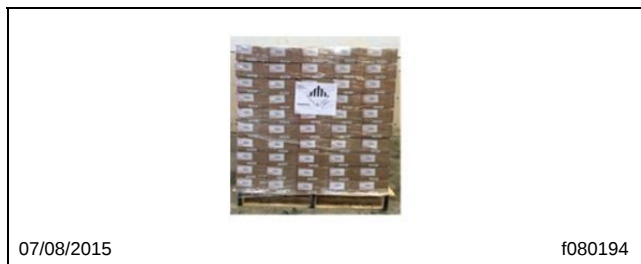
**Fig. 14, Preparing the Pallet**

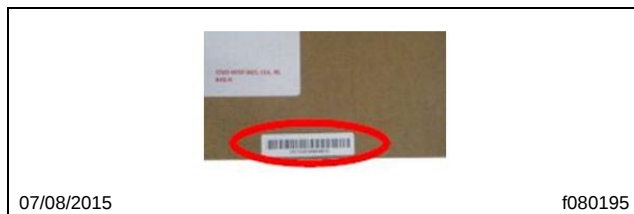
**Fig. 15, Box Serial Number**

- serial number on the original box ( **Fig. 15** )
- type of shipping material needed
