December 2015  
FL684A  
NHTSA #15V-361  
Transport Canada #15-257  
REVISED NOTICE

## Subject: Takata Driver Side Airbags

**Models Affected:** Specific model year 2008-2009 Sterling Bullet vehicles manufactured October 15, 2007, through November 10, 2008, with Takata Corporation driver side air bags.

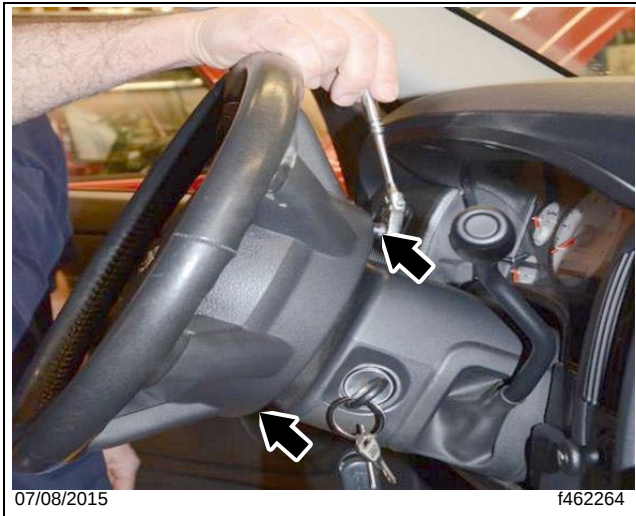
**Fig. 1, Driver Air Bag Screw Locations**

3. Disable the SRS, as follows:
  - 3.1 Disconnect and isolate the negative battery cable.
  - 3.2 Wait two minutes for the system capacitor to discharge before further service.
4. From the underside of the steering wheel, remove and save the two driver air bag screws that secure the driver air bag to the steering wheel armature. See **Fig. 1**.

21. Install the two screws that secure the driver air bag to the steering wheel armature. Tighten the screws 90 lbf-in (1000 N·cm) (Figure 1).
  22. Perform the "Supplemental Restraint System (SRS) Verification Test," using the procedure below.

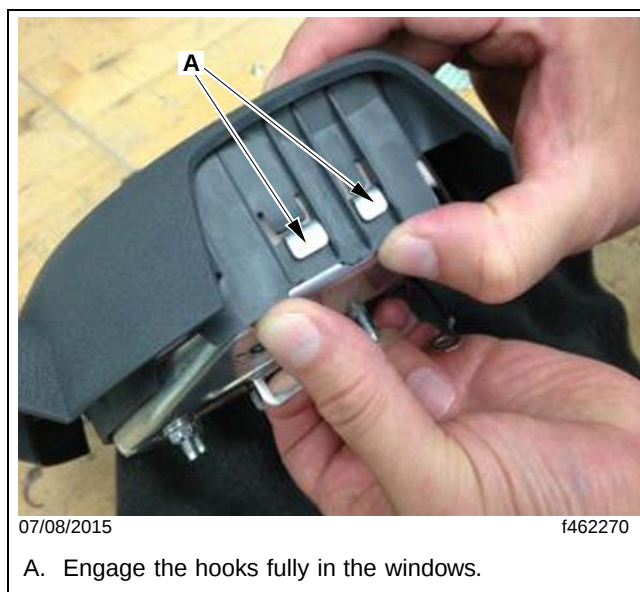
**Fig. 7, Inflator Assembly Hooks**

- 14.2 Pull on the inflator assembly to fully engage the windows and hooks on all sides. Make sure the hooks are fully engaged with the windows on all sides. See **Fig. 7**.

14. Install the new inflator assembly on the original driver air bag cover as follows:
    - 14.1 Insert the bottom hooks into the windows, then snap the remaining hooks on all sides into place.

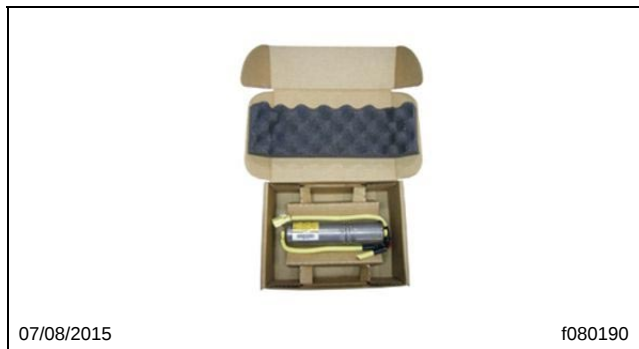
**Fig. 10, Packing the Inflator**

1. Package the un-deployed air bag inflator for return, using the replacement kit box.
  - 1.1 Confirm that the box is in acceptable condition. If a new box is needed, follow the procedure in "Requesting a New Box / Shipping Labels" at the end of these work instructions.
  - 1.2 Place the air bag inflator in the "cradle" of the box insert. See **Fig. 10**.
2. Close the box top flap, per box closure instructions located on front panel of the box. See **Fig. 11**.
3. Label each box as follows:
