October 2017  
FL684A-D  
NHTSA #15V-361  
Transport Canada #15-257  
FOURTH REVISED NOTICE

## **Subject: Takata Driver Side Airbags**

**Models Affected: Specific model year 2008-2009 Sterling Bullet vehicles manufactured October 15, 2007, through November 10, 2008, with Takata Corporation driver side airbags**

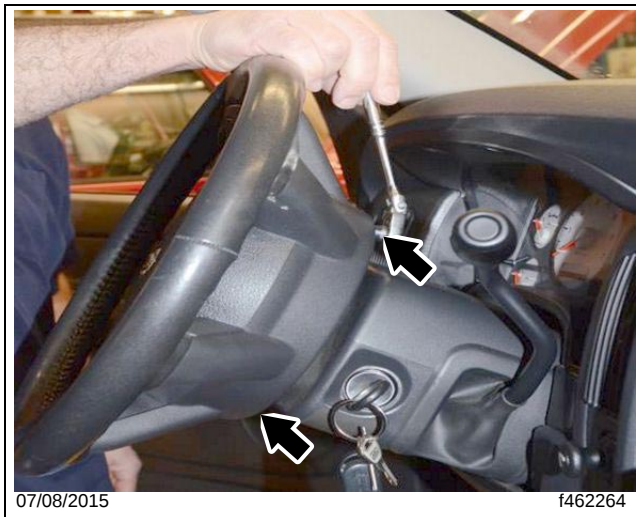
3. Disable the SRS, as follows:
  - 3.1 Disconnect and isolate the negative battery cable.
  - 3.2 Wait two minutes for the system capacitor to discharge before further service.
4. From the underside of the steering wheel, remove and save the two driver air bag screws that secure the driver air bag to the steering wheel armature. See **Fig. 1**.

Fig. 1, Driver Air Bag Screw Locations

21. Install the two screws that secure the driver air bag to the steering wheel armature. Tighten the screws 90 lbf-in (1000 N·cm) (Figure 1).
22. Perform the "Supplemental Restraint System (SRS) Verification Test," using the procedure below.

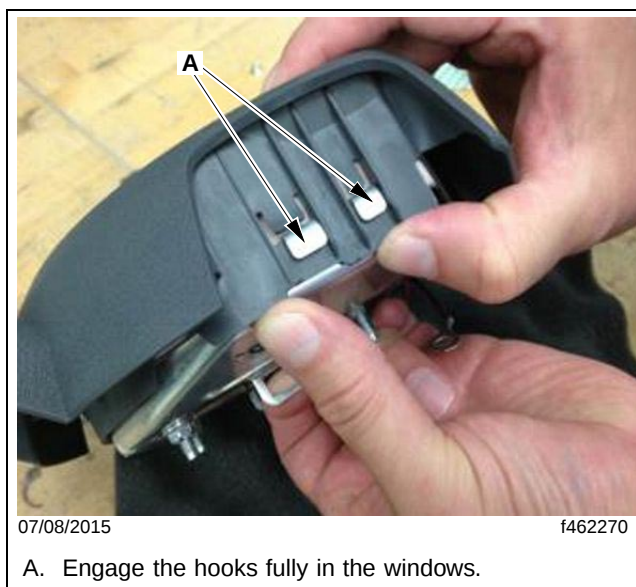
- 14.1 Insert the bottom hooks into the windows, then snap the remaining hooks on all sides into place.
    - 14.2 Pull on the inflator assembly to fully engage the windows and hooks on all sides. Make sure the hooks are fully engaged with the windows on all sides. See **Fig. 7**.

**Fig. 7, Inflator Assembly Hooks**
