SUBJECT: SAFETY RECALL: ZF DRIVE AXLE HUB CARRIERS

Ref.: **NHTSA # 15V-389**
NHTSA # (ZF RECALL) 15E-048
Transport Canada # 2015-263
MCI Service Bulletin 425

<i>MODEL</i>	D / J4500 Series	<i>TYPE</i>	Field Change Program	<i>SECTION/GROUP</i>	2-Axle	<i>DATE</i>	July 30, 2015
<i>SUBJECT</i>	ZF DRIVE AXLE HUB CARRIER						
<i>CONDITIONS</i>

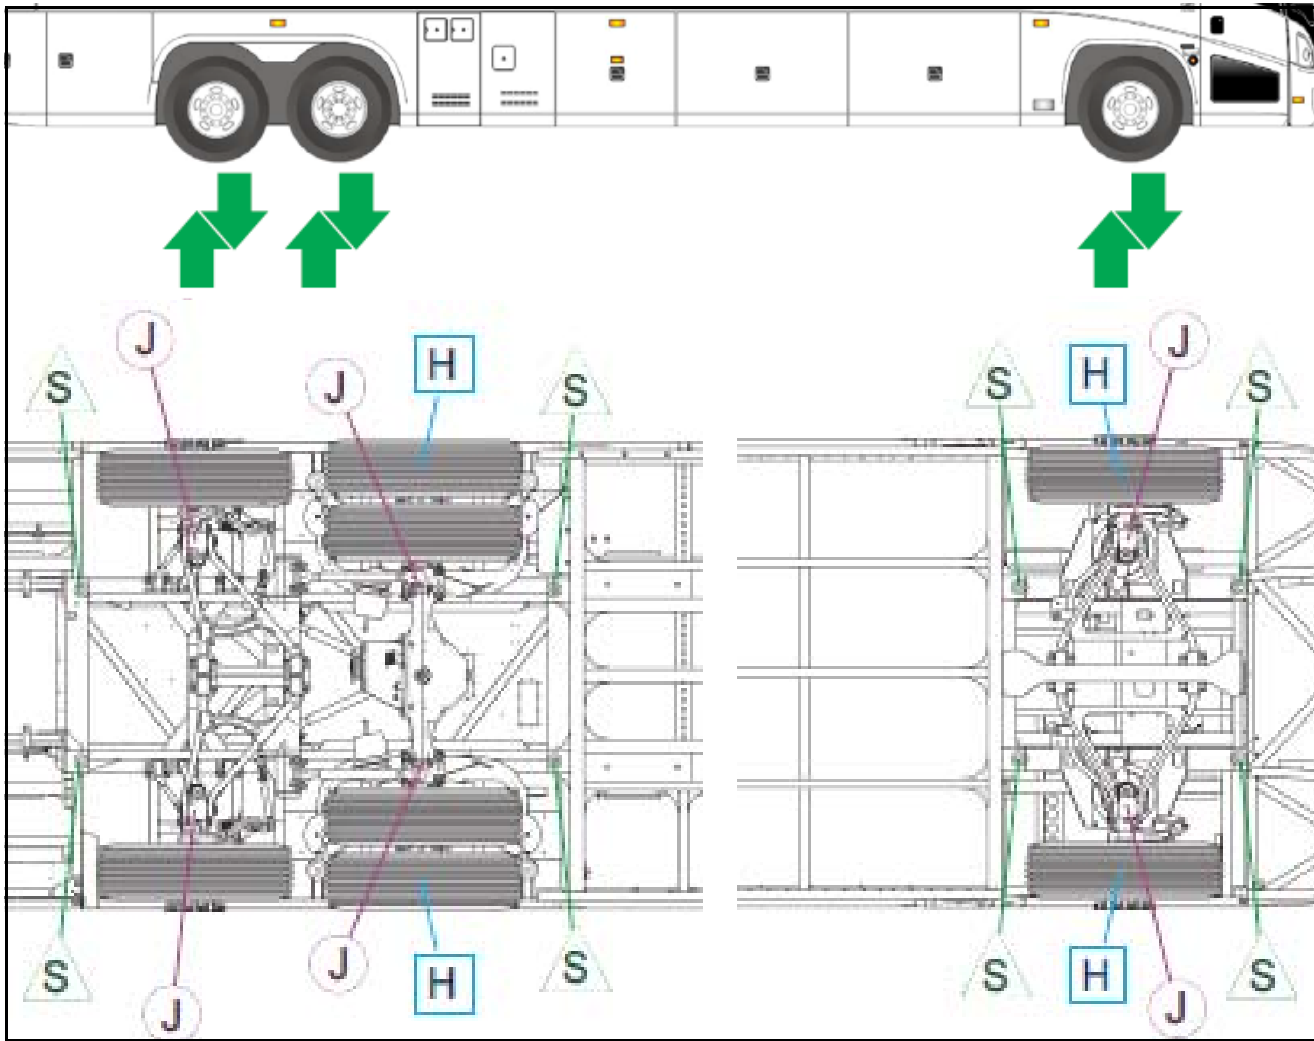
Figure 1. J4500 coach safety stands location.

Item	Figure 1 Description
S	Safety Stand (Primary locations)
J	Jacking Point
H	Hoisting Point

7. Lift the coach to desired work height. Position safety stands underneath the coach in only the specified locations shown in Section 3F in the MCI J4500 Maintenance Manual and Sections 3F and 3G in the MCI D Series Maintenance Manual (as shown in Figures 1 and 2 on Pages 4 or 5 of this document).

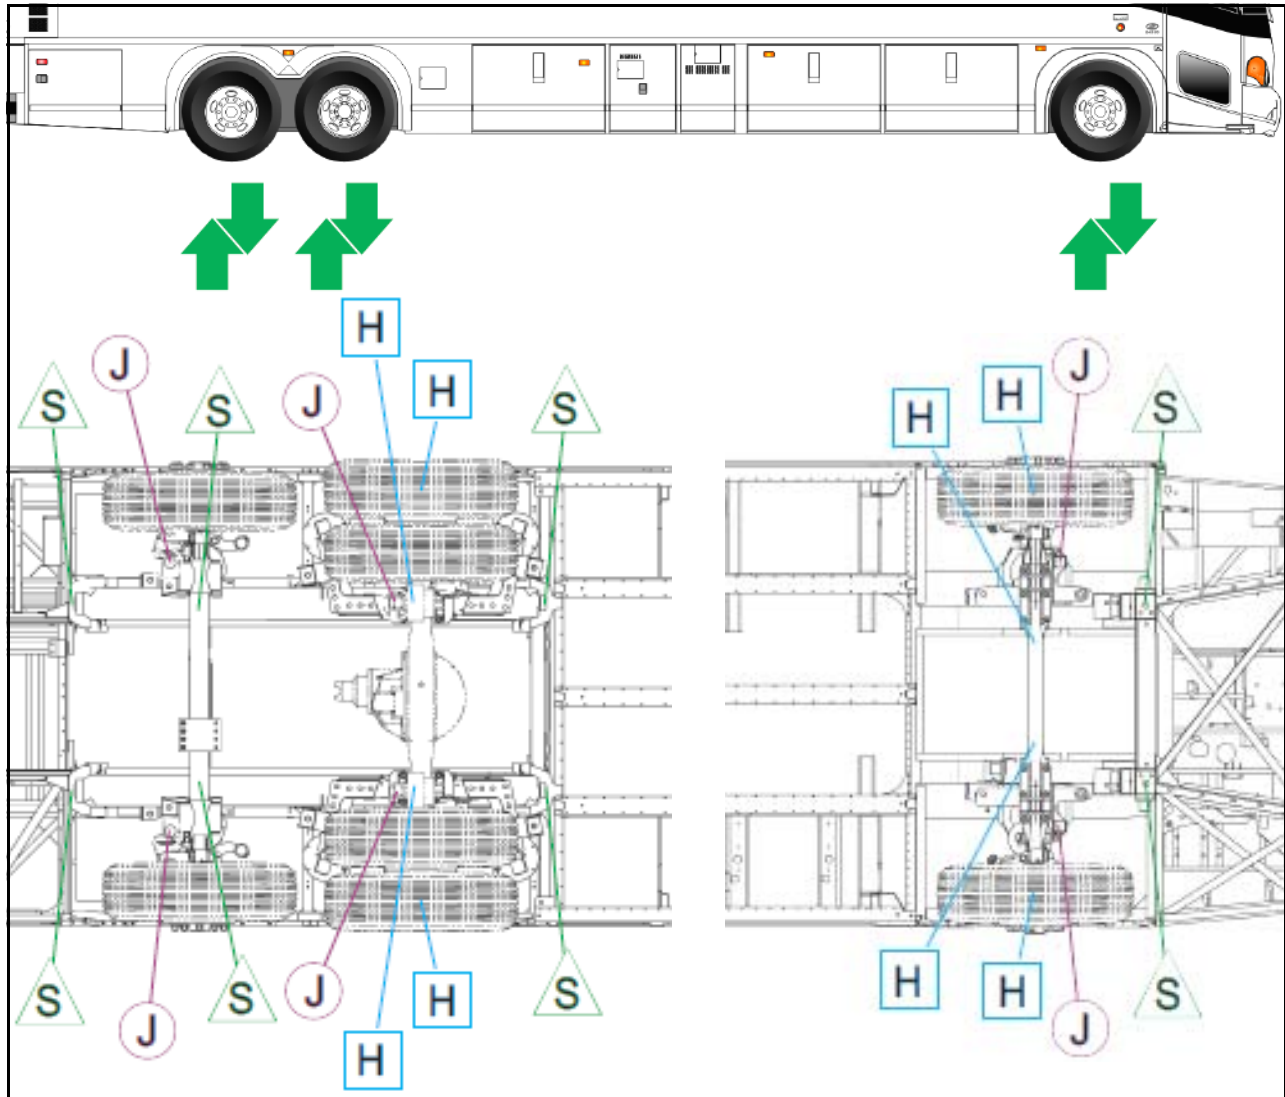
Figure 2. D Series coach safety stands location.

Item	Figure 2 Description
S	Safety Stand (Primary locations)
J	Jacking Point
H	Hoisting Point

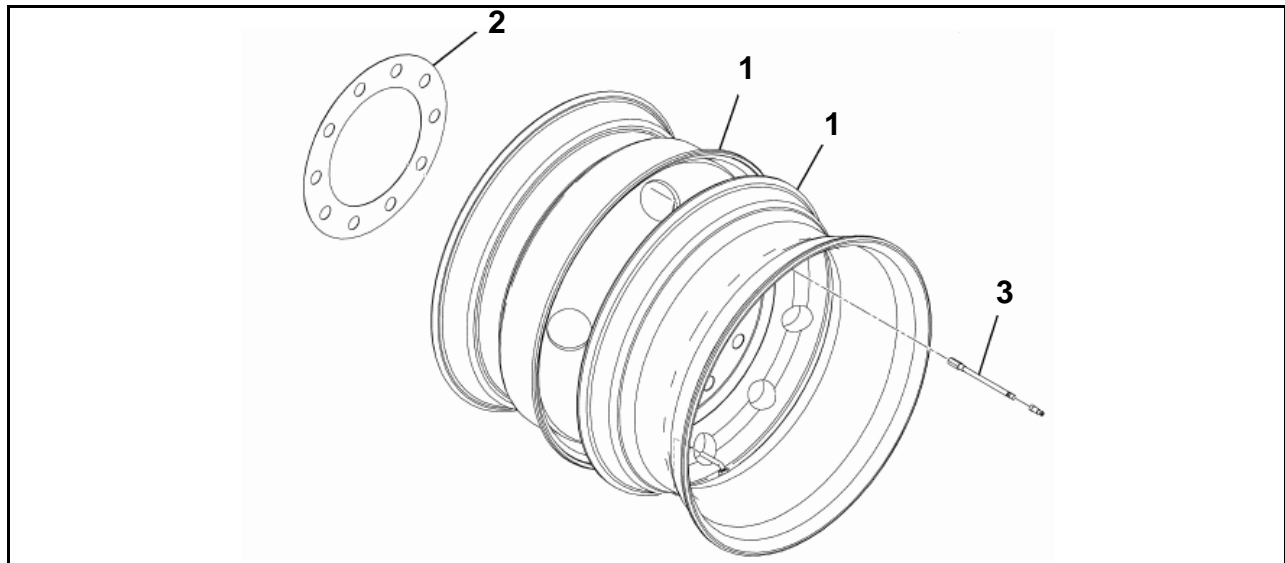
Figure 3. Drive axle wheel installation.

Item	Figure 3 Description
1	Wheel
2	Wheel guard spacer
3	Valve stem extension

Retain the wheel guard spacer ring for correct re-installation (refer to Figure 3).

Orient and align the inner tire valve stem extension with the outer wheel hub (Figure 3).

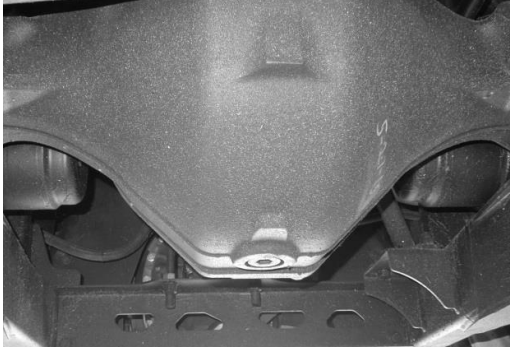
**1. Removing the oil from the axle.**

Using a 19mm or 3/4" Allen key socket remove the sump plug and drain down the oil in the axle into a clean dry and water free container.

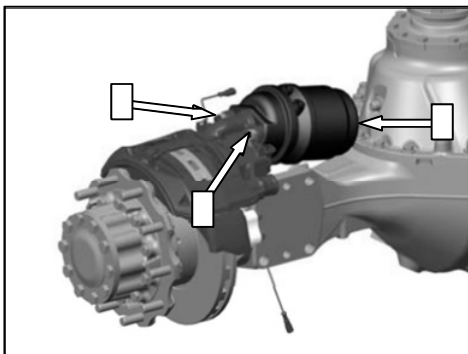
Removing the Brake Chamber.

Place vehicle on a suitable vehicle lift where the wheels can be removed in a safe manor and parking brake is disengaged.

Note: Make sure none of the electrical wiring to the ABS circuits are damaged and unplug the wear detection connectors at this point.

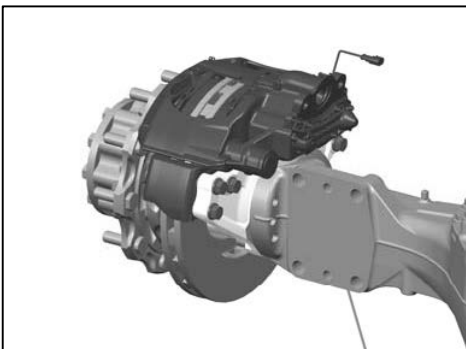
Removing the Brake Caliper Assembly

Using a short 10mm wrench back off the brake adjuster enough to pull the brake pads over any beading on the edge of the brake rotor.

Using special torque adaptors to remove the caliper carrier bolts, safely remove the brake caliper in upward direction using suitable lifting equipment.

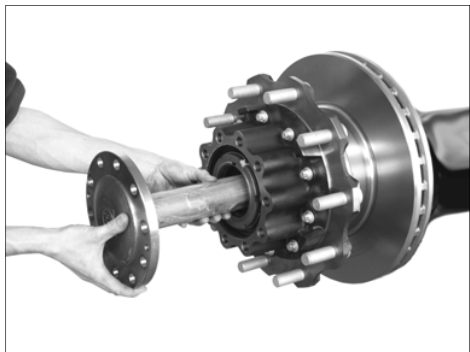
3. Disassembly of hub

Removing the Flange Shaft

Using a 14mm Allen Key Socket Loosen and remove all the screws from the flange shaft.

Pull flange shaft out of the axle using a tire lever on the end of one of the lug nut studs to the back of the flange.

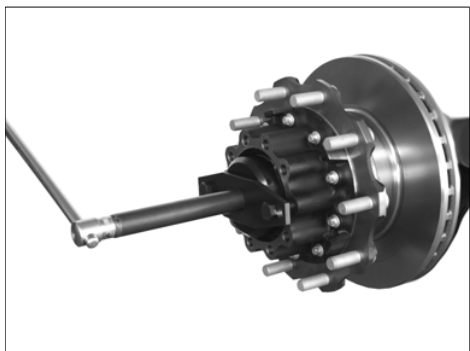
Remove the lock nut assembly.

Using a pin punch push the staked lock tab from the slot on the outer slotted nut far enough that the slotted nut is able to spin. (Tightened to 1200N/m (885 lbf.tf))

Using the special tool (5870 401 146) to loosen and remove the outer slotted nut and locking plate.

Again using the special tool (5870 401 146) loosen and remove the inner slotted nut (tightened to 850N/m (630 lbf.tf))

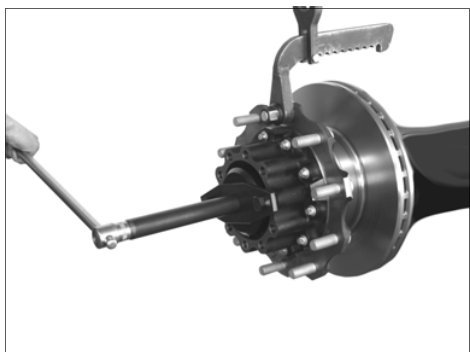
Remove the wheel Head.

Using a safe method of working, carefully remove the wheel head assembly and set aside.

(S) Load carrying fixture 5870.281.043

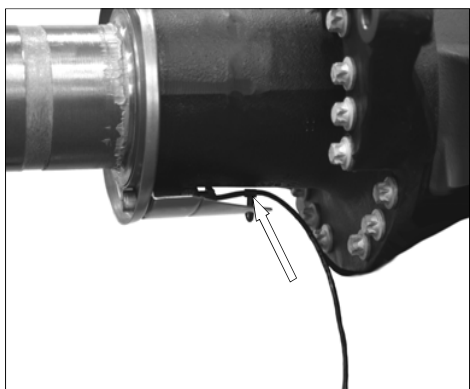
4. Disassembly of hub carrier

Removing the wheel head carrier

Gently remove the screen sheet from the hub carrier Using a hammer and drift around the circumference of the tube,

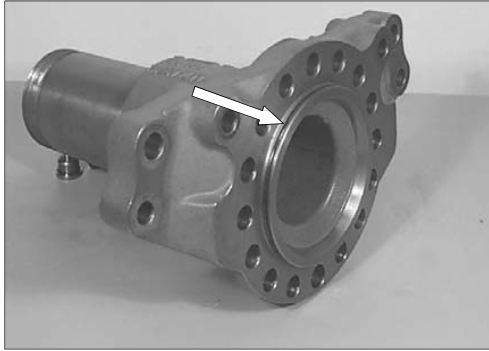
5. Reassembly of hub carrier

Take a new wheel head carrier from stock

Lubricate the O-ring (see arrow) and insert it into the annular groove on the hub carrier.

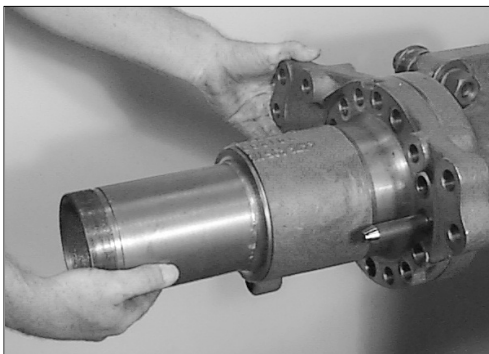
Slide the replacement wheel head carrier on to the locations pins (5870.204.029) as shown.

Fix wheel head carrier with cylindrical screws and washers making sure not to trap the o'ring.

Tightening torque (M18x1.5/10.9) $M_A = 440 \text{ N/m}$
 $= 325 \text{ lbf.tf}$

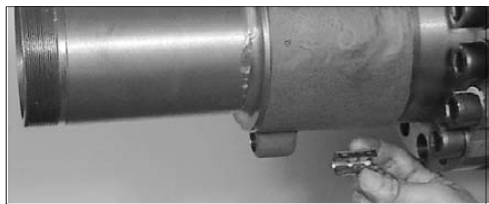
Reinstalling the ABS sensor assembly

Re-install ABS Sensor bushing into the hole on the hub carrier.

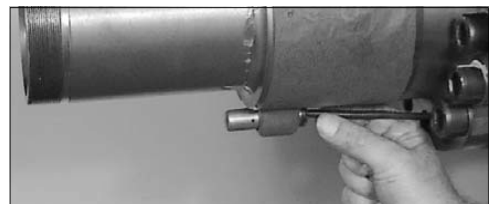
Re-install the ABS sensor by pushing the sensor in until it stops.

The sensor depth is set when the wheel head is fitted so cannot be incorrect unless it is not pushed all the way in at this stage.

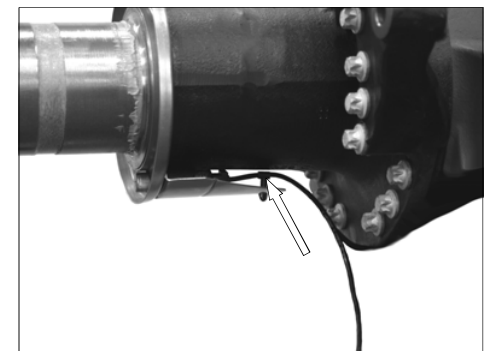
Refitting the Screen Sheet

Refit the original screen sheet or replace with a new item if old one was damaged during dis-assembly. This can be fitted by lightly tapping it on with a small hammer and soft punch until the shoulder is seated.

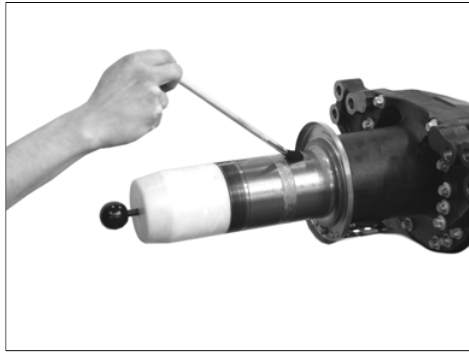
6. Reassembly of hub

Correct procedure for mounting wheel head Inc. Greasing

Note: To prevent hydro locking the wheel head at assembly the following procedure must be adhered to.

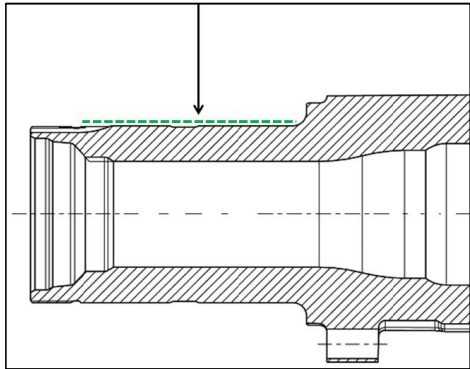
Greasing Procedure

Grease only on the area shown at the point of the arrow.

Note: the grease is used to provide a corrosion resistance coating only.

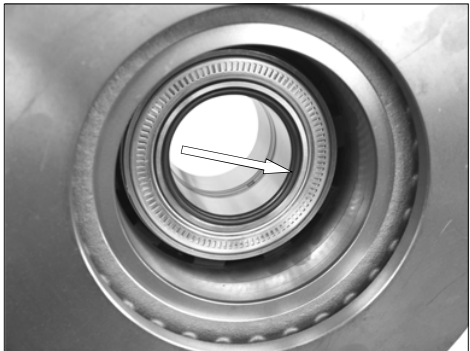
Re-fitting the wheel head.

Remove o'ring from compact bearing annular groove.

Lightly lubricate the O-ring and re- insert it into the annular groove (see arrow). This is the inner side of the rotor.

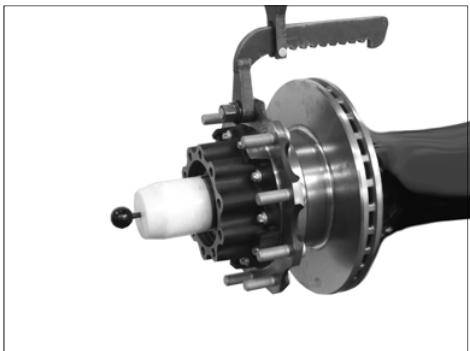
Carefully mount the preassembled hub to the hub carrier using a safe method of working or by means of the load carrying fixture supplied (5870.281.043) until contact is obtained.

Screw on inner slotted nut with the chamfer facing towards you and again using the slotted nut wrench (5870.401.146) Pre-tighten the inner slotted nut to a torque of:
Torque $M_A = 100 \text{ N/m} = 74 \text{ lbf.tf}$

This will effectively push the ABS sensor into the correct position (expect a grinding noise). Rotate the hub several times in each direction and using a rubber mallet strike the rotor every half turn to seat the compact bearing o'ring.

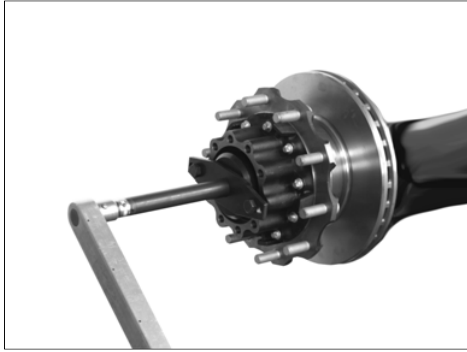
Final torque for inner slotted nut.

Again using the slotted nut wrench (5870.401.146)
Tightening the inner slotted nut to the specified torque:

Torque (Inner Slotted nut) $M_A = 850 \text{ N/m} = 627 \text{ lbf.ft}$

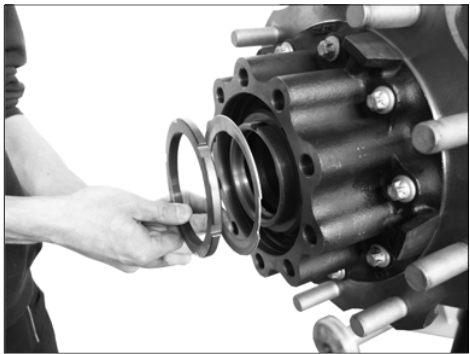
Mount locking plate with the tab facing towards the differential.

With the chamfer also facing towards the differential, screw the outer slotted nut up to the lock plate and torque.

Torque (outer slotted nut) $M_A = 1200 \text{ N/m} = 885 \text{ lbf.ft}$

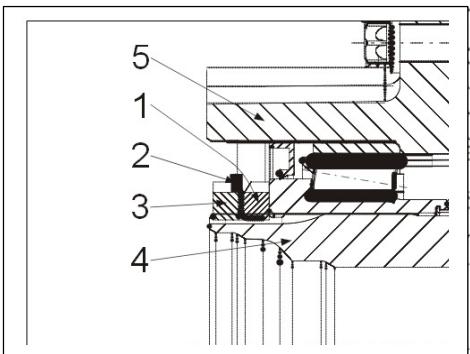
☞ Legend:

- 1 = Inner slotted nut
- 2 = Locking plate
- 3 = Outer slotted nut
- 4 = Hub carrier
- 5 = Hub

Note: Ensure correct installation position. Also see legend below for exact slotted nut and lock plate orientation.

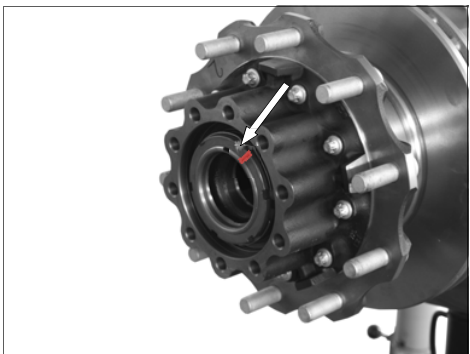
Secure slotted nut by Staking the locking plate into any of the slots of the outer slotted nut, taking care not to damage the mating surface of the wheel end, where the flange shaft o'ring is seated!

☞ **Note:** This is absolutely critical and must deform the lock plate enough to stop the outer slotted nut from spinning should the tightening torque be lost!

☞ **Note:** You **MUST** torque seal (shown with red paint) over the outer slotted nut onto the end of the hub casting so that any movement during service can be viewed on inspection.

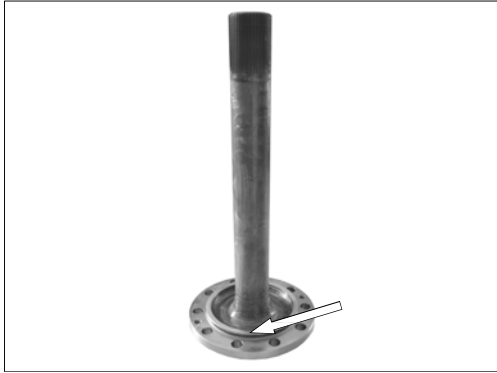
Re-installing the flange shaft.

Lubricate the O-ring (see arrow) and insert it into the annular groove of the flange shaft.

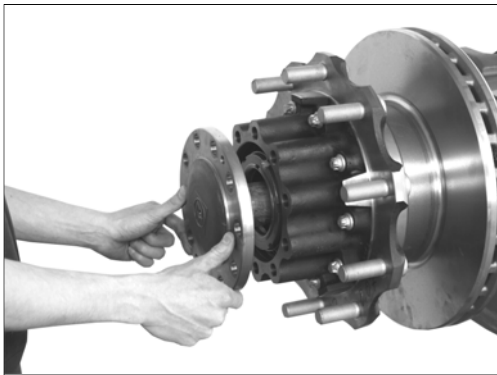
Insert the flange shaft into the hub carrier and gently locate the differential splines.

Push the flange up to the wheel end.

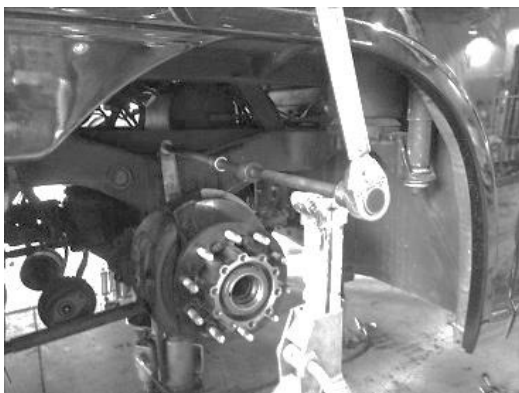
Mount brake caliper assembly to axle.

The Fitted screw must be nipped tight before torquing begins.

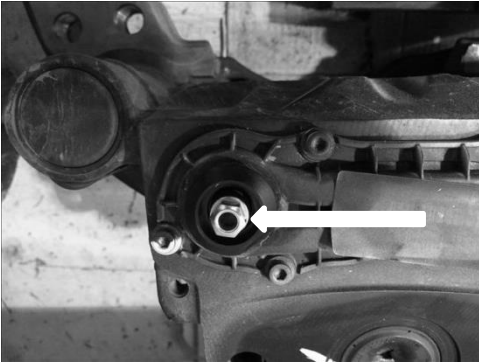
Adjusting the brake using a short 10mm wrench

While spinning the rotor adjust the brake in a clockwise direction until the rotor is no longer able to spin.

Back off adjuster 2 clicks and the clearance is set.

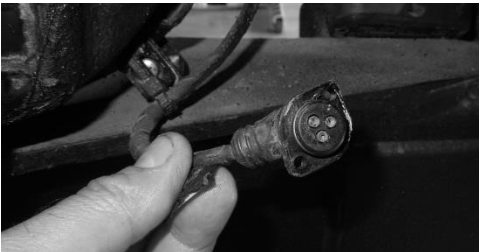
Refitting the wear indicator

Where relevant refit the connectors to the caliper to prevent electrical errors.

Refit the brake cylinder and torque the 2 x 24mm lock nuts to $M_A = 190 \text{ N/m}$
 $= 140 \text{ lbf.ft}$

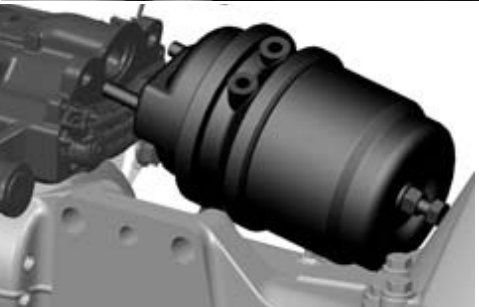
Recommendation

The Use lifting cart has been recognized as good method of lifting the parts on and off for safe working practice.

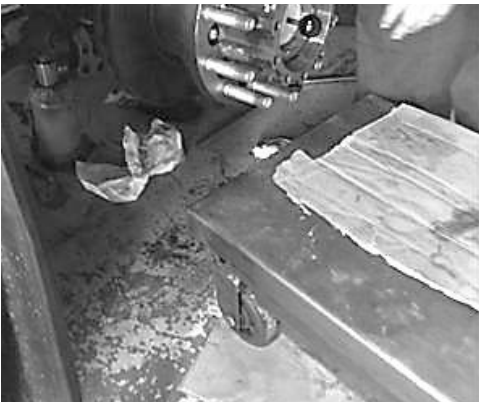
8. Refilling with the saved oil

Take the saved oil in the clean container and refill the axle

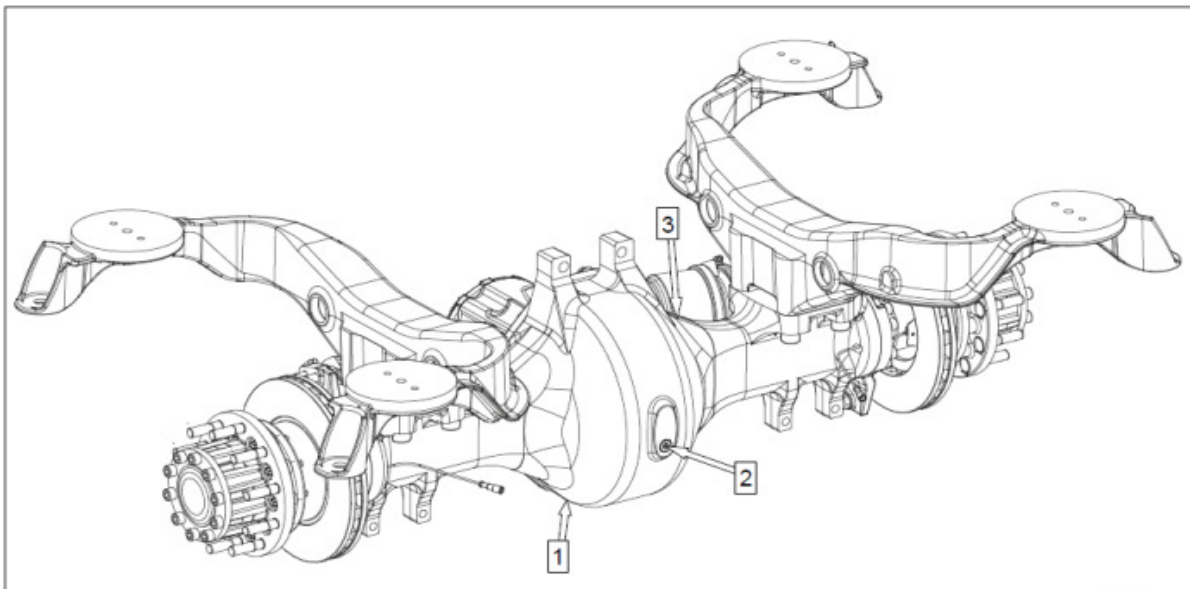
Fig. 1

Precondition for a correct oil change is the proper installation of the axle in each direction. Place the vehicle into a horizontal position.
