Safety Recall

Code: 24BL

**Subject: 2014-2015 MY Jetta, Beetle, Beetle Convertible, Passat
2015 MY Golf/GTI
Fuel Rail Leak**

Section B – Fuel Rail Replacement

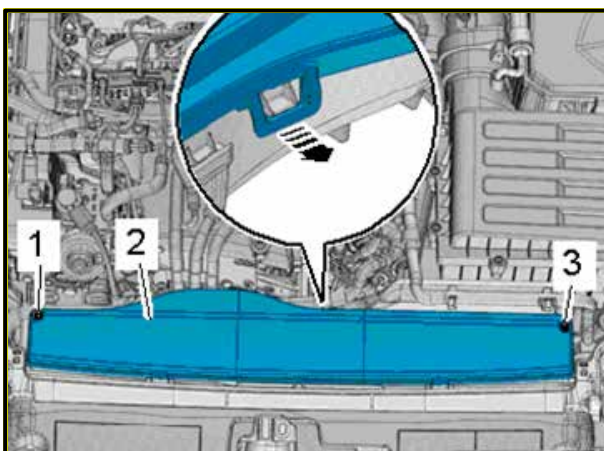
- Ü Remove the mounting bolts <1 and 3>.
- Ü Release the locking tab <arrow>.
- Ü Remove the air inlet cover <2>.

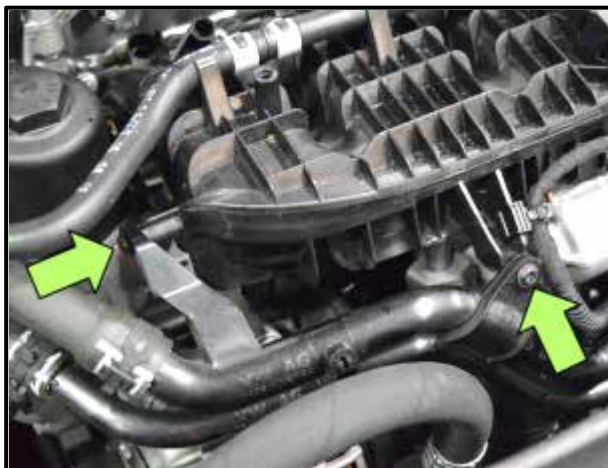
- Ü Remove the mounting bolts <arrows> for the coolant line from the intake manifold.

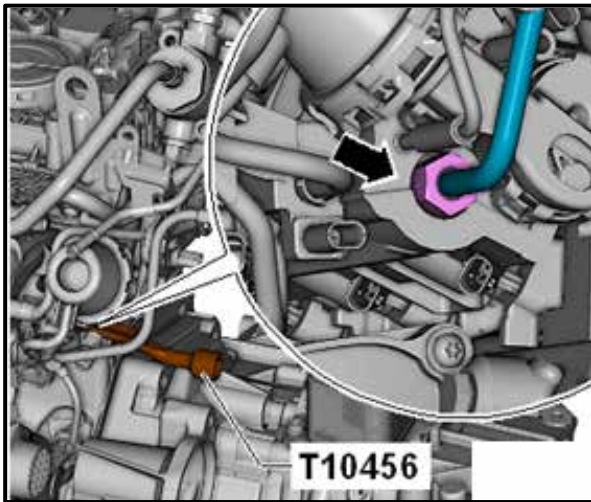
- Ü Loosen the union nut on the fuel rail <arrow> with the Flare Nut Attachment 17mm – T10456 and remove the high pressure line <as shown>.

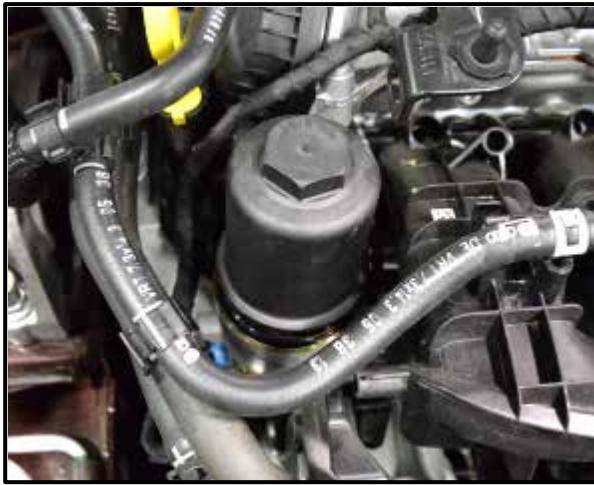
- Loosen and remove the oil filter.

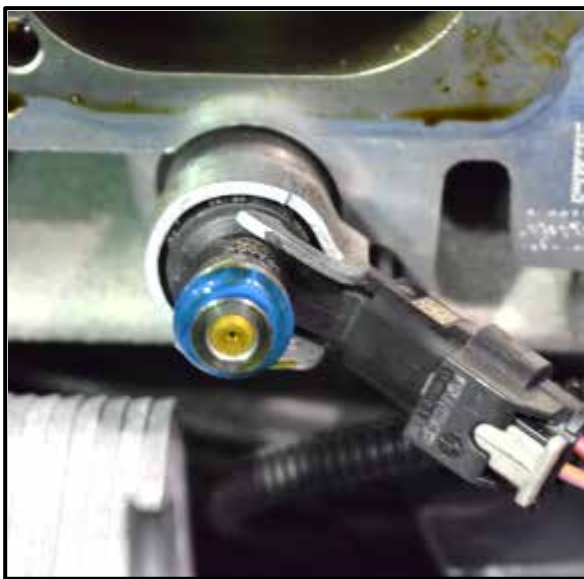
- Lubricate the upper o-ring on each fuel injector with clean engine oil <as shown>.

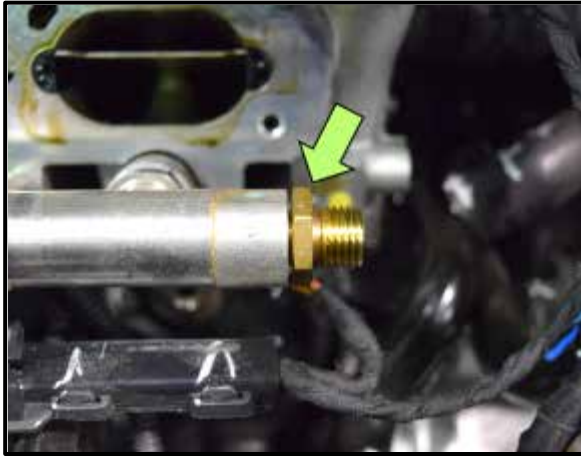
- Install the new fuel line adapter <arrow>, P/N 06K127065B, into the end of the fuel rail and torque to 40Nm.

CAUTION: The fuel line adapter **MUST** be torqued properly during this step. Failure to follow the torque specifications could result in a fuel leak.

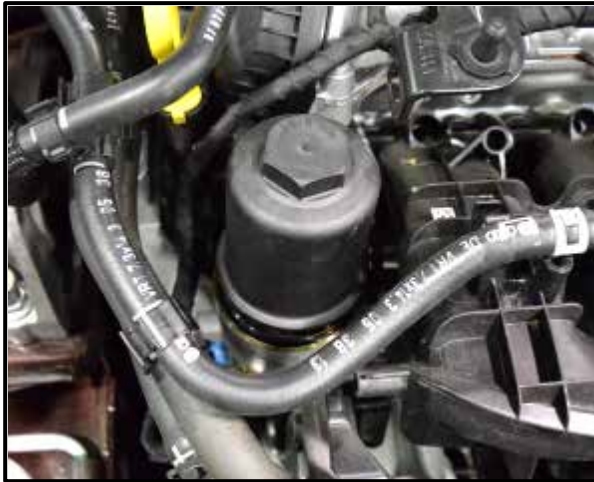
Ü Reinstall the oil filter.

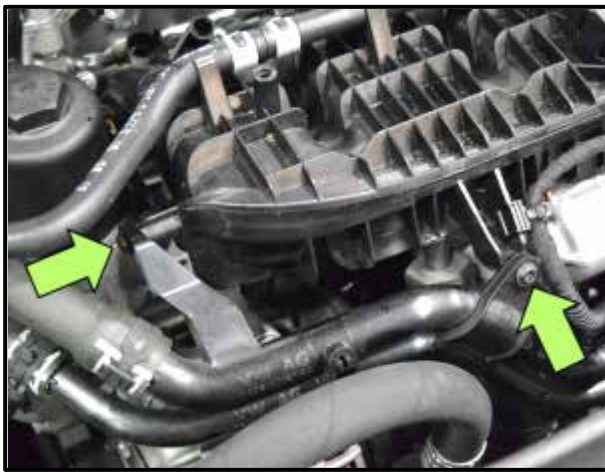
- Ü Reinstall the coolant hose mounting bolts <arrows>.
