# NON-COMPLIANCE RECALL J050 [NHTSA# 15V-037]: OCS HANDBOOK DESCRIPTION INCORRECT - UPDATE

SERVICE  
BULLETIN

NO.: 7-096USA

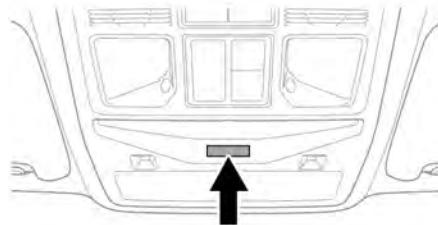
E164858

When checking the operational status of the front passenger air bag, make sure that the ignition is switched on.

\* It is possible to receive an intermittent indicator illumination with an empty seat. This is part of the system's adaptive behavior and does not affect the status of the front passenger air bags. However, if the indicator becomes permanently illuminated when the seat is empty and the seat belt is unbuckled, contact your Dealer/Authorized Repairer immediately.
