Dealer Service Instructions for:

Safety Recall R06 / NHTSA 15V-046 Occupant Restraint Control Module

Models

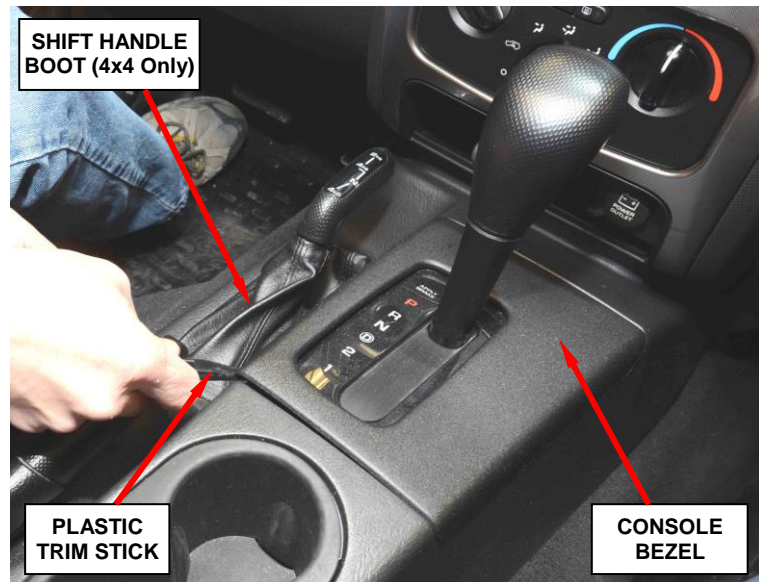
Figure 1 – Center Console Bezel and Shift Boot

1. Open the hood and disconnect the negative battery cable from the battery.
2. Remove and save the gear shift lever center console bezel (Figure 1).
3. Apply the park brake and place gear shift lever in the neutral position.
4. **For vehicles equipped with four wheel drive**, place the four wheel drive selector handle in the “four wheel low” position.
5. **For vehicles equipped with four wheel drive**, remove and save the four wheel drive lever shift handle boot (Figure 1).
6. **For vehicles with power windows**, remove and save the front window switch assembly (Figure 2).

26. **For vehicles equipped with four wheel drive**, install the four wheel drive lever shift handle boot (Figure 1).

27. Install the gear shift lever center console bezel (Figure 1).

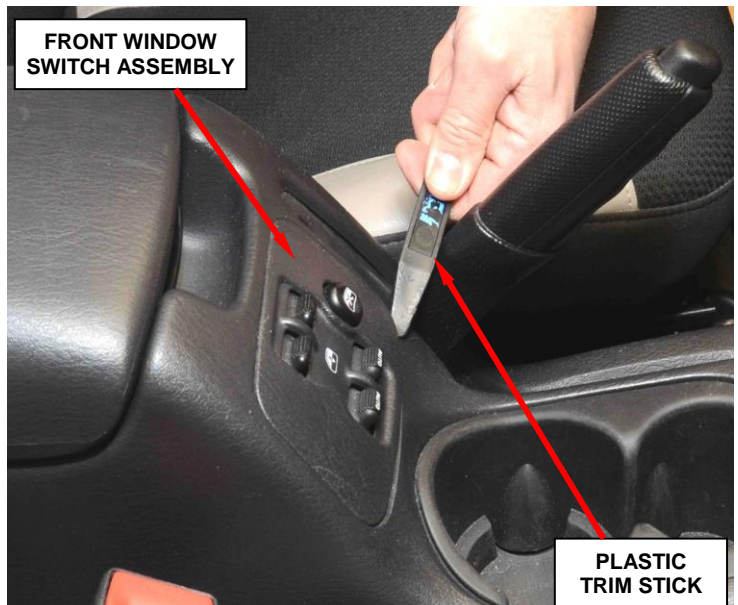
Figure 2 – Front Window Switch Assembly

25. Install the front window switch assembly (Figure 2).

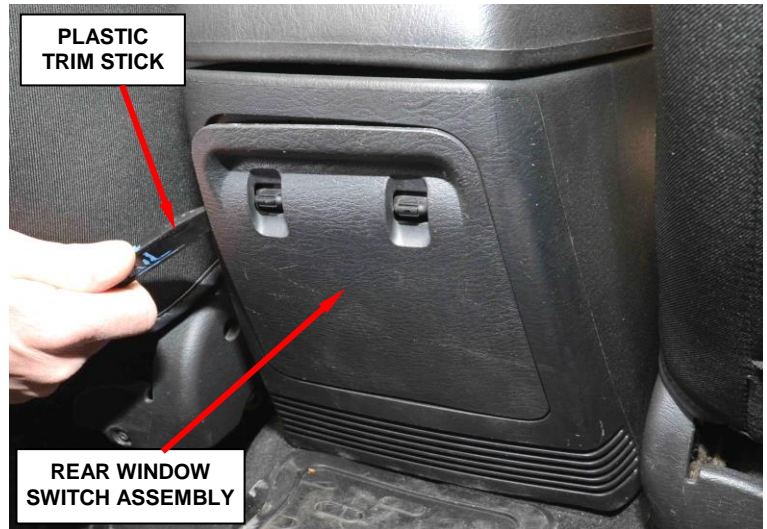
7. Remove and save the rear window switch assembly from the center console (Figure 3).
8. Remove and save the four center console retaining screws.
9. Carefully remove and save the center console assembly.
10. **For vehicles that had Safety Recall M35 performed,** remove and discard the foil mastic patch from the ORC module rubber cover (Figure 4).

Figure 3 – Rear Window Switch Assembly

24. Install the rear window switch assembly (Figure 3).

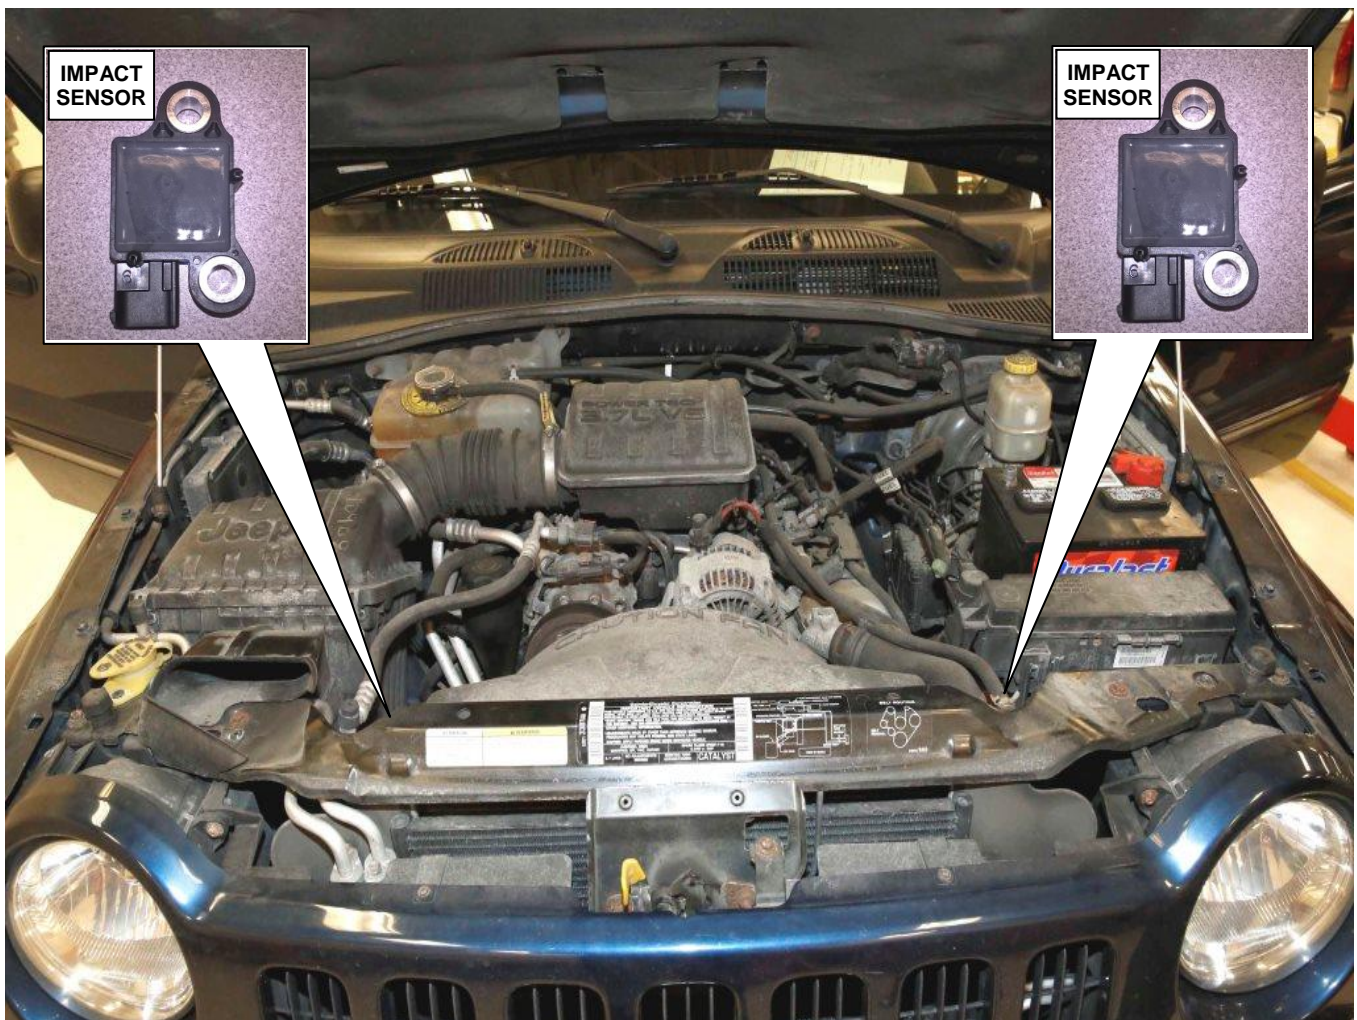
NOTE: The front impact sensors are located to the right and left of the radiator on the radiator support vertical member (Figure 10).

2. Remove and save the two mounting bolts on the front impact sensor.
3. Disconnect the electrical connector from the front impact sensor.
4. Remove and discard the original front impact sensor.

Figure 10 – Front Impact Sensor Location

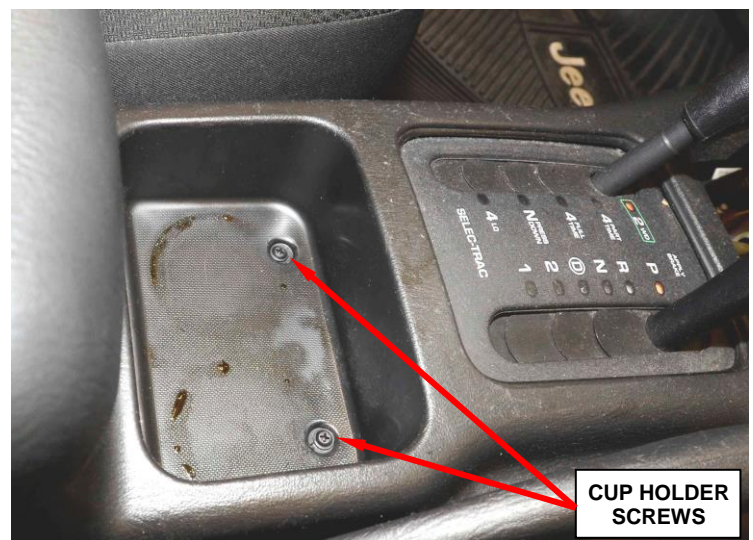
1. Disconnect the negative battery cable.
2. Remove and save the center console using the following procedure:
 - a. Remove and save the two retaining screws in the console storage bin (Figure 11).
 - b. Remove and save the cup holder insert from the console (Figure 11).
 - c. Remove and save the two screws under the cup holder insert (Figure 12).

**Figure 12 – Cup Holder Screws**

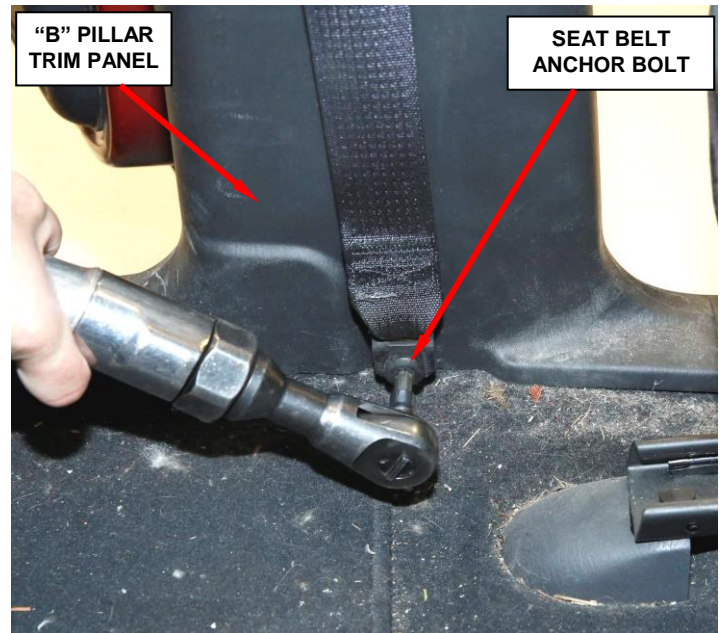
10. Install the center console.
11. **For vehicles that require side impact sensor replacement,** perform the following steps:
 - a. Remove and save the seat belt anchor bolt (Figure 21).
 - b. Remove and save the “B” pillar trim panel (Figure 21).
 - c. Remove and discard the original side impact sensor (Figure 22).
 - d. Install the new side impact sensor. Tighten the retaining bolts to 105 in. lbs. (12 N·m).

Figure 21 – Seat Belt Anchor Bolt

- e. Install the “B” pillar trim panel.
- f. Install the seat belt anchor bolt (Figure 21).
- g. Repeat Steps 11a. through 11f. on the opposite side of the vehicle to replace the second side impact sensor.

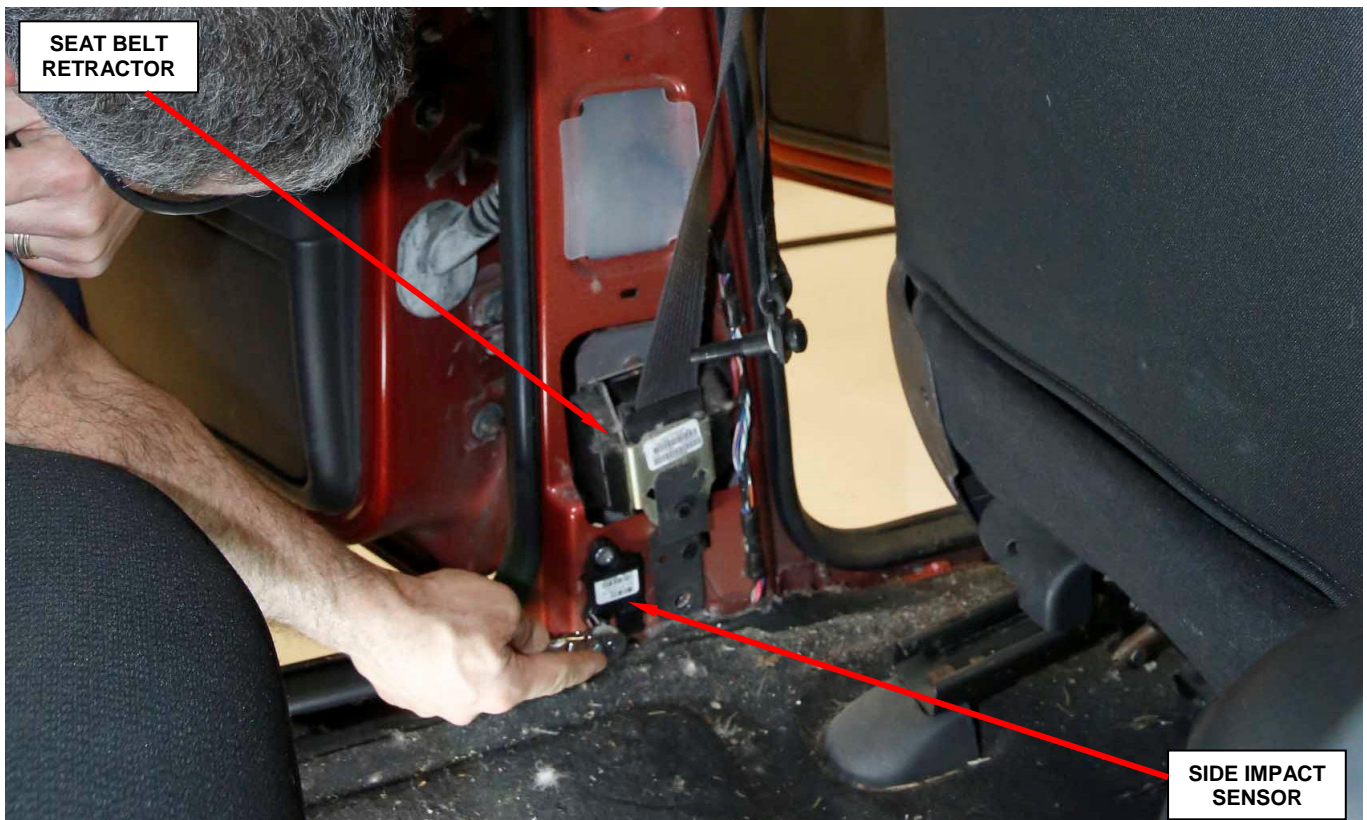
Figure 22 – Side Impact Sensor Location

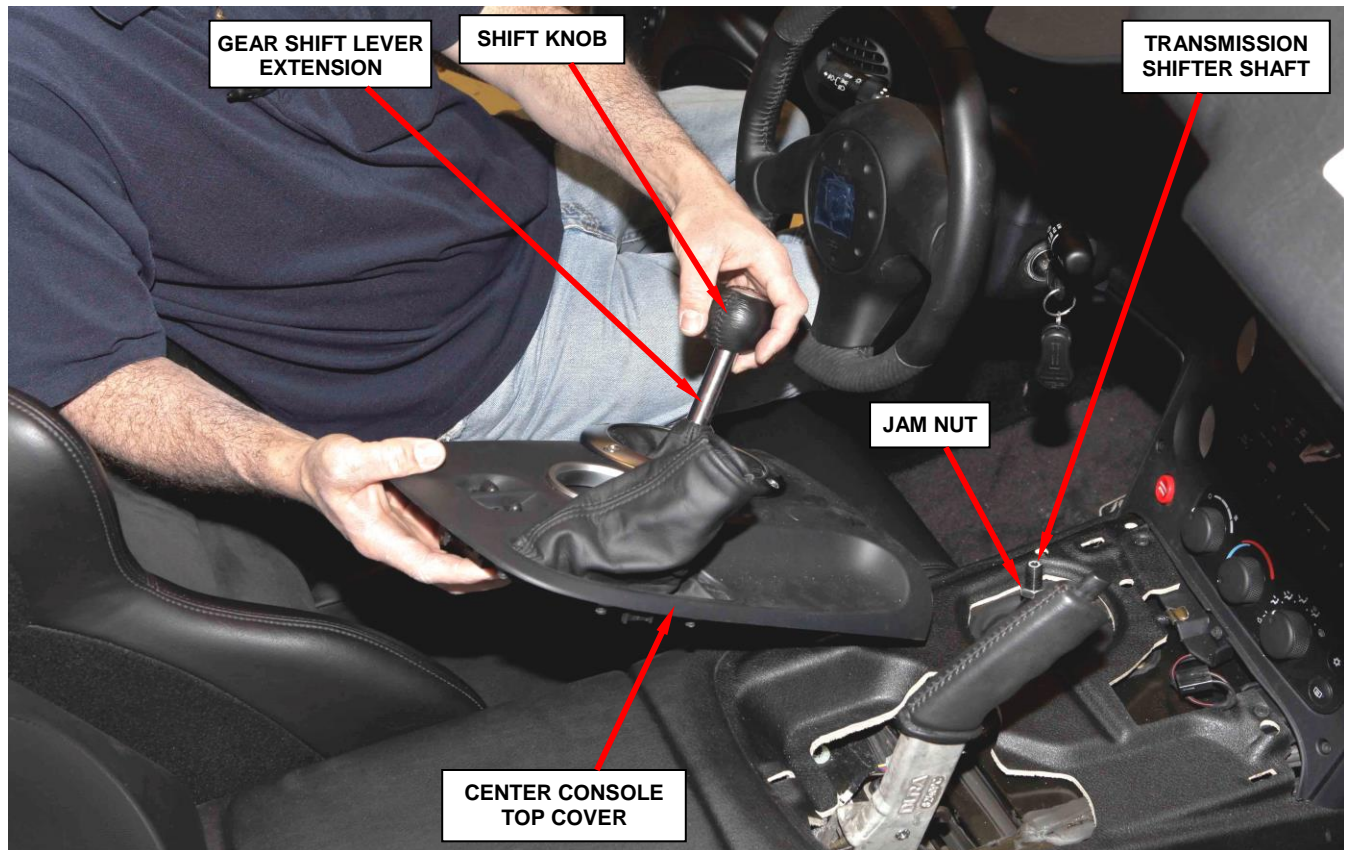
**Figure 24 – Center Console Top Cover**

5. Disengage the center console top cover from the center console (Figure 24).
6. Reaching under the center console top cover, loosen the jam nut that retains the gear shift lever extension to the transmission shifter shaft (Figure 24).
7. Unscrew and save the gear shift lever extension and gear shift ball as an assembly (Figure 24).
8. Remove and save the center console top cover (Figure 24).

30. Install the radio assembly (Figure 26).
31. Lower the steering column.
32. Install the instrument cluster bezel (Figure 29).
33. Install the left instrument panel speaker cover (Figure 28).
34. Install the steering column. Tighten the four steering column retaining nuts to 150 in. lbs. (17 N·m).
35. Install the left side knee bolster (Figure 27).
36. Install the instrument panel center stack bezel (Figure 25).
37. Place the center console top cover partially into position (Figure 24).
38. Screw the gear shift lever extension onto the transmission shifter shaft.

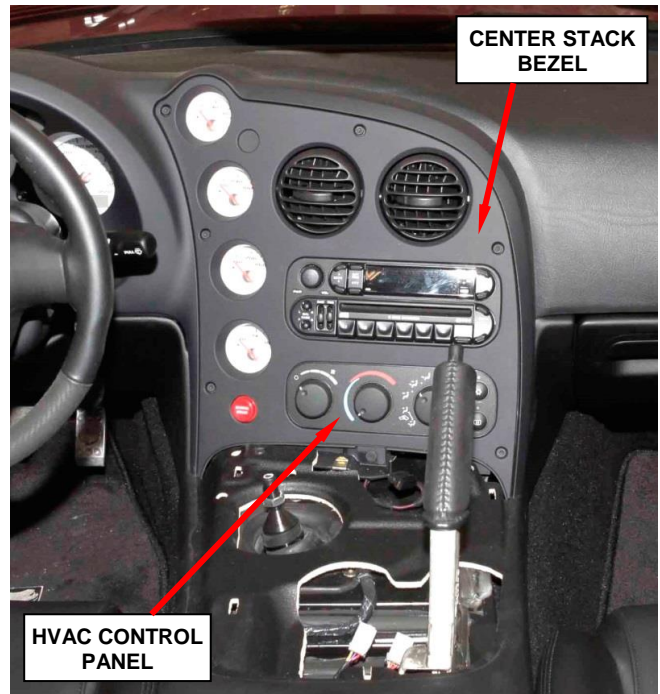
9. Remove and save the eight instrument panel center stack bezel retaining screws and then remove the center stack bezel and HVAC control panel as an assembly (Figure 25).

Figure 25 – Center Stack Bezel

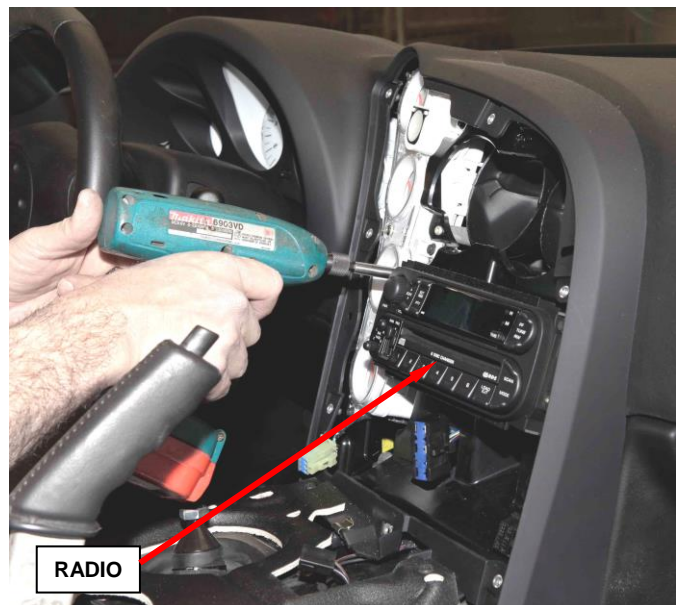
10. Carefully remove and save the radio (Figure 26).

Figure 26 – Radio Remove/Install

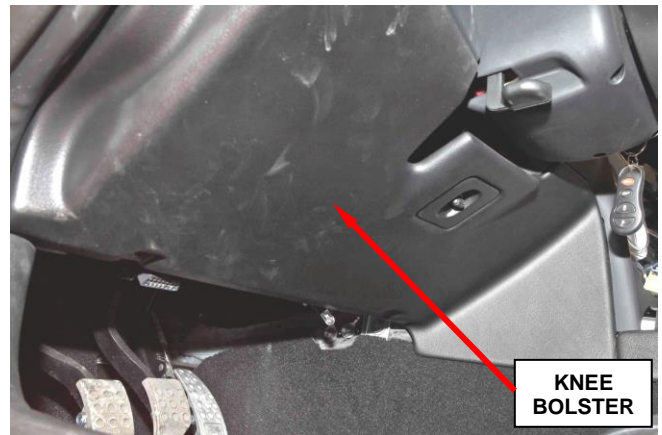
11. Remove and save the left side knee bolster (Figure 27).

Figure 27 – Knee Bolster

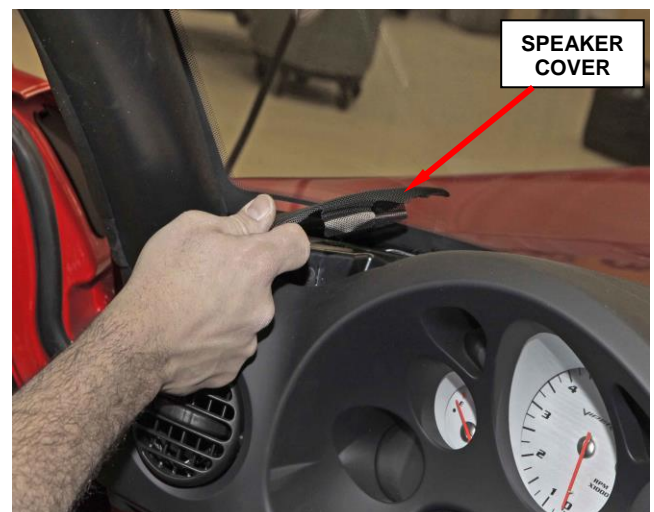
12. Remove and save the left instrument panel speaker cover (Figure 28).

Figure 28 – Left Speaker Cover

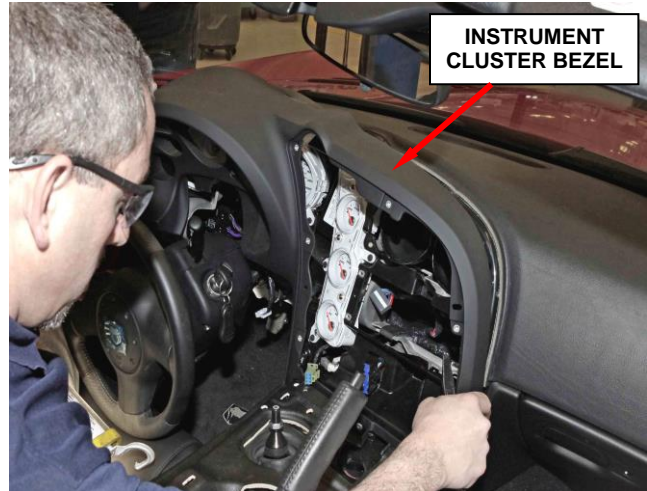
14. Remove and save the instrument cluster bezel (Figure 29).
15. Remove and save the instrument panel center stack white gauge cluster (Figure 30).
16. Remove and save the instrument panel black plastic frame retaining screws (Figure 30).
17. Temporarily reinstall the steering column.

Figure 29 – Instrument Cluster Bezel

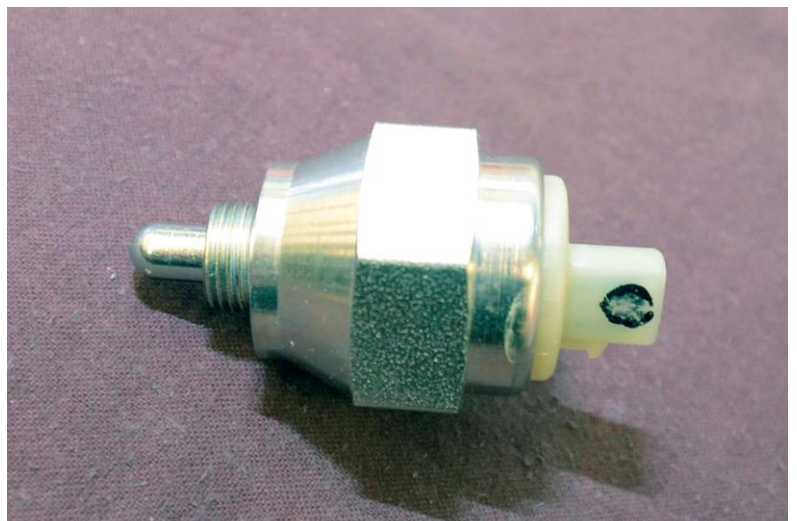
5. Using a 1 ½ inch socket, remove and discard the original transfer case four wheel drive indicator light switch (Figure 34).
6. Install the new transfer case four wheel drive indicator light switch. Tighten the switch to 20 ft. lbs. (27 N·m).
7. Place the transfer case shift cable bracket and shift cable into position.
8. Install the three transfer case shift cable bracket mounting bolts. Tighten the bolts securely.
9. Connect the transfer case shift cable to the transfer case lever on the transfer case.
10. Lower the vehicle from the hoist.

**Figure 34 – Transfer Case Switch**
