Recall Campaign: Head Protection System (Left Side)

F15 (X5) produced from August 30, 2013 to February 18, 2015

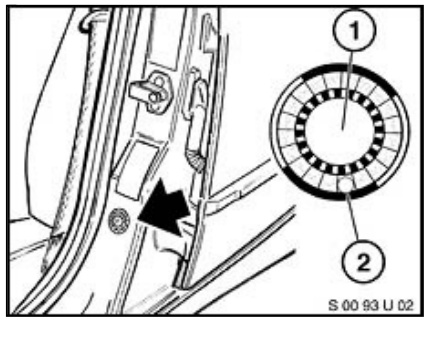
LABEL INSTRUCTIONS

<p>This Recall Campaign has been assigned code number 737. After the vehicle has been checked and/or corrected, obtain a label (SD 92-461) and:</p> <ul style="list-style-type: none"> A. Emboss your BMW center warranty number in the middle of the label (1); B. Punch out code number 737 (2), printed on the label; and C. Affix the label to the B-pillar as shown.
---	---

If the vehicle already has a label from a previous Service Action/Recall Campaign, affix the new label next to the old one. Do not affix one label on top of another one, because a number from an underlying label could appear in the punched-out hole of the new label.
