This Service Information bulletin supersedes SI B65 05 15 **dated March 2015**.

NEW **Recall Campaign: Head Protection System (Right Side)**

NEW F15 (X5) produced from August 30, 2013 to February 18, 2015

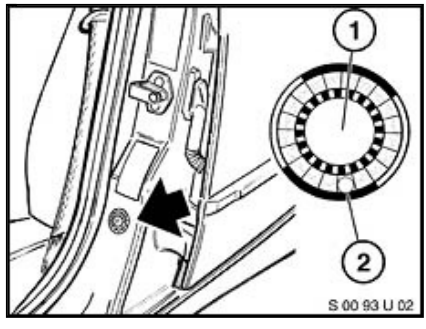
NEW LABEL INSTRUCTIONS

<p>This Recall Campaign has been assigned code number 736. After the vehicle has been checked and/or corrected, obtain a label (SD 92-461) and:</p> <ol style="list-style-type: none"> Emboss your BMW center warranty number in the middle of the label (1); Punch out code number 736 (2), printed on the label; and Affix the label to the B-pillar as shown.
---	---

First check if a Recall Campaign label with a code number **736** is already attached to the B-pillar.

If a code number **736** has been punched out, the Campaign has already been performed and no further action is necessary.

If the vehicle already has a label from a previous Service Action/Recall Campaign, affix the new label next to the old one. Do not affix one label on top of another one, because a number from an underlying label could appear in the punched-out hole of the new label.
