SI B65 11 15  
Audio, Navigation, Monitors, Alarms, SRS

## Recall Campaign 15V-318: Driver's Front Air bag Module (Final Repair)

## MODEL

Model Years 2002-2006

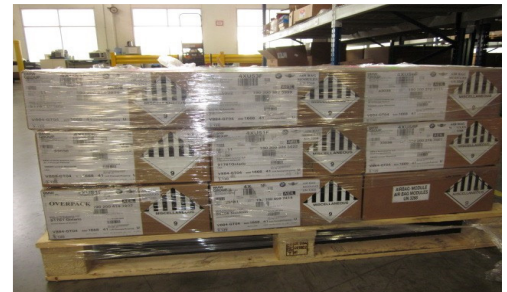
Place the recall airbag components neatly on a pallet, and securely shrink-wrap them to the pallet.

**Note:** The total height of the pallet and boxes cannot exceed 60 inches.

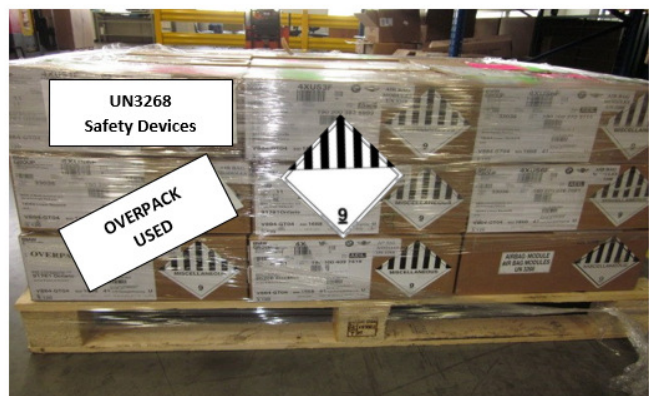
Securely attach the following labels on each side of the shrink-wrapped pallet.

- o Class 9 Label
- o UN3268 Safety Device \*
- o OVERPACK USED \*

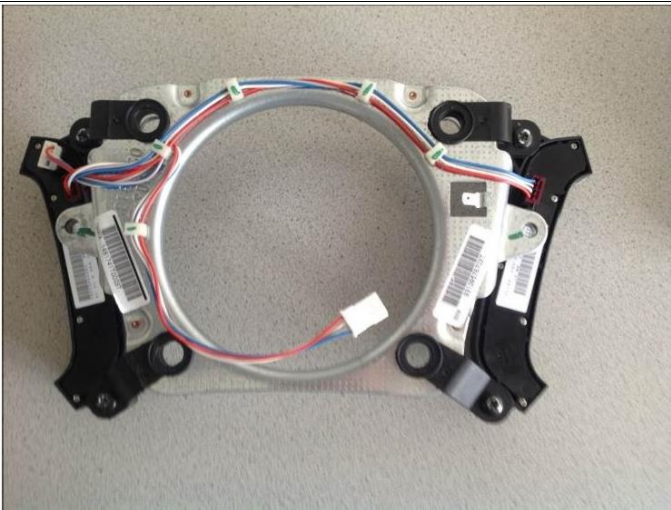
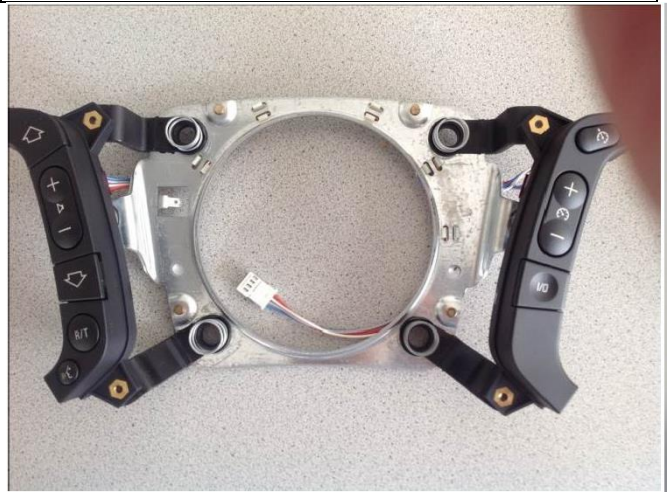
After disassembly:

- 1- Module
- 2- Horn Ring with MFL
- 3- Horn contact path
- 4- Torx bolt
