SIB 65 11 15

**RECALL 15V-318: DRIVERS FRONT AIR BAG MODULE (FINAL REPAIR)**

This Service Information Bulletin (Revision 9) supersedes SI B65 11 15 dated **December 2022**.

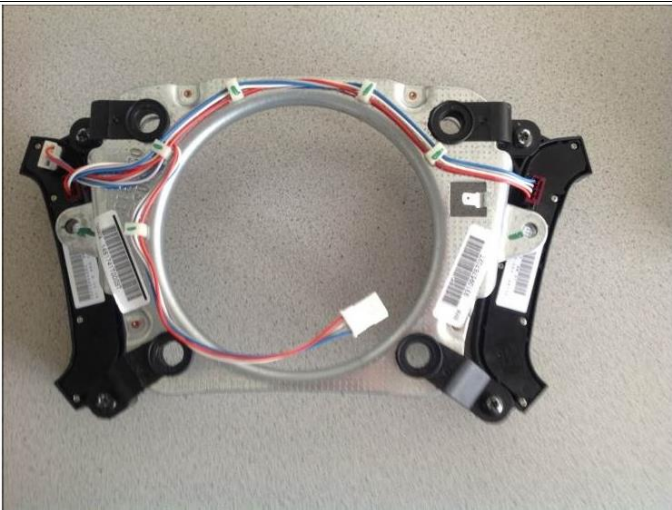
After disassembly:

- 1- Module
- 2- Horn Ring with MFL
- 3- Horn contact path
- 4- Torx bolt
